Service Bulletin: SB A119-302; Agusta A119 Air Conditioner Compressor Mount Inspection.

Subject: Supplemental Inspection requirements for the A119 Compressor Mount.

Applicability: Agusta A119 Helicopter, Equipped with the Air Comm Corporation A119-200-1 Air Conditioning System.

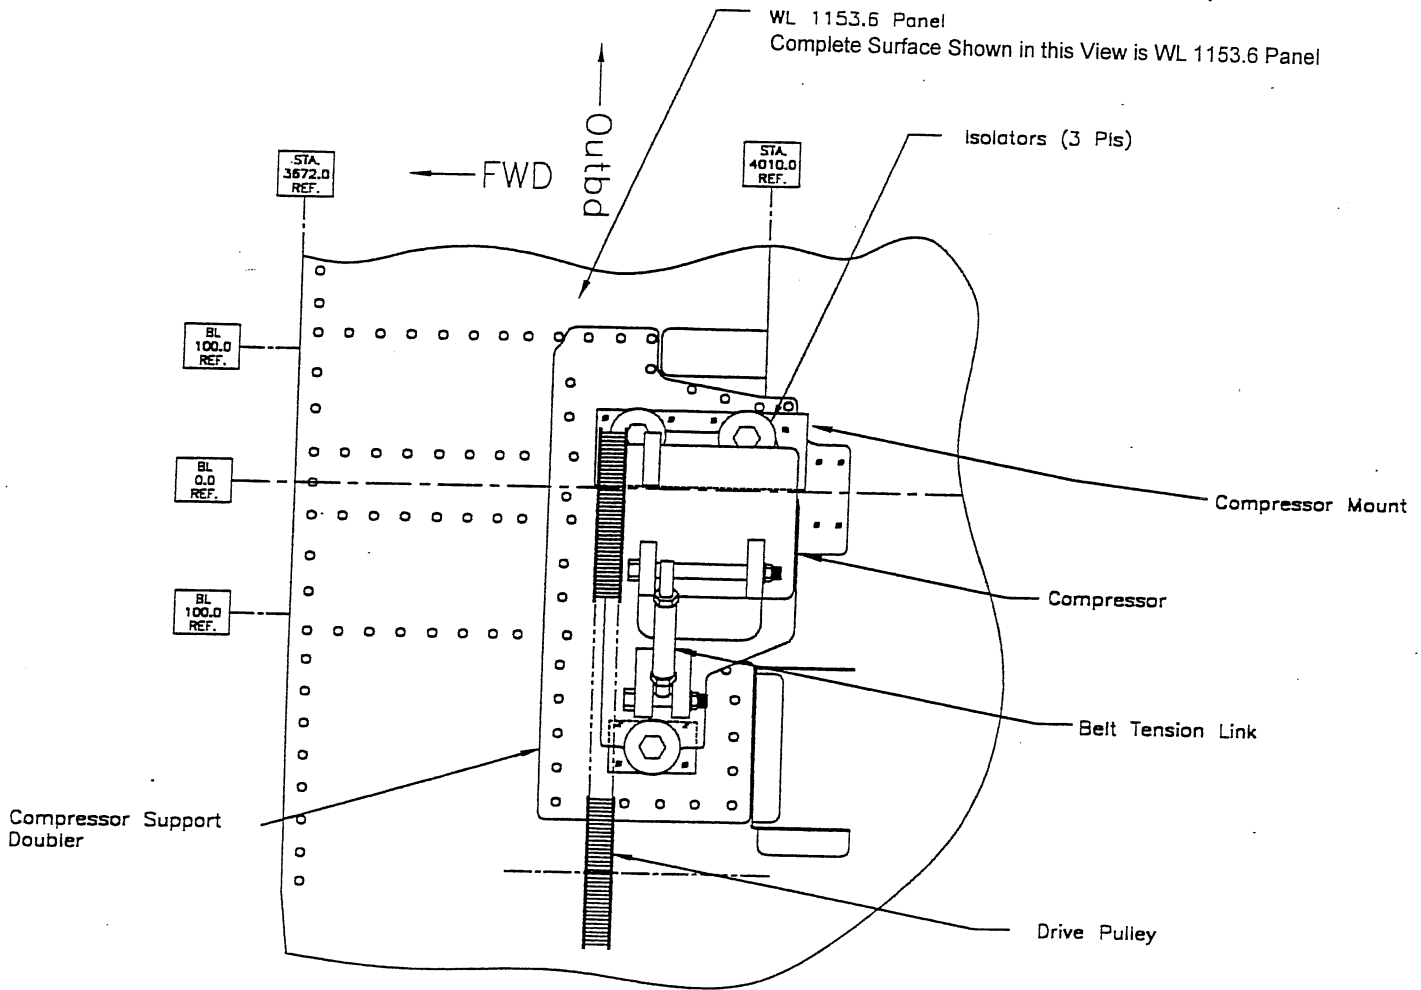
Figure 1-1, Compressor Installation. (View looking Down)

The original air conditioning system encountered cracking in the WL 1153.6 skin panel at the Compressor Mount attaching points.

1. Check the structural integrity of the following components
 - a. Compressor Lugs, check for cracking (**Note: No cracks are allowable**).
 - b. Compressor Mount Lugs, check for cracks (**Note: No cracks are allowable**).
 - c. Compressor Pivot, and Belt Tension Arm Bolts, check for condition, and security.
 - d. Check for cracks in Compressor Support Doubler, and WL 1156.3 Engine Deck area. (**Note: No cracks are allowable**).
 - e. Check lower surface of WL 1156.3 of the Engine Deck, in the area of the compressor mounting rivets, for rivet condition and/or skin cracks. Access through Aircraft Maintenance Steps above fuel cell area, and Engine Deck Access Panel. Use of Flashlight and Inspection Mirror is required. (**Note: No cracks are allowable**).

- a. Incorporation of rubber compressor mount isolators.
- b. Incorporation of a structural doubler between the compressor mount and the engine deck.
