**Service Bulletin:** SB A119-3024; Agusta A119 Air Conditioner Oil Cooler Inlet Screen Assembly, Engine Governor Control Cable Guard and Replacement of Compressor Drive Belt.

**Subject:** Installation of A119 Air Conditioner Oil Cooler Inlet Screen Assembly, Engine Governor Control Cable Guard and Compressor Drive Belt.

**Date:** 25 July 2005.

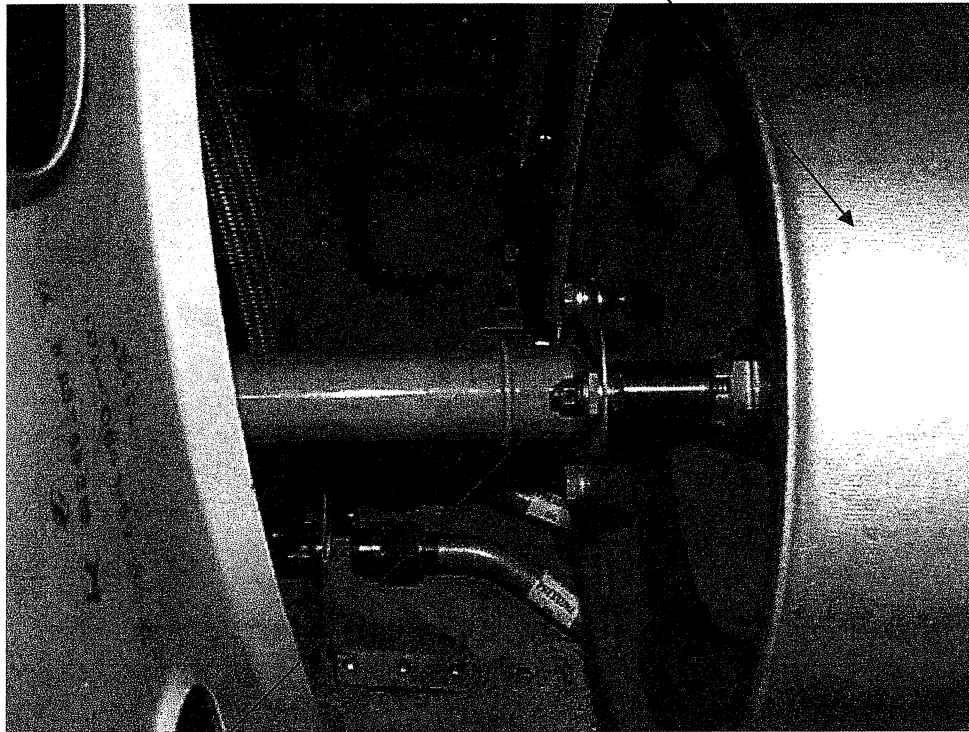
Figure 1

Oil Cooler Housing

Drive Shaft Coupling

1. Disconnect the oil cooler drive shaft coupling just forward of the oil cooler blower inlet area per Agusta A119 Service Manual.

Insure that the oil cooler drive shaft is supported so as not to damage the driveshaft or coupling disc.

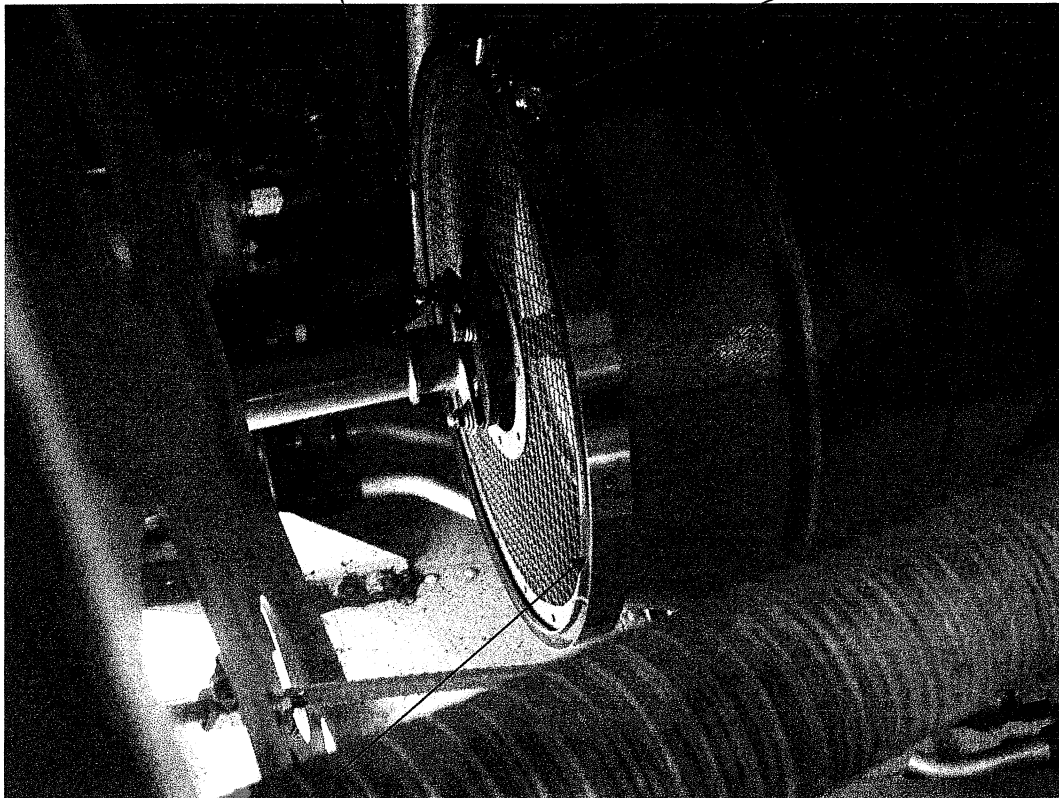
Figure 2

A119-3024-1 Inlet Screen

Clamp retaining nut

994FM-1075 Clamp

1. Install A119-3024-1 screen assembly between the driveshaft segments placing the screen securely on the forward flange of the oil cooler blower housing.
2. Install the 994FM-1075 clamp around the screen and blower housing flange, and secure in place. Torque the clamp retaining nut to 50 in-lbs, and safety the retaining bolt and clamp halves using .032 safety wire.
3. Reconnect the oil cooler drive shaft coupling just forward of the oil cooler blower inlet area per Agusta A119 Service Manual.

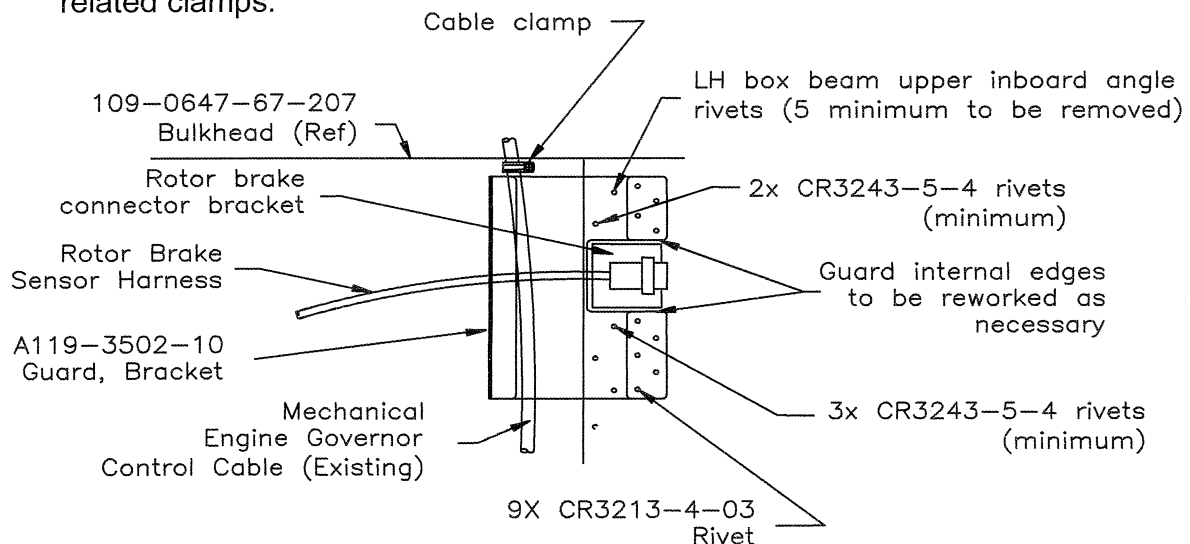
**Figure 3**

The A119-3502-10 Guard mounts to the top side of LH box beam (see Figure 3) in front of bulkhead 109-0647-67-207.

1. Remove the two shims attached to the A119-3502-10 Guard by removing existing rivets. Discard the shims.
2. Fill the holes on the Guard where the rivets holding the shims were installed with MS20426A4 rivets.
3. Remove 5 rivets from LH box beam upper inboard angle (3 forward and 2 aft of Rotor Brake Connector Bracket).

- Align the Guard as shown in Figure 3 and verify clearance with the Rotor Brake Connector Bracket.

- Evaluate location of the Rotor Brake Connector Bracket and the resultant rivet edge distance on the Guard.
  - If a minimum edge distance of 2 times the diameter cannot be achieved rework the Guard on one of the internal edges until the edge distance becomes acceptable.
  - If position of the Rotor Brake Connector Bracket does not allow the installation of Guard it is acceptable to trim the internal edges of the Guard.
  - If position of the Rotor Brake Connector Bracket does not allow the installation of Guard remove the bracket and relocate it one rivet forward (rivets to be used CR3243-5).

- Protect reworked areas with primer.
- Install the bracket using proseal 890 (or equivalent) and the Cherry rivets as indicated in Figure 3.
- Relocate mechanical governor cable to avoid chafing with Guard by relocating related clamps.
