Service Bulletin: SB A119-306; Agusta A119 Air Conditioner Compressor Drive Belt Change from "Cogged" to Poly-V Belt.

Subject: Removal & Replacement of A119 Air Conditioner Compressor Drive Belt Design Change.

Date: 26 August 2005, Rev D (previous revisions never issued).

Applicability: Agusta A119 Helicopter, Equipped with the Air Comm Corporation A119-204-1 & -2 Air Conditioning Systems.

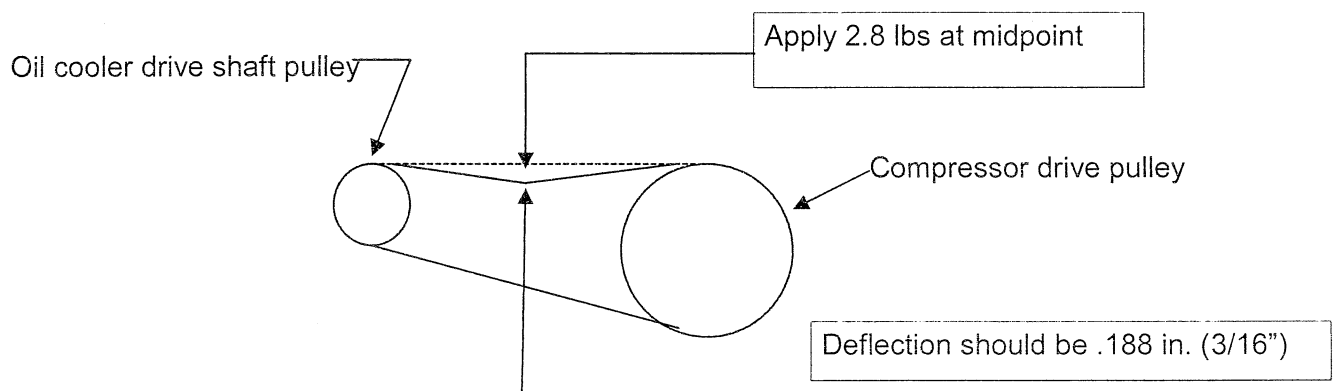
Proper belt tension is important to insure a long belt service life and to avoid excessive loads on the compressor, and bearing assemblies.

When applying 2.8 lbs. of force to the mid span of the belt the deflection should be .188 inches (3/16")

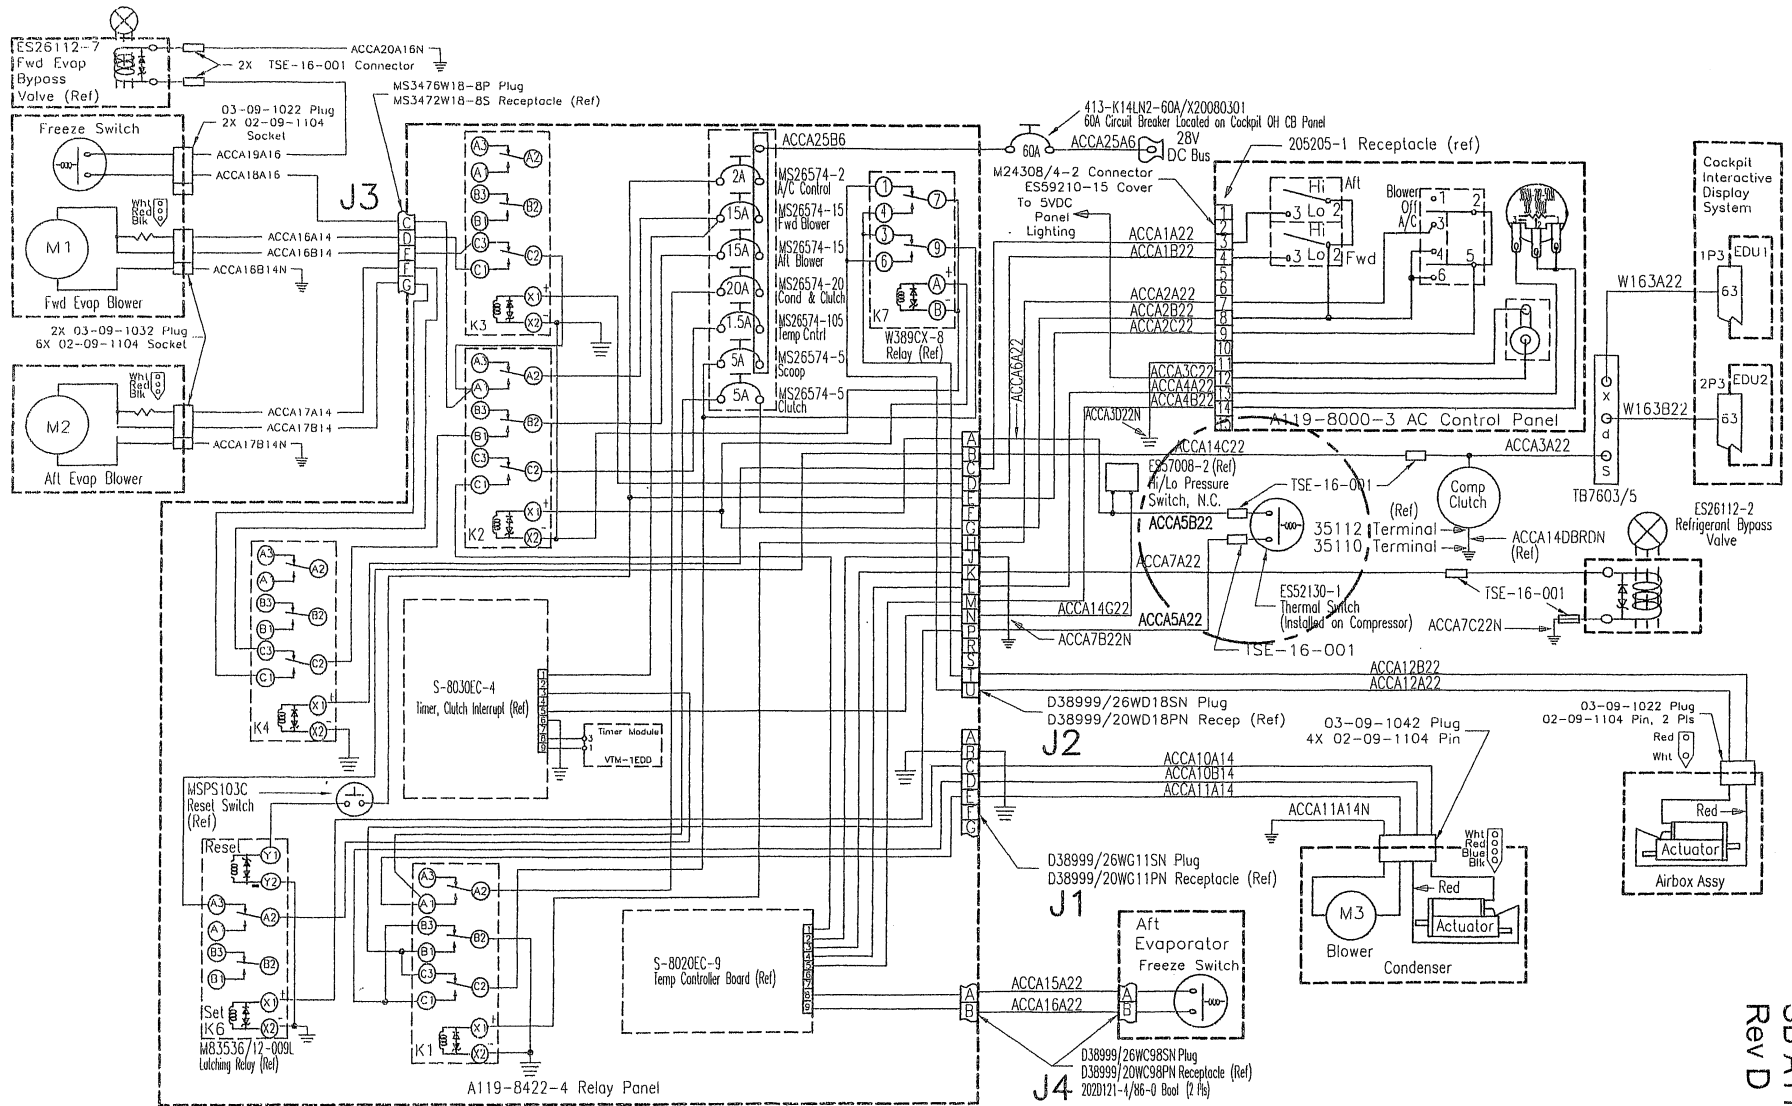
Figure 1.1
Electrical Installation

2. Disconnect #8 and #10 refrigerant lines from the ports located on the aft side of the air conditioner compressor body. Remove and discard O-rings from hose fittings. Cap lines to prevent contamination, and oil loss from the system.
3. Cut safety wire, and loosen Jam nuts on compressor belt tensioning link assembly. Turn the barrel section of the link assembly to loosen the compressor belt tension.
4. Disconnect the Compressor clutch wire at the compressor.
5. Disconnect and Cap wires ACCA5A22 & ACCA5B22 connecting to the compressor temperature sensor wires using two each 35115 caps, and secure wires as necessary. (Figure 1.1)

The new A119-3040-1 Compressor assembly is not equipped with a temperature sensor, therefore the need to cap and secure wires ACCA5A22 & ACCA5B22 is required to comply with this Service Bulletin.
