Service Letter: No. 319

Subject: Relocation of Air Conditioning System Charging/Service Ports.

Applicability: Bell Model 412 and 412EP which are equipped with the ACC 412EC-100 cabin Air Conditioning System.

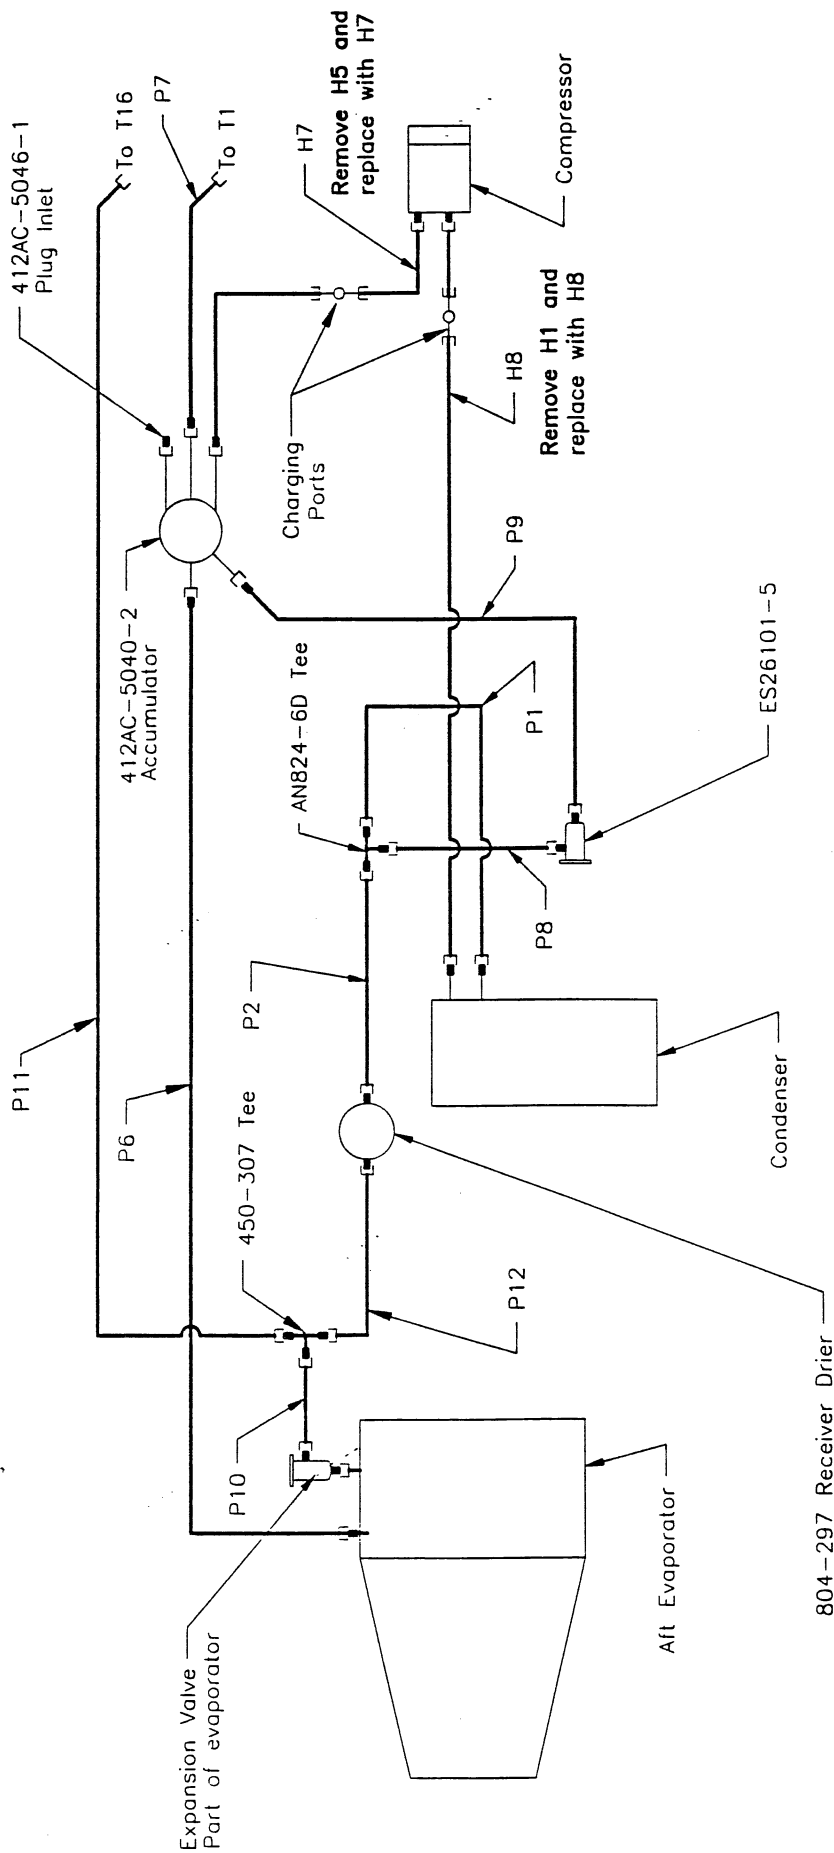
Air Comm Corporation	
TITLE: Service Port Relocation	
Dwg No. SL319	Rev N/C
Sheet 4	of 6

Modified Plumbing
Charging port relocation

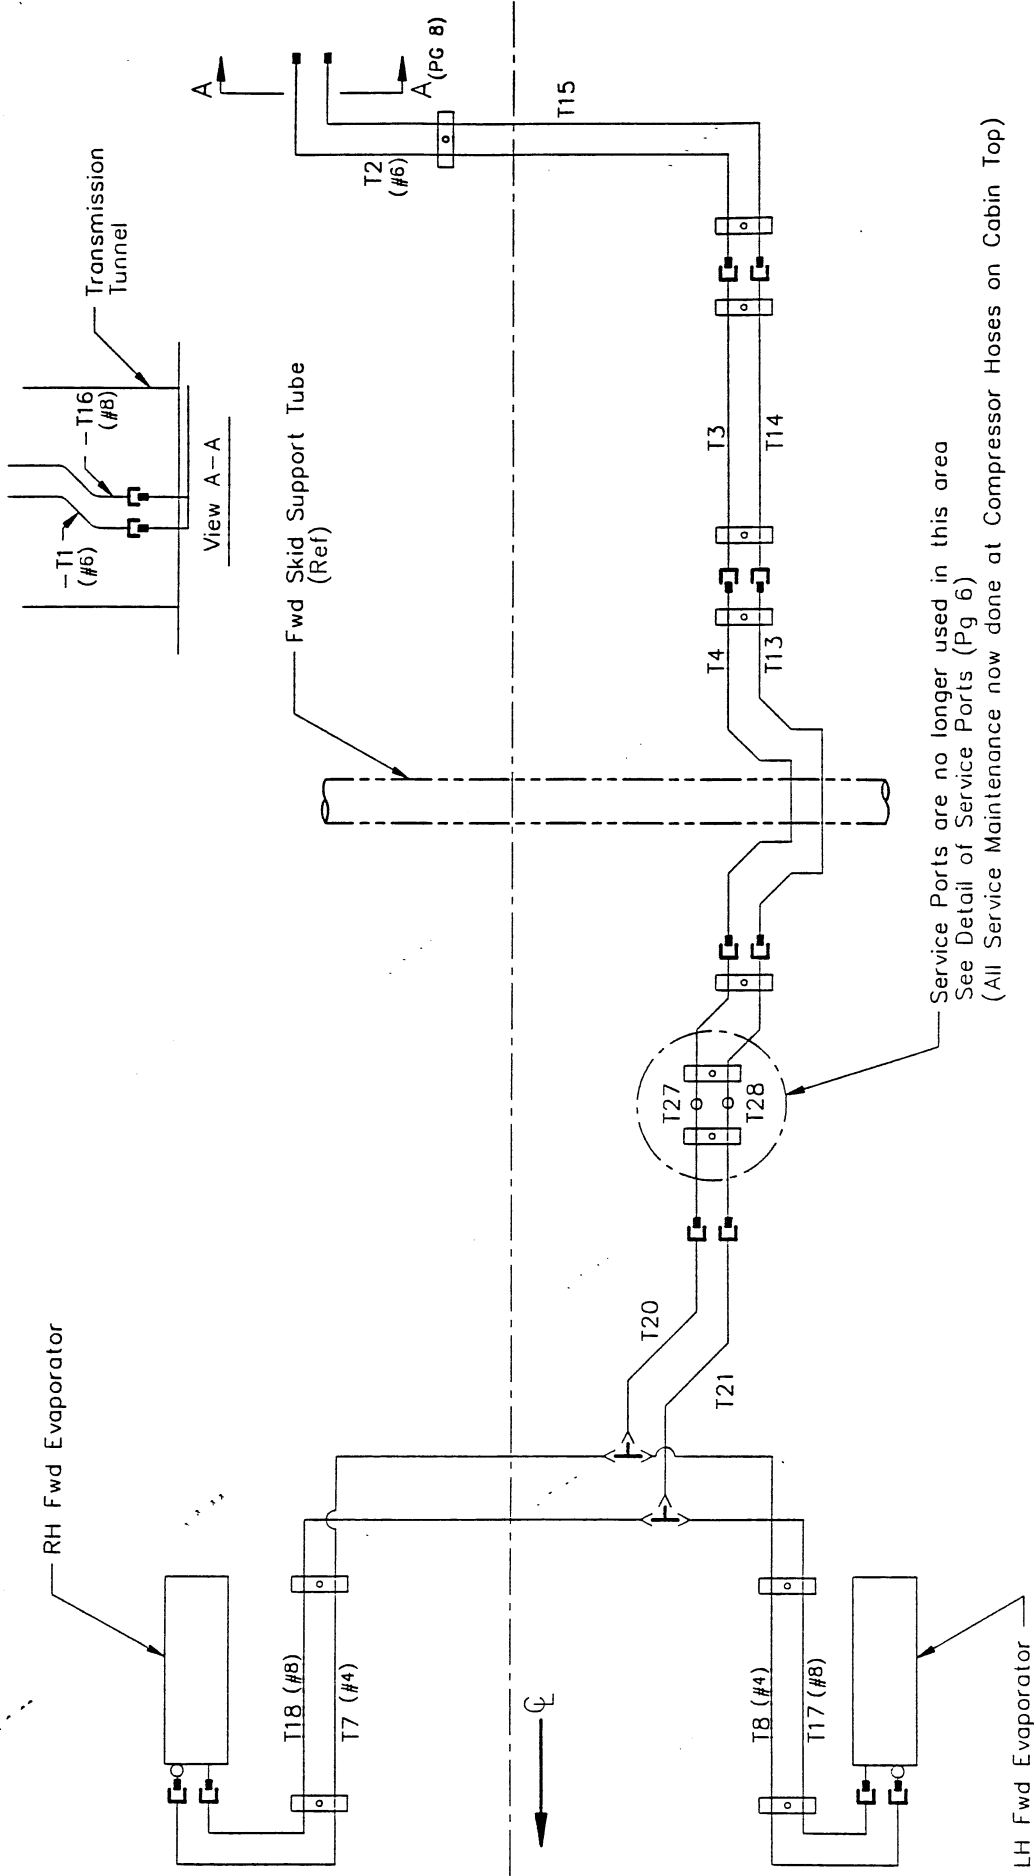
Dwg No: SL319 Rev N/C

Service Ports are no longer used in this area
See Detail of Service Ports (Pg 6)
(All Service Maintenance now done at Compressor Hoses on Cabin Top)

3. Install hardware shown on Page 5 at the existing belly mounted fittings. This arrangement is intended to preclude use of the belly service ports.
4. Remove the transmission access cowling to allow installation of the new service port plumbing.

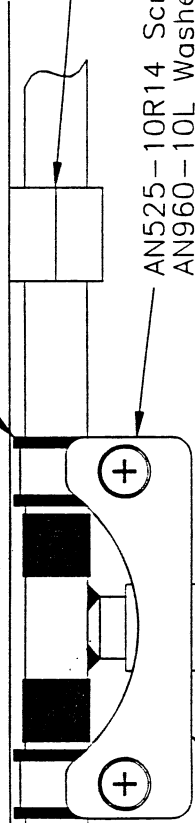
Modified Plumbing - T22 Tube (#8)

Service Port (Low Pressure - Small)

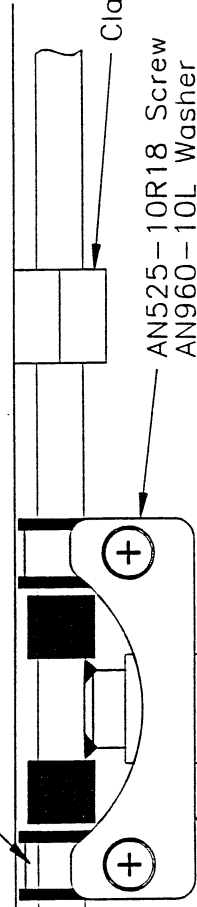
Modified Plumbing - T19 Tube (#6)

Service Port (High Pressure - Large)
