**Service Bulletin**

**Title:** SB 429-207 Bell 429 Condenser Fan Motor Mount Fastener Inspection

**Applicability:** Bell Helicopter Textron Canada Limited 429 Aircraft equipped with any Air Comm Corporation 429EC-200 or 429EC-202 Air Conditioning Systems. Not applicable to any 429EC-200 or 429EC-202 Systems with SK-429EC-7000 accomplished.

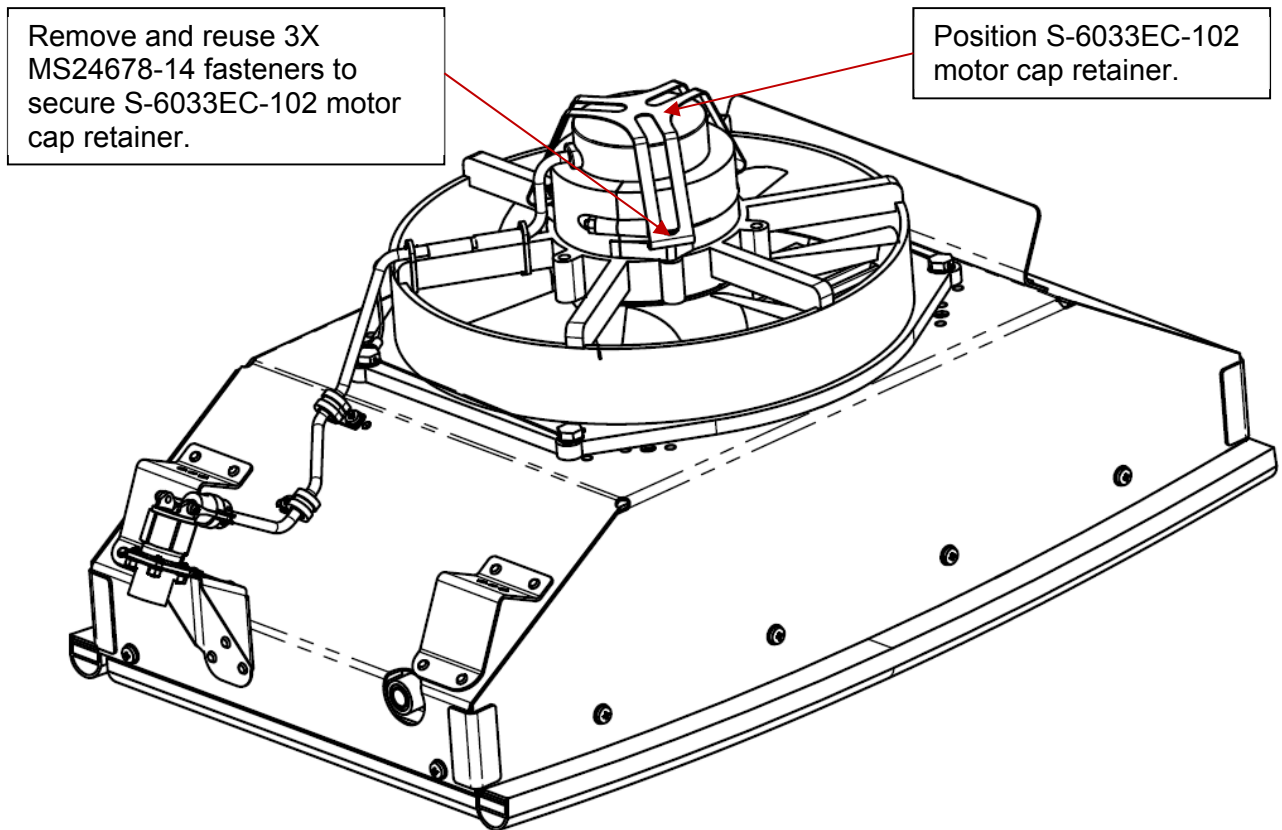
Figure 1

During a required inspection, an operator reported finding the blower motor cap detached from the motor body. This service bulletin was created to ensure safety of flight and to comply with all regulations. This bulletin adds an additional fan motor cap retainer to the assembly.

1. Verify SB 429-205 has already been conducted. Conduct SB 429-205 if it has not been conducted.
2. Remove the condenser assembly from the aircraft per 429EC-200M-1 Instructions for Continued Airworthiness.
3. Remove the 3X MS24678-14 fasteners and 3x washers securing the fan motor. The 3X MS24678-14 fasteners will be reused.
4. Discard the 3X washers.
5. Apply Loctite 222 to 3X MS24678-14. Install the S-6033EC-102 motor retainer as shown in figure 1 and figure 2, secure it using the 3X MS24678-14. Torque fasteners to 20-25 in-lbs.
