Service Bulletin: SB407-300; Bell 407 Air Conditioner Drive Pulley Bevel Washer Replacement.

Subject: Tail Rotor Driveshaft Bevel Washer Replacement.

Date: 15 April, 2004

Applicability: Bell Helicopter Model 407 series equipped with the Air Comm Corporation air conditioner system.

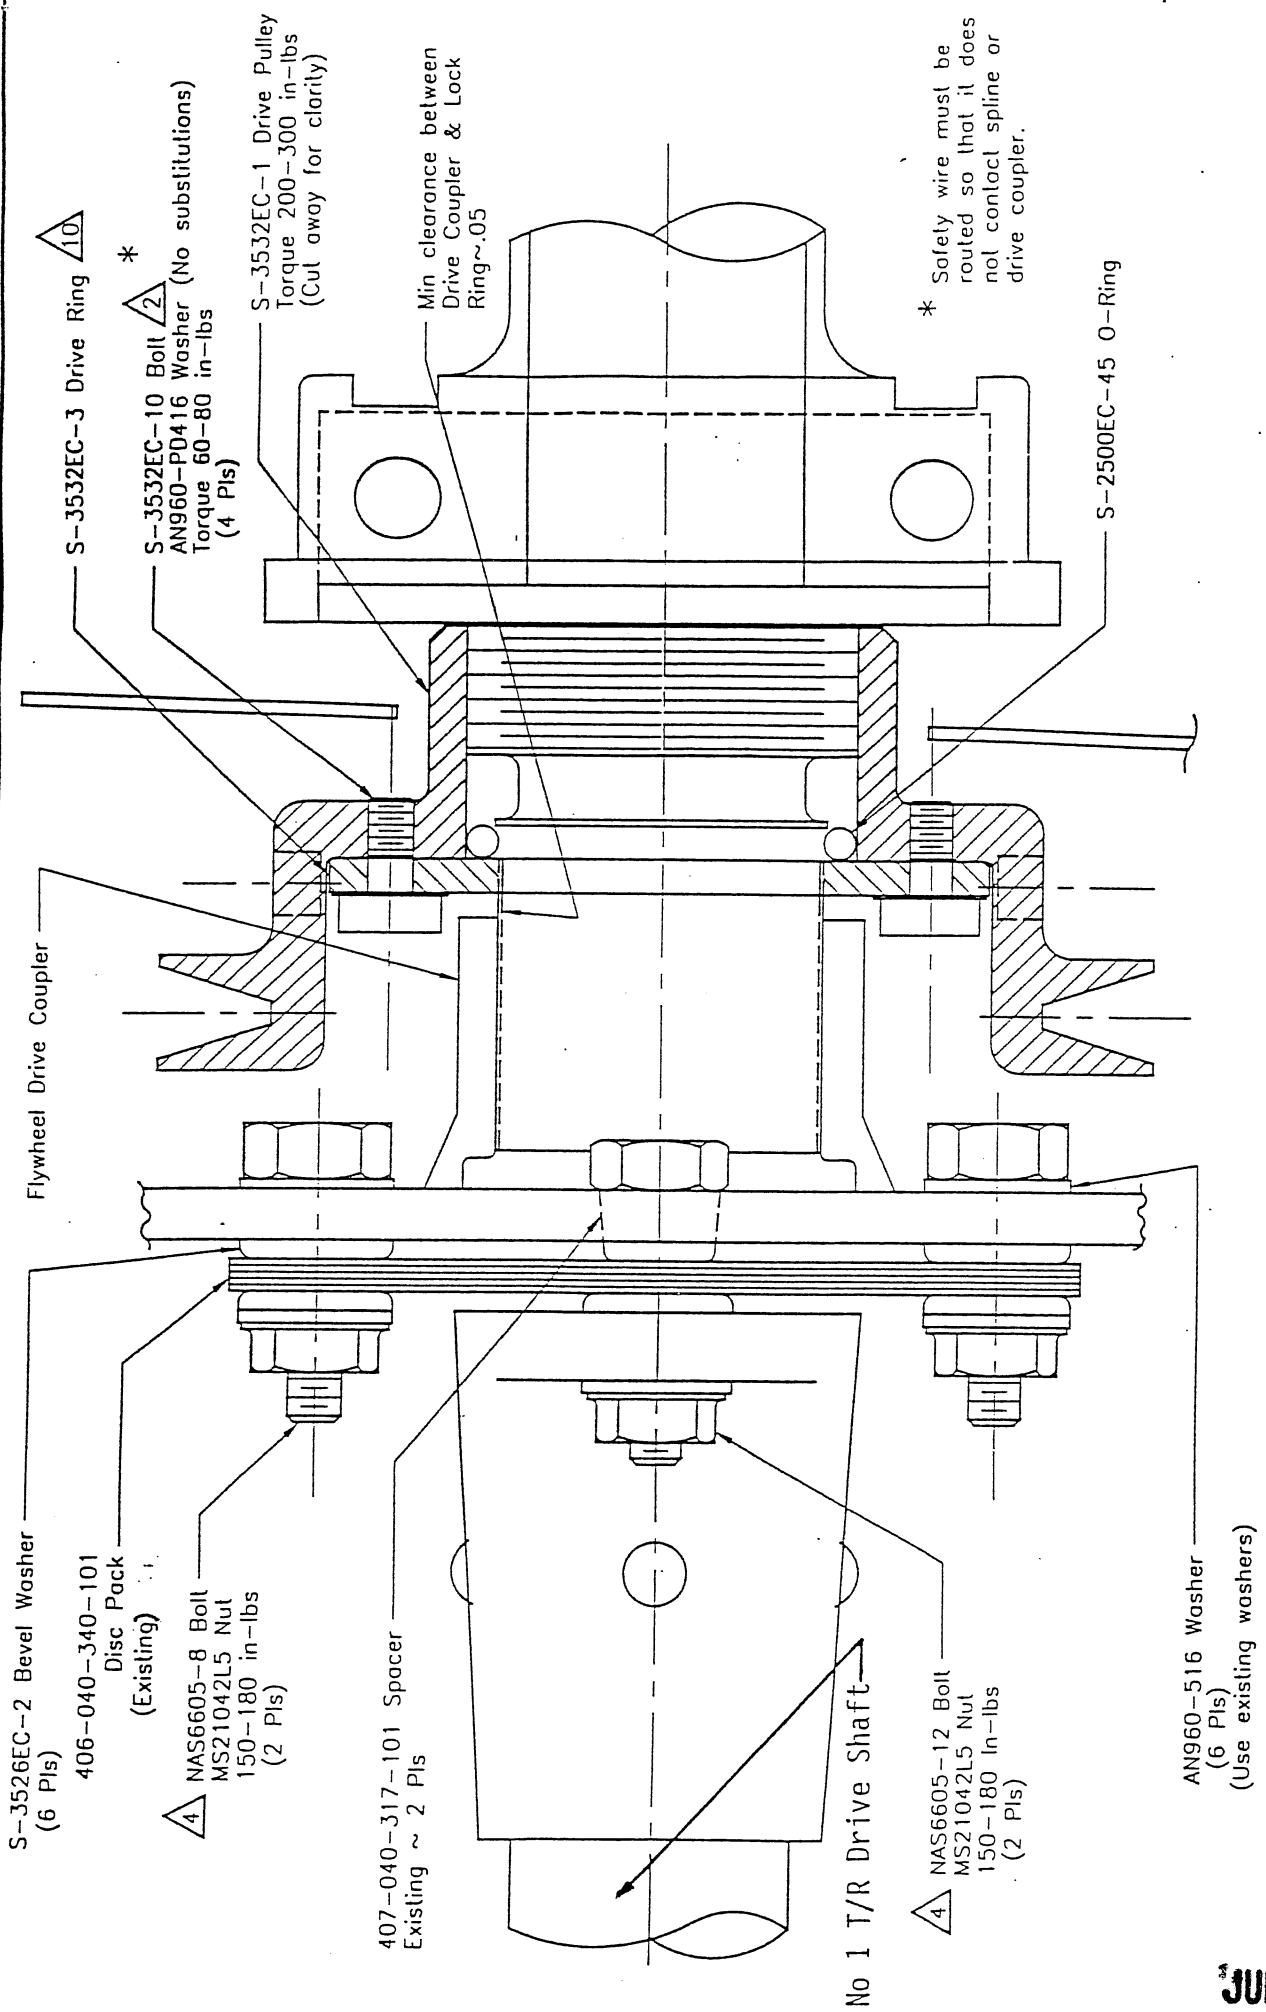
Figure 1 Original Compressor Drive Sleeve Installed;
 S/N 53000 to 53319

It has come to our attention that contact between the new Disc Pack and the flywheel can occur on aircraft equipped with the Air Comm Air Conditioner. This has shown to result in slight scouring of the flywheel hub.

1. Remove mounting hardware for Disc Pack P/N 406-040-340-101, which includes washers P/N S-3526EC-2 (.055 thick). Upon removal of Disc Pack, discard washers (6 each).
2. Installation of new Disc Pack P/N 407-340-340-101 includes washers P/N S-3526EC-4 (4 each) and washers P/N S-3526EC-5 (2 each). When installing the new disc pack, install washers (P/N S-3526EC-4) between the existing washer P/N AN960-516 (existing washer is against the nut) and disk pack on all 4 mounting bolts. Install washers (P/N S-3526EC-5) on 2 mounting bolts, between disk pack and flywheel.
3. Torque application is: torque on nuts must be minimum of the run-on-tare torque plus 150 inch-lbs to a maximum of the run-on-tare torque plus 180 inch-lbs.

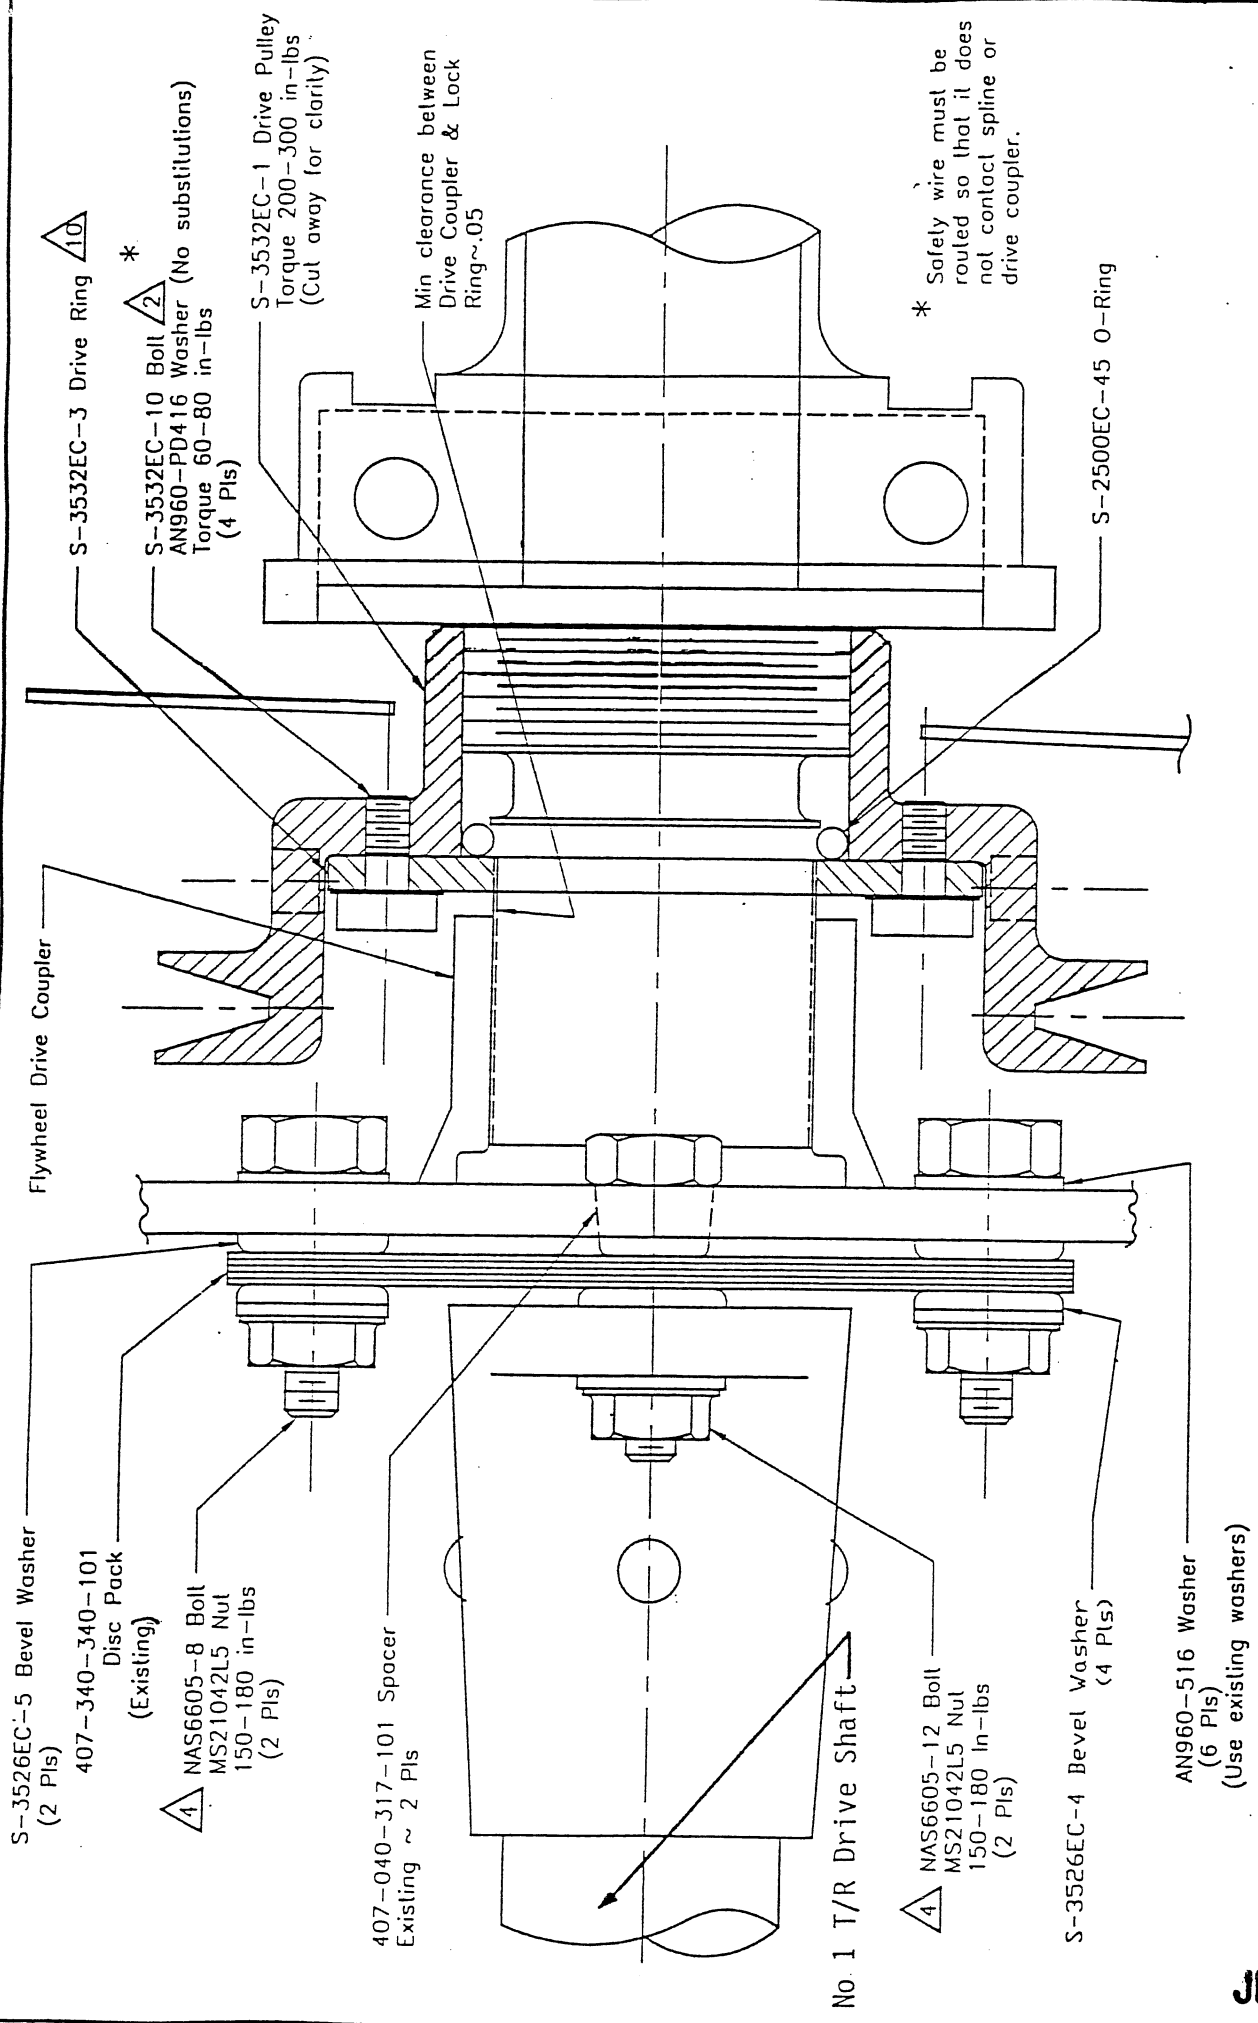
Figure 2 Revised Compressor Drive Sleeve Installed;
 S/N 53320 & Subsequent

This bulletin provides instructions for installation of new bevel washers. The effect of this change is to increase the spacing between the disc pack and the flywheel by .021 inches. The location of the drive coupler is unchanged.
