Service Bulletin: SB EC135-302; Eurocopter EC135 Air Conditioner Compressor

Bearing, Pulley, and Spline Shaft Change.

Date: 30, October 2006, Rev N/C

Applicability: Eurocopter Helicopter model EC135 Equipped with the Air Comm

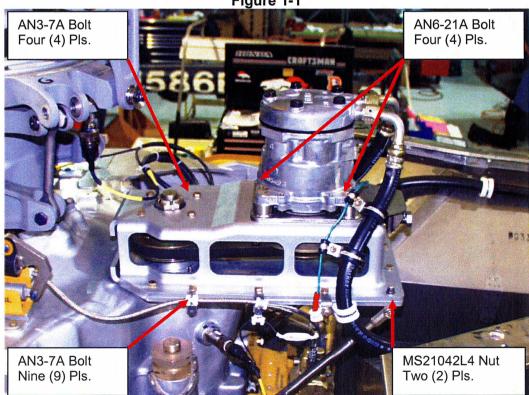
Figure 1-2

- 5. Remove the four (4), AN3-7A bolts & NAS1149F0332P Washers which attach the EC135-3010-2 Bearing Retainer Assy. to the Upper compressor mount assembly. (See figure 1-2)

- 6. Remove the nine (9), AN3-7A Bolts & NAS1149F0332P Washers from the upper compressor mount assembly. (See figure 1-2)
- 7. Remove the two (2), MS21042L4 Nuts & NAS1149F0432P Washers from the aft outboard support studs. (See figure 1-2)

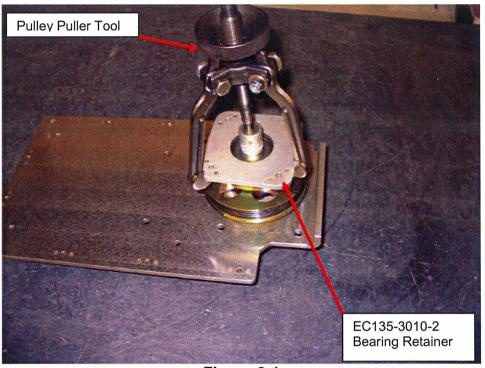
Figure 2-1

- 1. Remove the MS24665-423 Cotter Pin, and AN310-14 Nut from the top of the EC135-3030-2 Sleeve. (Note: Retain the AN310-14 nut for reinstallation purposes.)
- 2. Remove the EC135-3010-2 Bearing retainer using a pulley puller. (See Figure 2-1)

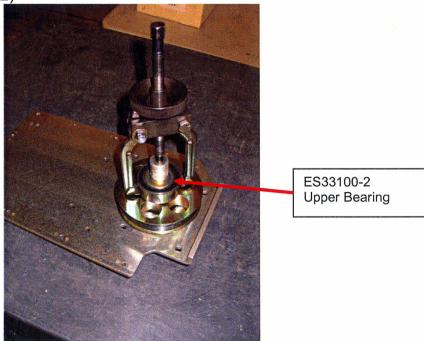
Figure 2-2

3. Remove the upper ES33100-2 Bearing from the EC135-3030-2 Sleeve using a pulley puller tool. (See Figure 2-2)

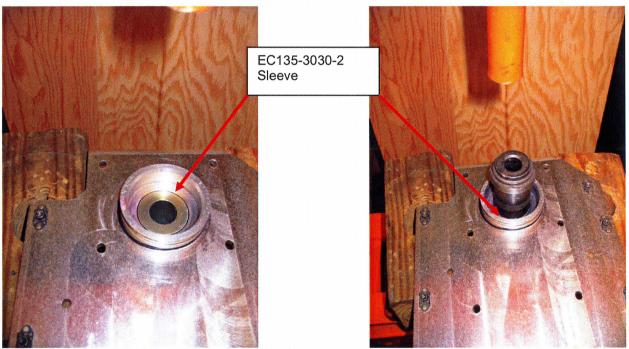
Figure 2-3

- 4. Once the upper ES33100-2 Bearing has been removed from the EC135-3030-2 Sleeve, you will be able to remove the EC135-3010-18 Pin and the EC135-3030-1 Spline Shaft from the Sleeve by pushing the pin out of the sleeve assembly.
- 5. With the use of a bearing press you can now remove the lower ES33100-2 Bearing, EC135-3030-2 Sleeve, and EC135-3010-14 Pulley from the EC135-3002-1 Lower Mount Assy. It will be necessary to turn the Lower Mount upside down to press the bearing, sleeve and pulley out of the mount. (See Figure 2-3)

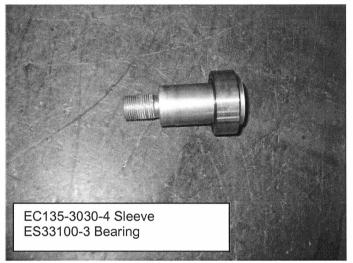
Figure 3-1

1. Using a bearing press, Install the ES33100-3 Lower Bearing on the EC135-3060-1 Sleeve. (See Figure 3-1)

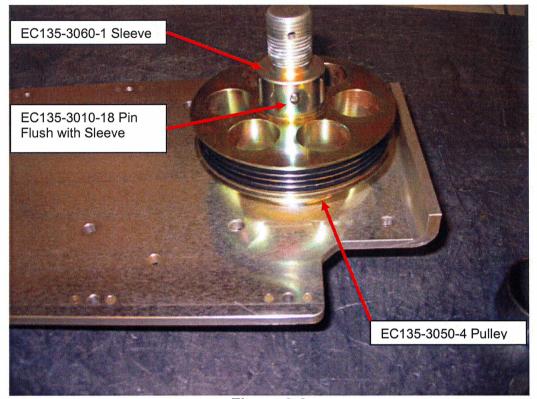
Figure 3-2

Prior to installation of the upper ES33100-3 Bearing, insure that the EC135-3010-18 Pin is flush with both sides of the EC135-3060-1 Sleeve. (See figure 3-2)
