Service Bulletin

Title: SB 429-201-1 Bell 429 Condenser Fan Motor Mount Fastener Inspection

Date: February 17, 2017

Applicability: Bell Helicopter Textron Canada Limited 429 Aircraft equipped with any Air Comm Corporation 429EC-200 or 429EC-202 Air Conditioning Systems.

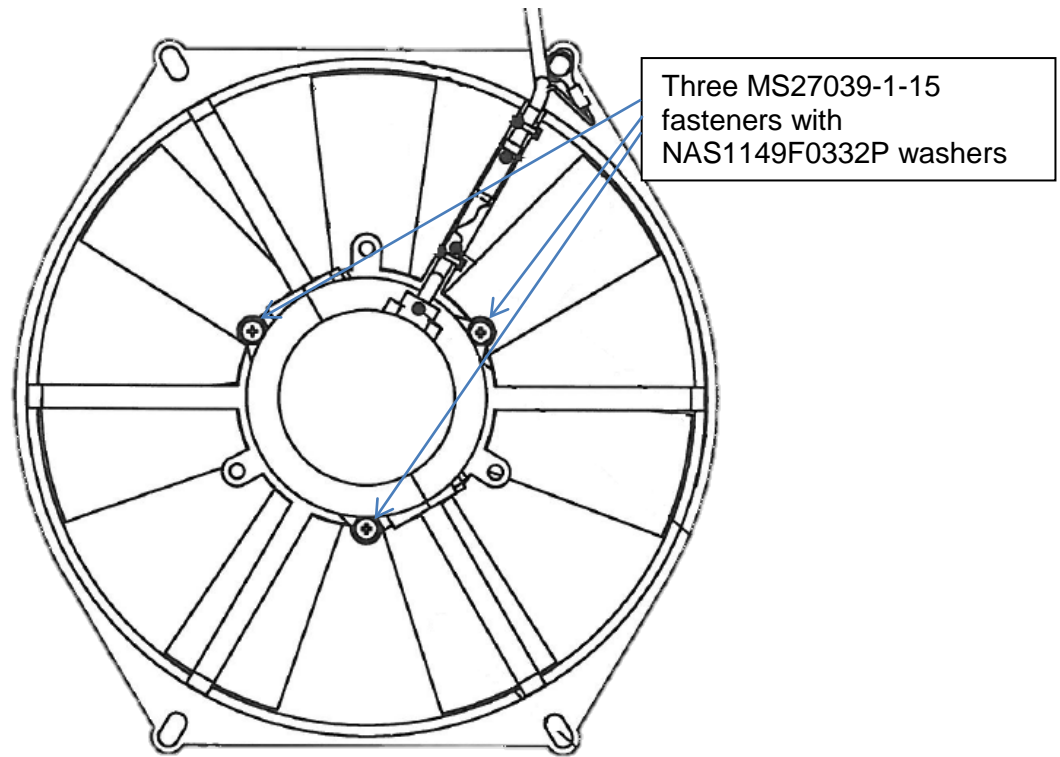
During an annual inspection, an operator reported finding the condenser fan motor detached from the condenser blower assembly and resting on the collective control tube. The condenser fan motor is secured to the condenser blower assembly by 3 fasteners with thread locker applied. Evidence suggests that some motor mount fasteners may have had misapplied thread locker.

1. Locate and visually inspect the condenser fan motor securement. Refer to Figure 1 to identify the three MS27039-1-15 fasteners mounting the condenser motor to the condenser blower assembly.

- e) Make log entry that the air-conditioning system is DEACTIVATED per ACC service bulletin SB 429-201-1.
4. Replace missing fasteners and remove and reinstall existing fasteners as follows:

- a. Clean the threads of the fastener of any debris and/or existing thread locker residue.
 - b. If no thread locker is found on existing fasteners, report incident to ACC at: Phone 303-440-4075, Fax 303-440-6355, or E-mail service@aircommcorp.com

- c. Apply Loctite 222 to the fastener threads and re-install fastener with 20 to 25 in-lbf torque.
 - d. Once all fasteners are secure, apply torque stripe to the head of each fastener.

- e. Allow a minimum of 6 hours for Loctite to cure prior to aircraft flight operations.
5. Make log entry that this service bulletin SB 429-201-1 has been performed.
