Service Letter: No. 343

Subject: Modification to Bell 407 Air Conditioner Belt Tensioning Collar in conjunction with Bell Helicopter Technical Bulletin No. 407-02-35.

Applicability: Bell Helicopter Model 407 equipped with Air Comm Corporation Air Conditioner System.

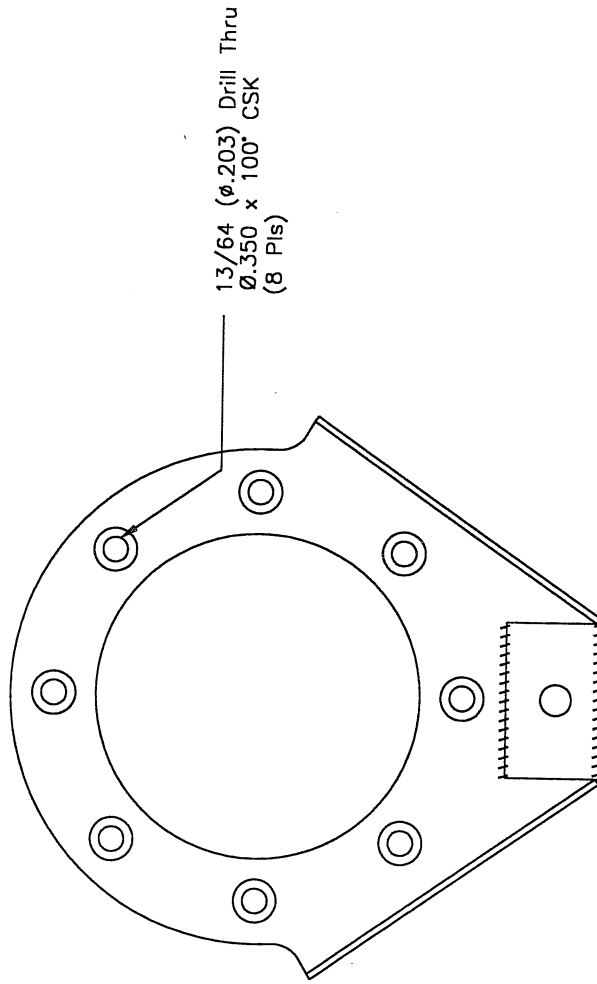
Figure 1-1, Modification of S-3010EC-5 Belt Tensoning Collar. View Looking Forward

These changes in hardware subsequently reduce the spacing between the aft portion of the air conditioner drive pulley, and the fasteners that secure the air conditioner belt tensioning collar to the aft engine firewall structure.

It is therefore necessary to modify the existing belt tensioning collar to accommodate countersunk screws, thus maintaining the necessary clearance between the air conditioner drive pulley and the belt tensioning collar assembly.

1. Insure all surfaces of the S-3010EC-5 Belt Tensioning Collar are clean and free of Pro-Seal.
2. Using an $\text{Ø} .350 \times 100^\circ$ Counter Sink Tool, or Equivalent. Countersink all eight (8) existing mounting holes in the forward facing side of the S-3010EC-5 Belt Tensioning Collar.
