### Service Bulletin

- Service Bulletin:** SB EC135-300; Eurocopter EC135 Air Conditioner Compressor Bearing inspection.
- Subject:** Compressor bearing inspection & installation of the EC135-3008-1 Bearing Cover.
- Date:** 30, October 2006, Rev N/C
- Applicability:** Eurocopter Helicopter model EC135 Equipped with the Air Comm Corporation EC135-200 Dual Forward Evaporator Air Conditioning System.
- Reference:**
1. FAA / STC # SR00565DE, Eurocopter Helicopter EC135 Air Conditioning System.
  2. EC135-300 Compressor Installation Drawing.
  3. EC135-302 Compressor Installation Drawing.
  4. EC135-3002 Compressor Mount Assy. Drawing.
  5. EC135-3008 Bearing Cover Drawing
  6. EC135-3010 Bearing Retainer Assy. Drawing.
- Compliance:** Mandatory, within 25 hours of receipt of this bulletin.

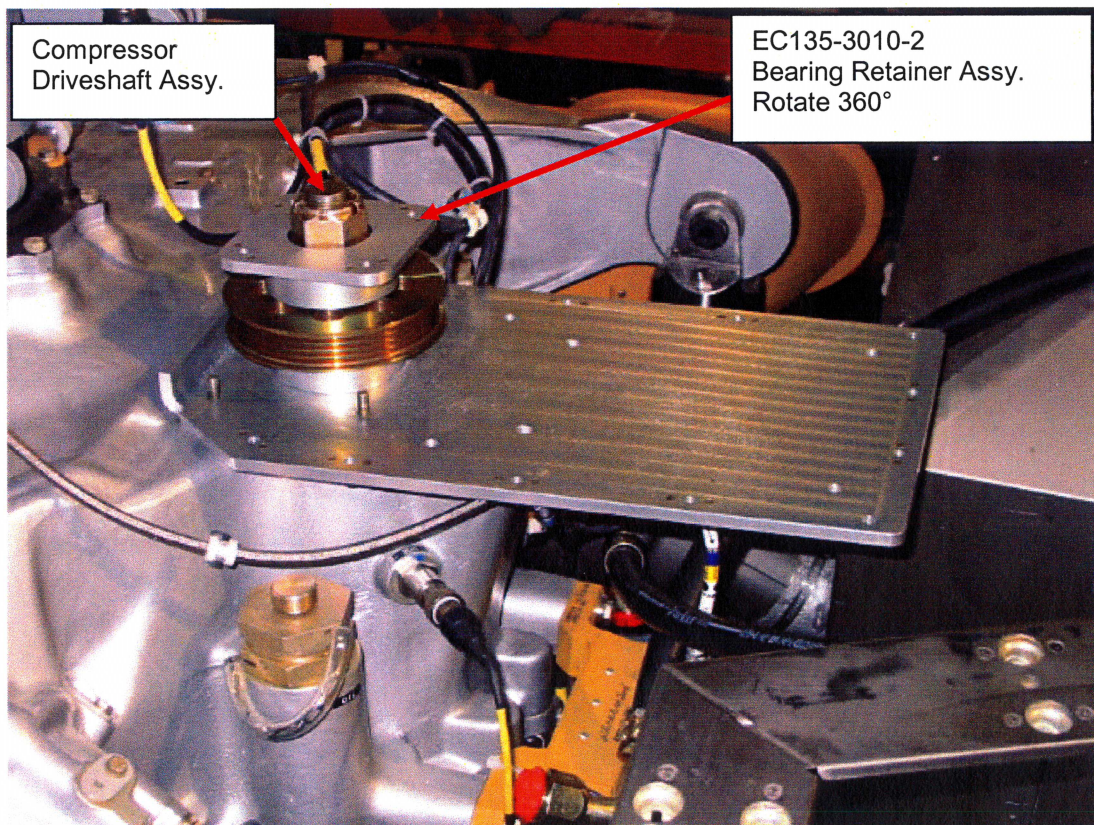
**Figure 2-1**

Operators in the field have noted corrosion / rust on the upper bearing assembly of the EC135 air conditioner Compressor Drive Assembly. This corrosion / rust maybe an indication the upper bearing may have experienced contamination from water collecting on the upper exposed surface of the bearing seal.

1. Visually inspect the upper and lower surfaces of the EC135-3010-2 Bearing Retainer Assembly for any signs of corrosion or rust on the bearing retainer or the bearing seals. (See figure 2-1)
2. Rotate the EC135-3010-2 Bearing Retainer Assembly 360 degrees around the Compressor Driveshaft Assembly by hand. The bearing should turn smoothly, with no binding noted.

If corrosion, rust, or binding of the bearing is found, the compressor drive bearings must be replaced. Please contact ACC Customer Service for a copy of **Service Bulletin SB EC135-302**, for replacement parts and instructions.
