Service Bulletin

Title: Bell 407 Driveshaft Mounted Pulley and Drive Ring installation inspection

Date: 4 December 2014

Applicability: Owner/Operators of Bell 407 Helicopters with STC SR00222DE Air

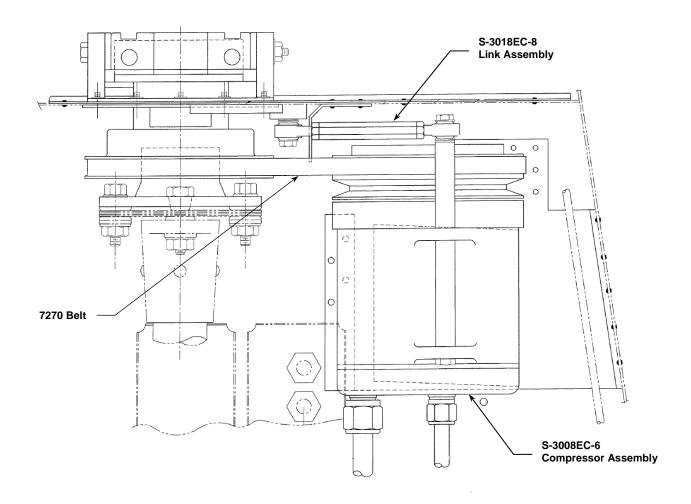
Figure 3.1
Air Conditioner Compressor Installation
(View Looking Down)

Proper torqueing of the compressor pulley and installation of the drive ring assembly is critical to ensure trouble free operation of the air conditioner system. There have been field reports of the compressor pulley loosening and causing damage to the oil cooler blower shaft.

- b. Adjust the tensioning link assembly to loosen compressor drive belt. Check S-3532EC-4/-1 drive pulley for play relative to the oil cooler blower shaft, both in the direction of rotation as well as for lateral movement relative to the shaft (Figure 3-1 & 4-1).
