Service Bulletin

Title: SB 412-112316 Bell 412 Compressor Mount Nut Cracks

Date: November 23, 2016

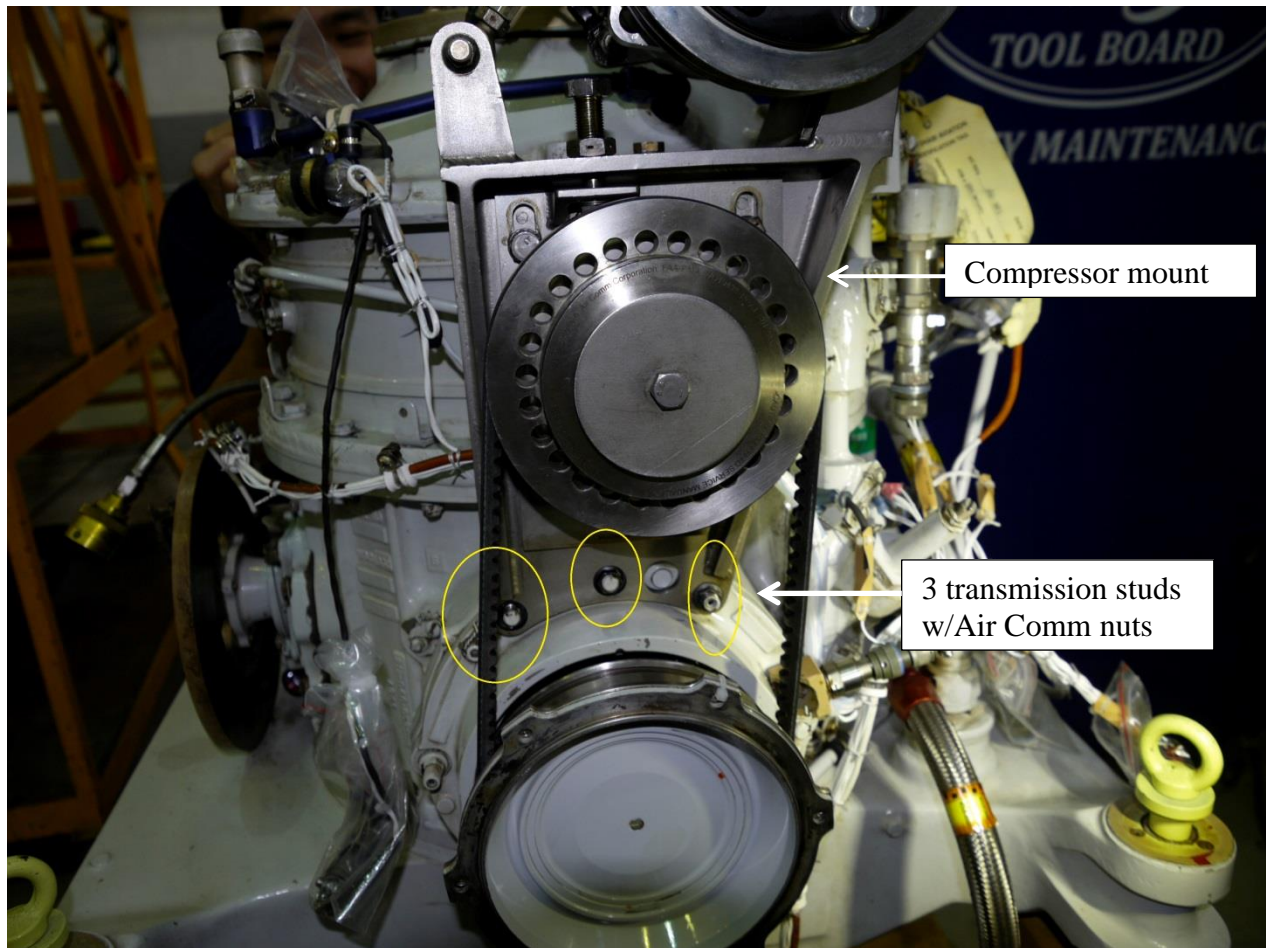
During inspection an operator has reported finding cracks in the nuts securing the compressor mount to the main transmission housing. Although the nuts remained intact and capable of securing the mount it is believed that continued use would eventually lead to failure of the nuts and subsequently a loss of rigidity of the compressor mount. The compressor mount is secured to the transmission by 6 fasteners; three close tolerance 3/8 shear bolts on the top (high side) of the mount and three 3/8 studs on the low end of the mount. The cracks have been found in the nuts securing the low end of the mount to the transmission studs. The nuts are made from MS21042 self-locking steel nuts modified in height to accommodate the stud length.

Referring to the photo on page 2, locate the 3 nuts identified at the lower end of the compressor mount and visually inspect in place for cracks. If cracks are found, replacement hardware can be obtained from the Air Comm Corporation Service Department. Please contact us at: Phone 303-440-4075, Fax 303-440-6355, or E-mail service@aircommcorp.com
