Service Letter

Title: SL-374 Bell 412 Compressor Drive Pulley Belt Guard Change

Date: December 6, 2016

Applicability: Bell Helicopter 412 Aircraft equipped with the Air Comm Air Conditioning System, all serial numbers. The system serial number is marked on the compressor mount.

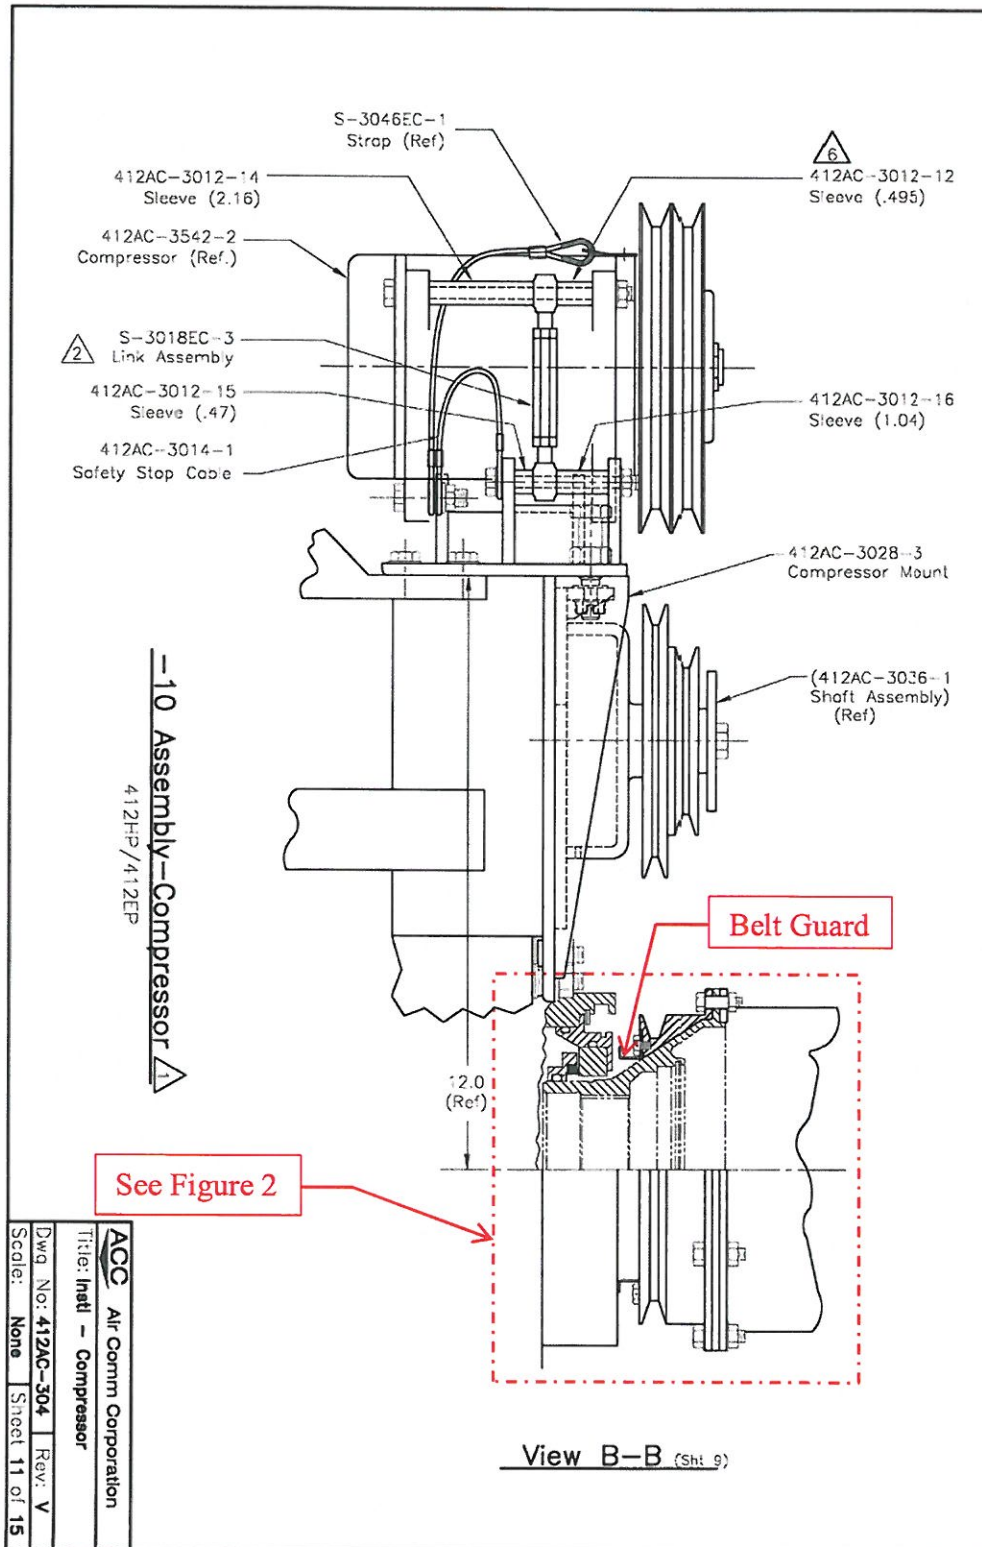
Figure 1. Compressor Drive Installation View

An operator has reported finding a severed compressor drive belt and belt guard that was dislodged and damaged. The issue was believed to have been due to the belt guard fasteners loosening, allowing the guard to dislodge and contact the drive belt. This service bulletin provides information to ensure the security of the belt guard fasteners.

- 1) Referring to Figures 1 & 2 above, ensure that the lock wire and NAS1802 screws securing the belt guard to the pulley are all in place.
- 2) If any anomalies are found, remove the lockwire and torque the 8 screws to 35-40 in-lb. Note that per the 412AC-304 Compressor Installation drawing the torques had been specified to be 12-15 in-lb.
- 3) Re-install lockwire MS20995C-32 per QQ-W-423B Cond. A
