Service Bulletin

Service Bulletin: SB407-3526; Bell 407 Air Conditioner Drive Pulley Bevel Washer Replacement.

Subject: Tail Rotor Driveshaft Bevel Washer Replacement.

Applicability: Bell Helicopter Model 407 series equipped with the Air Comm Corporation air conditioner system.

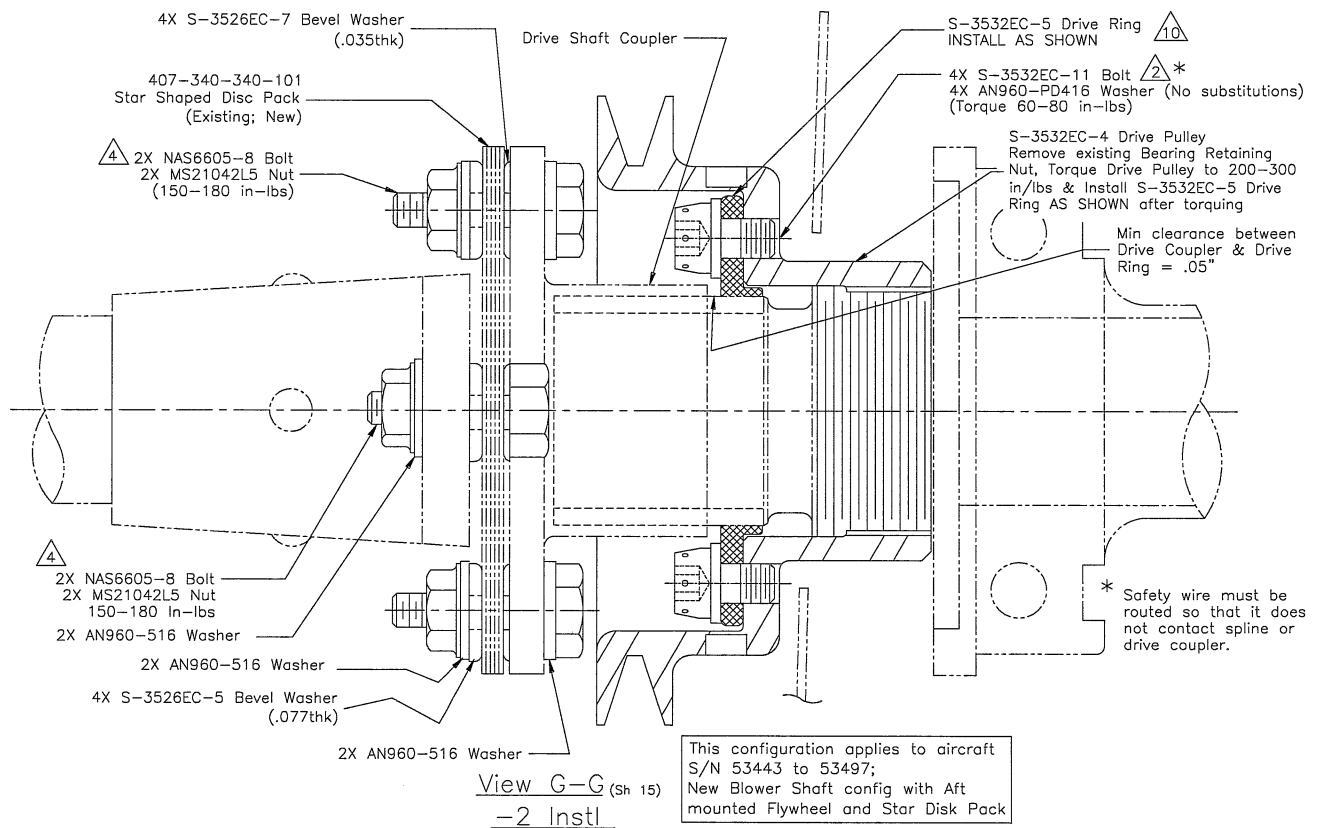
Installation Configuration -2 (Installation of S-3526EC-7 Bevel Washers)

Field inspections have indicated that some wear maybe occurring between the inside shoulder of the S-3526EC-4 Bevel Washer and the base of the NAS6605 Bolt head on Bell 407 Helicopters equipped with an Air Comm air conditioner system.

Configuration	Part Number	Description	Quantity
-2	S-3526EC-7	Bevel Washer	4
	NAS6605-8	Bolt	2
	MS21042L5	Nut	4
*	*	*	*
-3	S-3526EC-7	Bevel Washer	4
	NAS6605-10	Bolt	2
	MS21042L5	Nut	4

4. Torque all fasteners in accordance with the specific Applied torques shown on the face of the illustrations for the appropriate configuration (-2, or -3).
