Page 1 of 8 SB412-7042 Rev A

SB412-7042; Bell 412 Air Conditioner System

Condenser Frame Modification.

Bell Helicopter Model 412 EP, HP, SP equipped with the

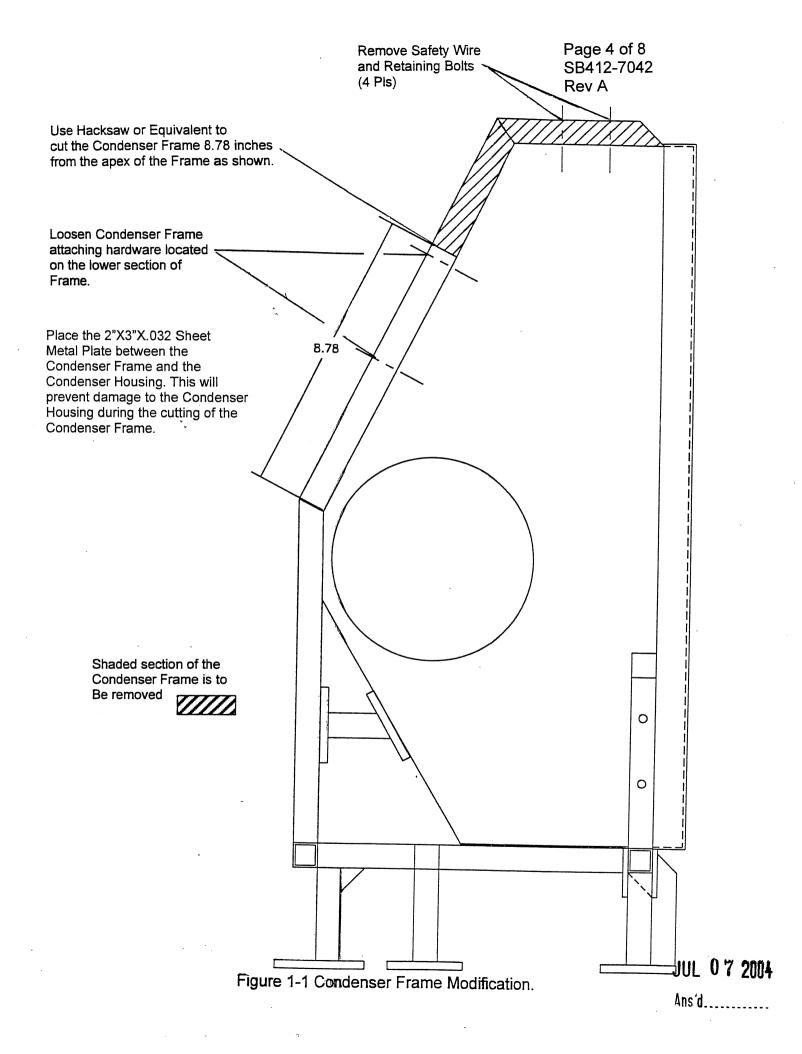
Recently the Air Comm Corporation has made a change to the design of it's Bell 412 Air Conditioner System Condenser Frame Assembly. This change removes a small section of the Condenser Mounting Frame from the back of the Condenser Housing. Thus increasing the clearance between the Condenser Assembly and the Re-phase arms of the helicopters rotor system.

- 1. Remove the upper, and lower forward sections of the Transmission Cowlings from the cabin roof to gain access to the Condenser and Condenser Frame assembly.
- 2. Remove safety wire from the four (4) Condenser Frame mounting bolts located in the top of the Condenser Assembly. Remove and discard the mounting bolts. (See figures 1-1 & 1-2)
