Service Kit

Title: Bell 429 Air Conditioner Relay Box update

Date: 27 August 2015 (Rev A)

Applicability: Bell Helicopter Model 429 Equipped with the Air Comm Corporation 429EC-200 and -202 Air Conditioning Systems

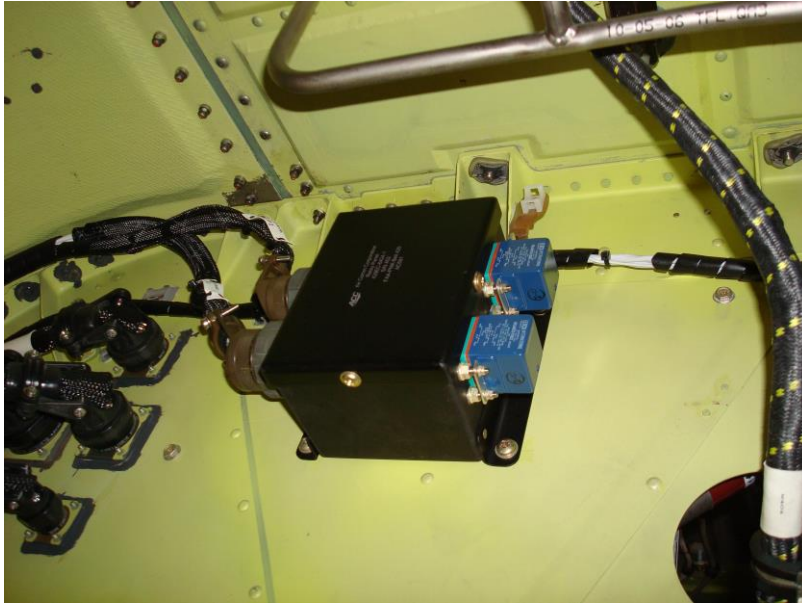
- 1.1 Access the AC Relay Panel (shown below) labeled 429EC-8424-2 and remove the cover (3 phillips head screws). Note that the modification can be done with the Relay Panel in place, although removing the box will simplify the updates.

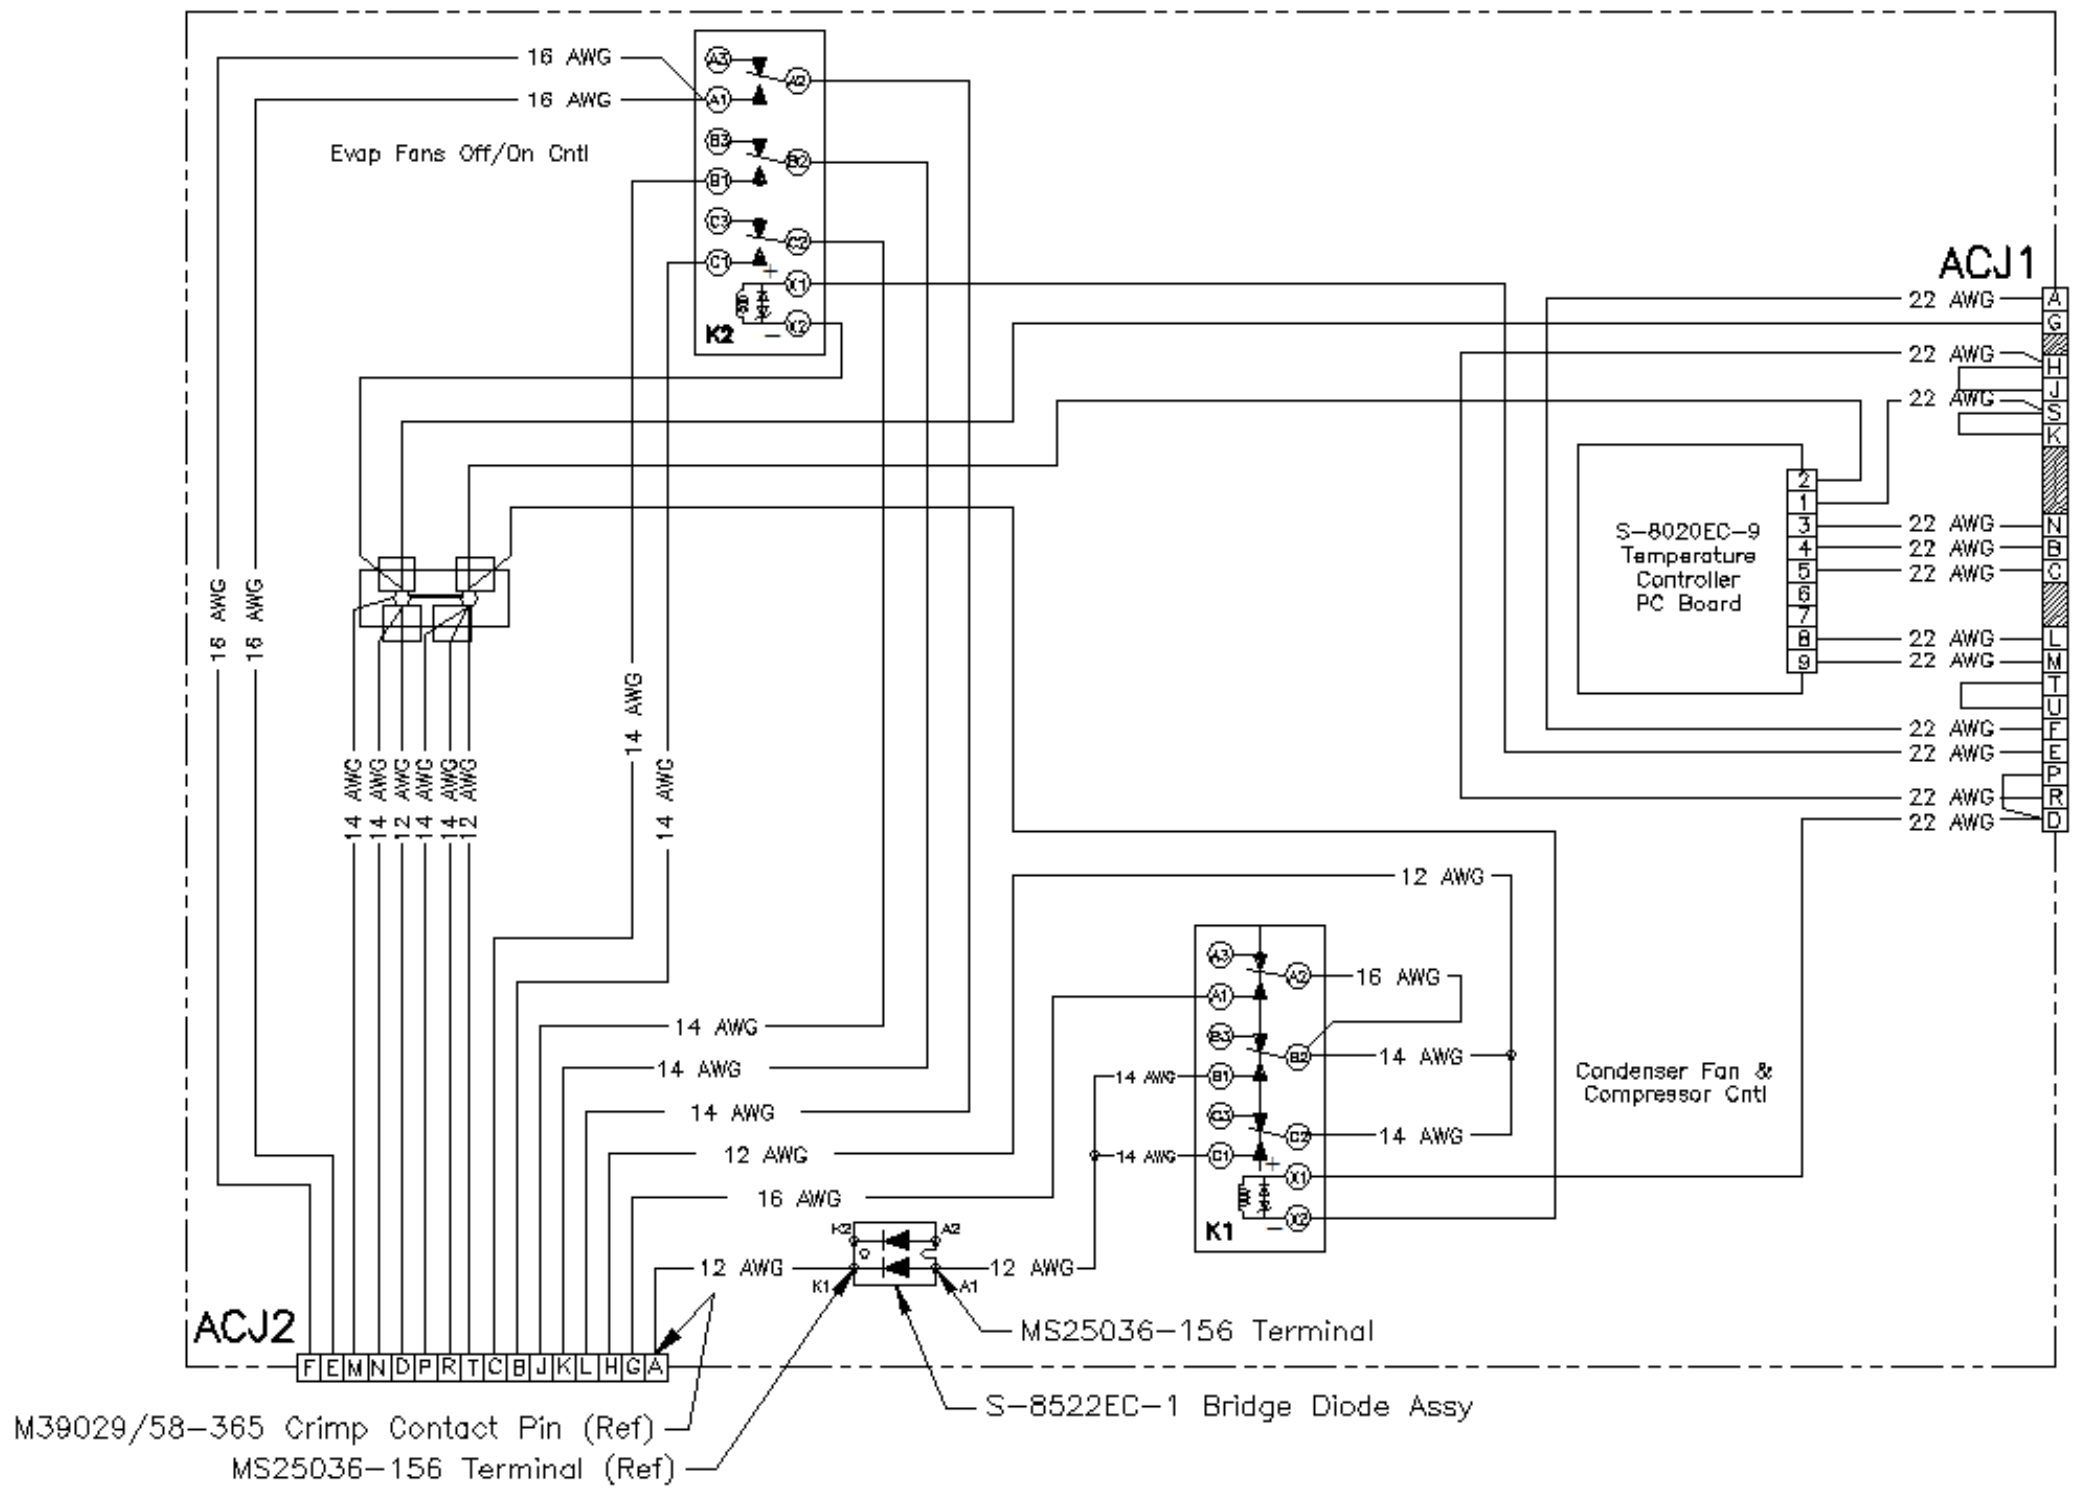
429EC-8424-2 Relay Panel
Schematic (Modified with Bridge Diode)

In rare cases, an anomaly may occur when the non-essential (NE) bus de-energized (possibly due to an OEI event) and the aircraft is in forward flight with the air conditioner operating. Under certain conditions, the ram air flowing through the condenser may rotate the blower motor causing a small voltage to be generated and applied to the bus which prevents some NE bus loads, including the indicator light, from de-energizing. The potential for occurrence is greater at higher forward airspeeds.

This Service Kit provides the instructions and list of components for modifying the air conditioning system relay panel box to alleviate this issue. The modification adds a blocking diode into the condenser blower circuit and can be obtained for no charge from the service department at Air Comm corporation. Please contact us at: Phone 303-440-4075, Fax 303-440-6355, or E-mail service@aircommcorp.com

- 1.2 Modify the relay panel box per the schematic and the instructions in steps 1 thru 4 in the figures below.
