Service Bulletin

- Title:** AS350 Air Conditioner Compressor / Transmission Strut Interference. (Flat Belt Configuration)
- Subject:** This service bulletin addresses the upgrade of existing AS350 Air Comm Corporation compressor drive installations to preclude contact between the air conditioning compressor pulley and the L/H aft transmission support tube.
- Date:** 2 April 2009
- Applicability:** Eurocopter Model AS350 B, B1, B2, BA, B3, C, D, and D1 equipped with Air Comm Corporation air conditioning. (Flat Belt Configuration) Air Comm Corporation Serial number AS350-001 through AS350-043
- Reference:** 1) STC. Number SR00643DE, AS350 Cabin Air Conditioner
2) ACC Drawing Number AS350-300 Compressor Installation Rev L
3) ACC Drawing Number AS350-200 Air Conditioner General Arrangement Rev D
- Compliance:** Mandatory within 100 hours of receipt of this bulletin.

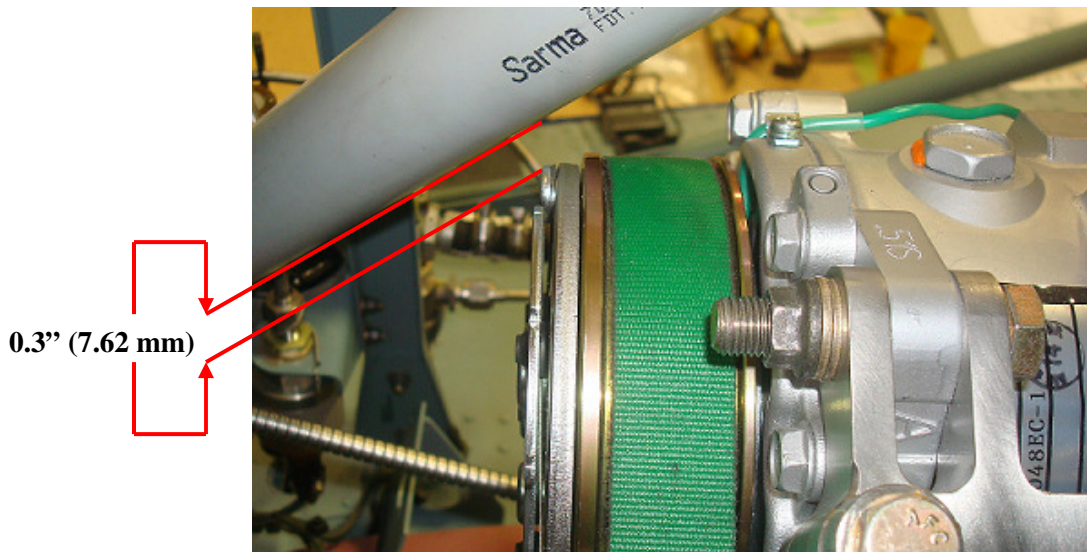
Figure 1 Compressor to Transmission Support Tube Clearance
(View looking outboard)

I Discussion: Air Comm Corporation has received reports of damage caused by contact between the L/H aft transmission support tube and the pulley on the air conditioner compressor. This service bulletin provides a new drive belt and strut protection clamps to prevent possible damage to the strut.

1. Locate the S-3048EC-1 compressor assembly and inspect for a minimum of 0.3” (7.62 mm) clearance between the L/H transmission support tube and the face of the S-3048EC-1 Compressor Pulley (See fig 1).
 - a. If 0.3”(7.62 mm) of clearance is observed DO NOT perform steps 5 and 6 of the accomplishment instructions.
 - b. If 0.3”(7.62 mm) of clearance is not observed proceed to step 2 of the removal instructions.

6. Install the new ES35350-3 drive belts onto the tail rotor drive shaft. Stow QTY 1 in accordance with the AS350-200M-1 air conditioner ICA and reassemble the tail rotor drive shaft in accordance with applicable AS350 maintenance manual.
7. Install the ES35350-3 drive belt onto the air conditioning compressor assembly and adjust belt tension in accordance with the AS350-200M-1 air conditioner ICA. Torque the compressor pivot bolts (QTY 2) to 160-190 in.lbs (18.07-21.46 nm)
8. Replace the safety wire removed in step 3 using MS20995 C32 safety wire in accordance with NASM33540 or equivalent.
9. Using the mark from step 5 center the S-3542EC-2 rubber sheet and install using QTY 2 S-3542EC-2 clamps. (Ref Fig 2) Safety wire the S-3542EC-2 clamps using MS20995 safety wire in accordance with NASM33540
10. Return air conditioner to service
