Service Bulletin

Title: SB 429-206 Bell 429 Condenser Fan Motor Mount Fastener Inspection

Applicability: Bell Helicopter Textron Canada Limited 429 Aircraft equipped with any Air Comm Corporation 429EC-204 or 429EC-206 Air Conditioning Systems.

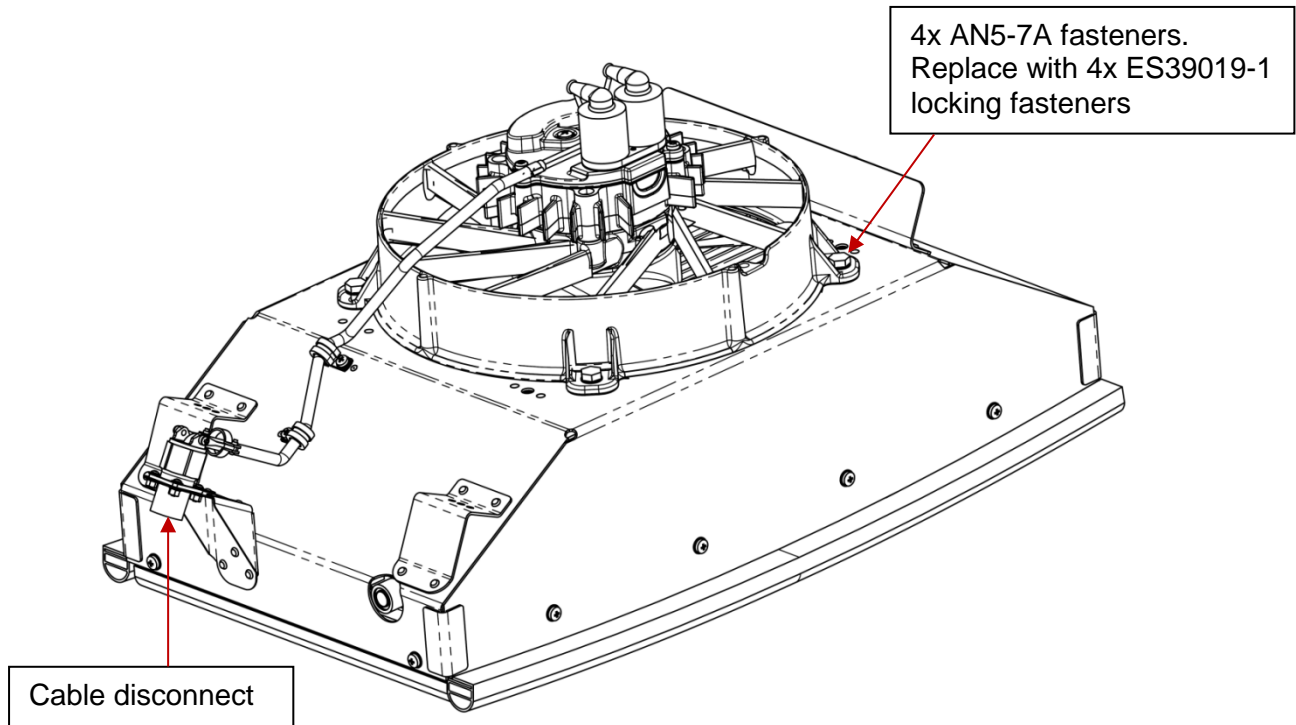
During an internal safety audit, ACC found the condenser blower assembly was missing secondary locking features in critical areas. This service bulletin is intended to rework the condenser blower assembly by adding secondary locking features to all fasteners in order to ensure safety of flight and to comply with all regulations.

2. Remove the condenser assembly from the aircraft per 429EC-200M-1 Instructions for Continued Airworthiness.
3. Remove the condenser blower assembly from the condenser assembly by removing 4x AN5-7A fasteners and disconnecting the cable. See Figure 1 for location of AN5-7A fasteners and cable disconnect.
