Service Bulletin

Title: SB EC145-022216; Airbus EC145 Heater Hose Chaffing Prevention Measures

Date: 25 February, 2016

Applicability: Airbus Helicopter model EC145 equipped with the Air Comm Corporation air conditioner system, all kits prior to Jan. 2014.

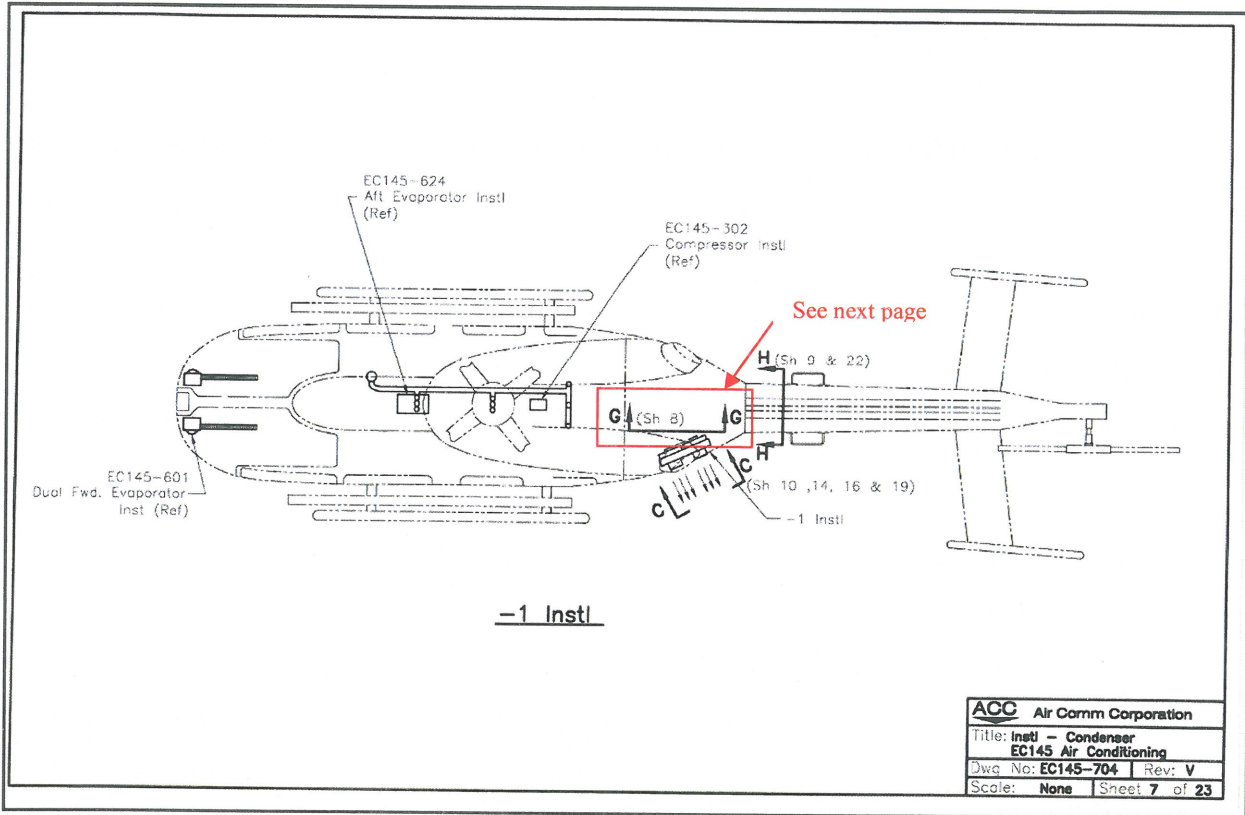
1. Refer to section view G-G shown on the overall aircraft view below and in detail on the following page.

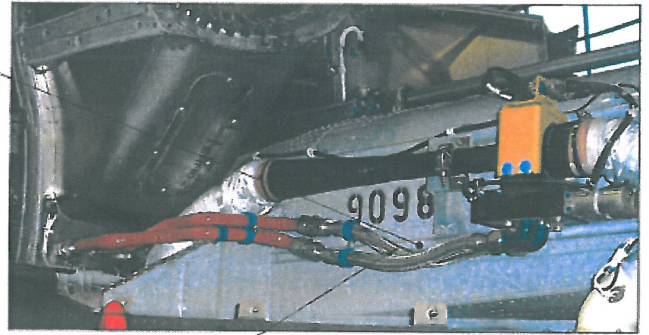
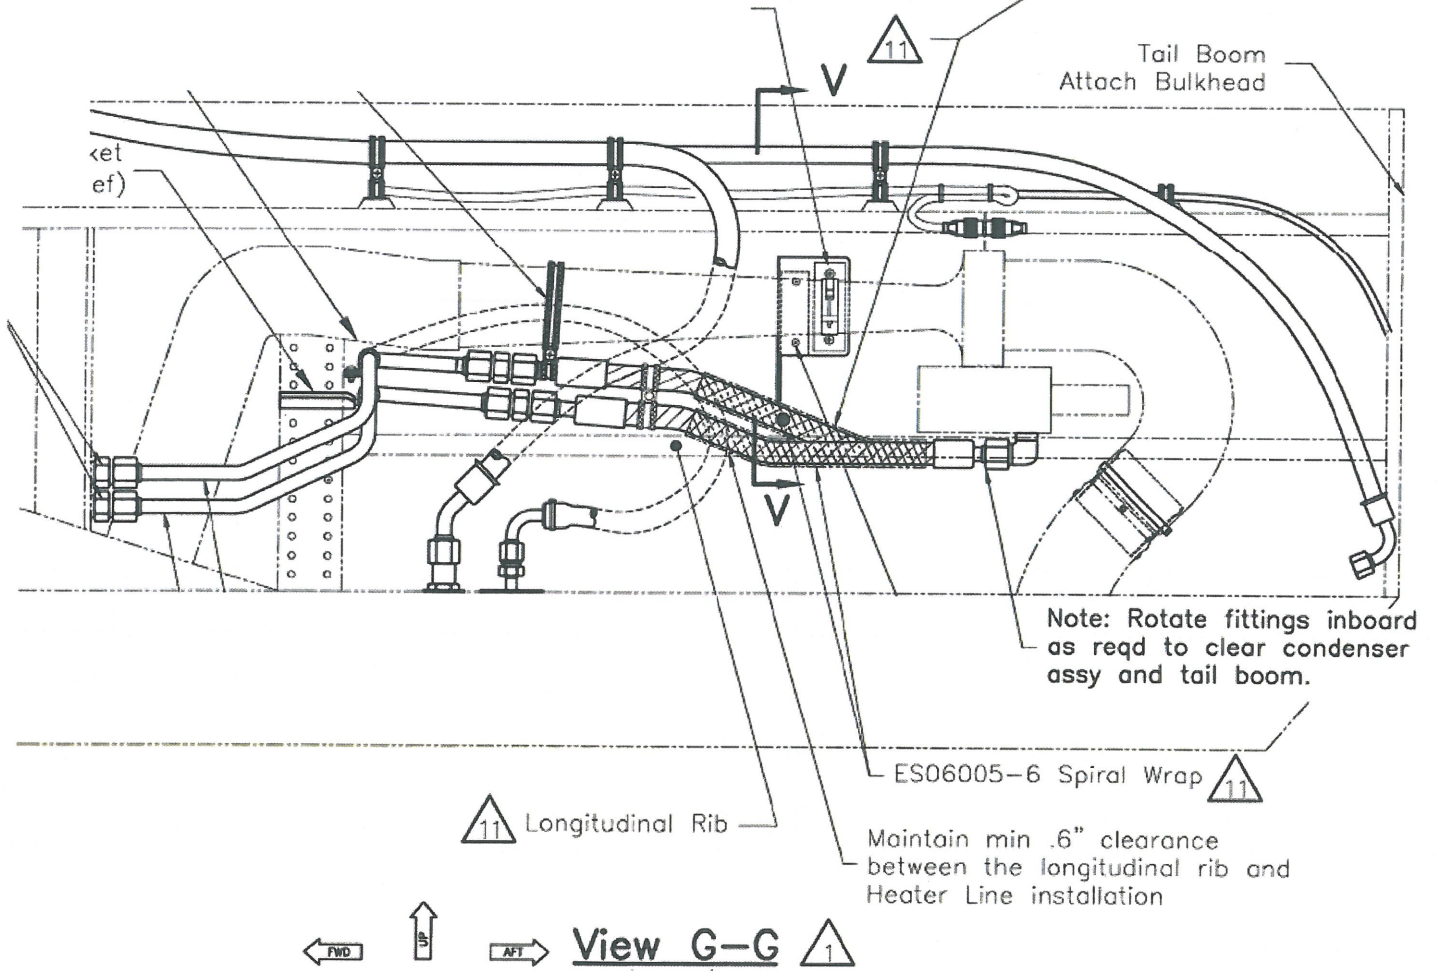
△11 Longitudinal Rib

2. Note the cross hatched zones shown in view G-G on page 3. If the aircraft is equipped with thermal sleeving on the two heater tubes in this region then this Service Bulletin does not apply. The sleeving will provide the necessary anti-chaffing function. However, verify the .6in. clearance between sleeving and structure per the note in view G-G. Adjust the clamping of the tubes if necessary to achieve this clearance.

3. If the aircraft heater tubes are not supplied with the thermal sleeving in the noted region, inspect the heater lines to ensure there is no damage to the heater lines if chaffing has occurred. Contact ACC for the materials and install the ES06005-6 spiral wrap material onto the hoses as noted by the cross hatched region in view G-G below and flag note 11 below. Also, adhere the ES06004-3 tape to the airframe in the appropriate region that could be contacted by the tubing per flag note 11 below.

If factory hose covers are not previously installed, locally wrap the stainless steel covered heater hoses with ES06005-6 Spiral Wrap approx as shown, as required. Apply ES06004-3 Anti-Friction Tape to the longitudinal rib in the vicinity of the heater hoses, as required, to prevent chaffing of the heater hoses against the rib on the aircraft. (Sh 8)
