Service Letter: No. 348

Subject: Condenser Scoop Actuator Replacement Procedure.

Applicability: Bell Helicopter Model, 206, 407, 427 Equipped with the Air Comm Air Conditioning system.

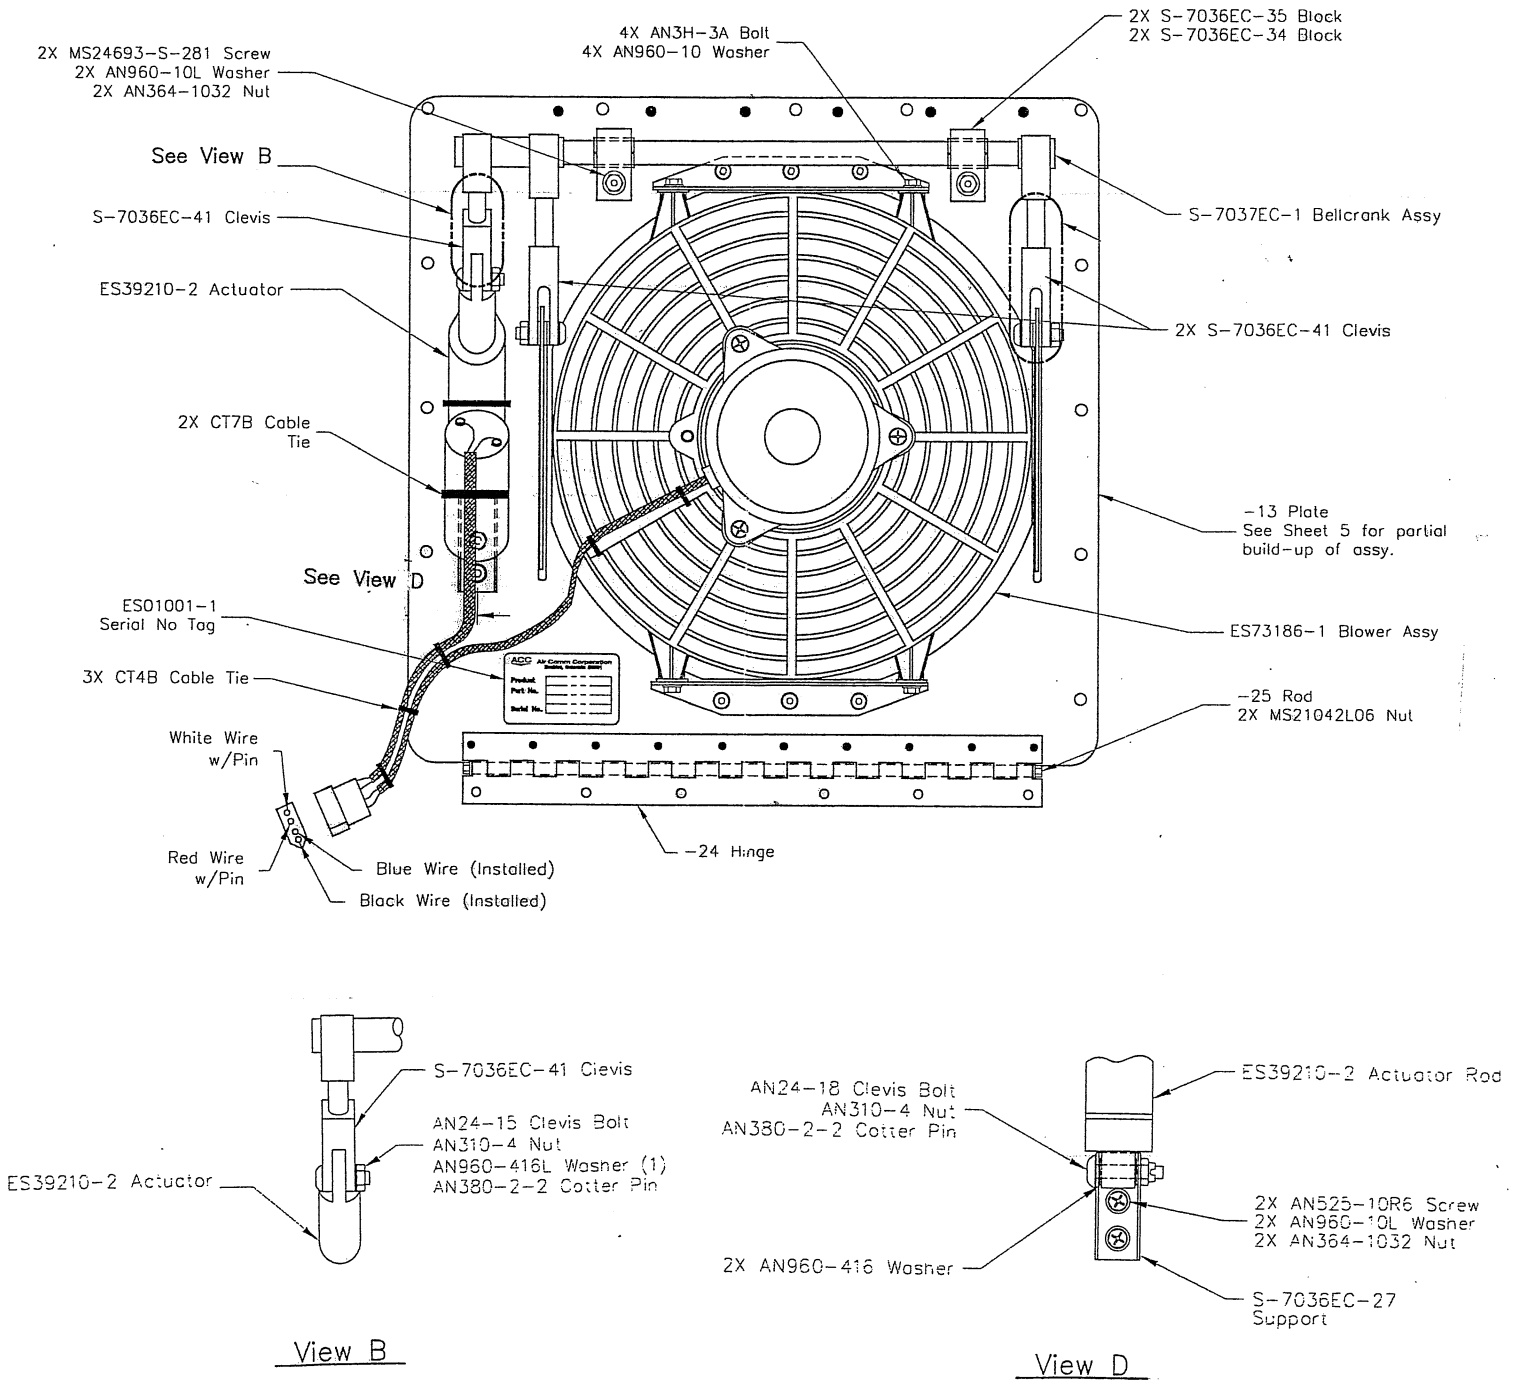
6. Remove the "red" & "white wires" from the molex connector and remove & discard failed actuator.

Install the new ES39210-2 Actuator assembly in the reverse order of its removal, and adjust the condenser scoop in accordance with Air Comm Service Letter SL 329, Condenser Scoop / Bellcrank Replacement & Adjustment Procedure.
