**Service Bulletin:** SB EC145-702; Eurocopter EC145 Air Conditioner Condenser Upgrade.

**Subject:** Up-grade of existing condenser installation, Aircraft S/N 9089.

**Date:** 30, November 2006, Rev N/C

**Applicability:** Eurocopter Helicopter model BK117-C2, S/N 9089

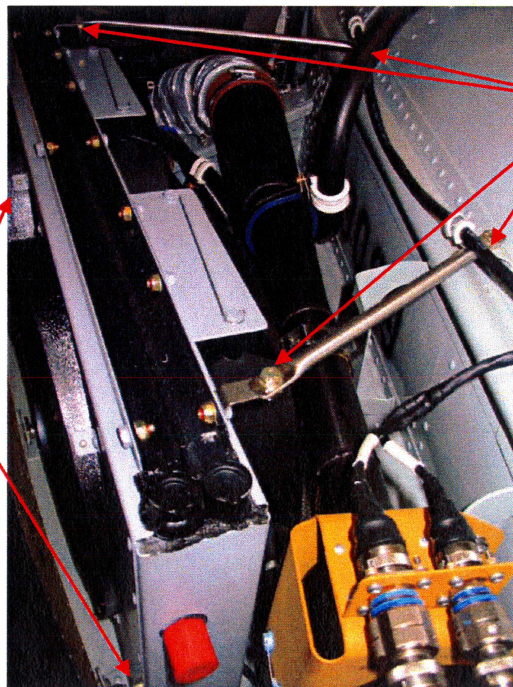
**Figure 1-1**

Operators in the field have noted cracking to the deck surfaces adjacent to the air conditioner condenser mounting points.

1. Discharge / Recover refrigerant form the air conditioner system.
2. Disconnect the Molex connector to the EC145-7000-1 Condenser Blowers.
3. Remove the EC145-7000-1 Condenser Assy., EC145-7010-14 & EC145-7010-22 Supports from the tail boom connecting points and the top of the condenser assembly. See Figure 1-1.

Remove the EC145-7000-1 Condenser assembly from the aircraft, by removing the existing Bolts, Nuts, and Washers from the condenser support brackets at the base of the condenser assembly.

Remove and discard the attaching hardware, and supports.
