Service Letter: No. 322

Subject: Engine Bleed Port Gasket - Engine Compartment Bleed Air System.

Applicability: Bell Model 407

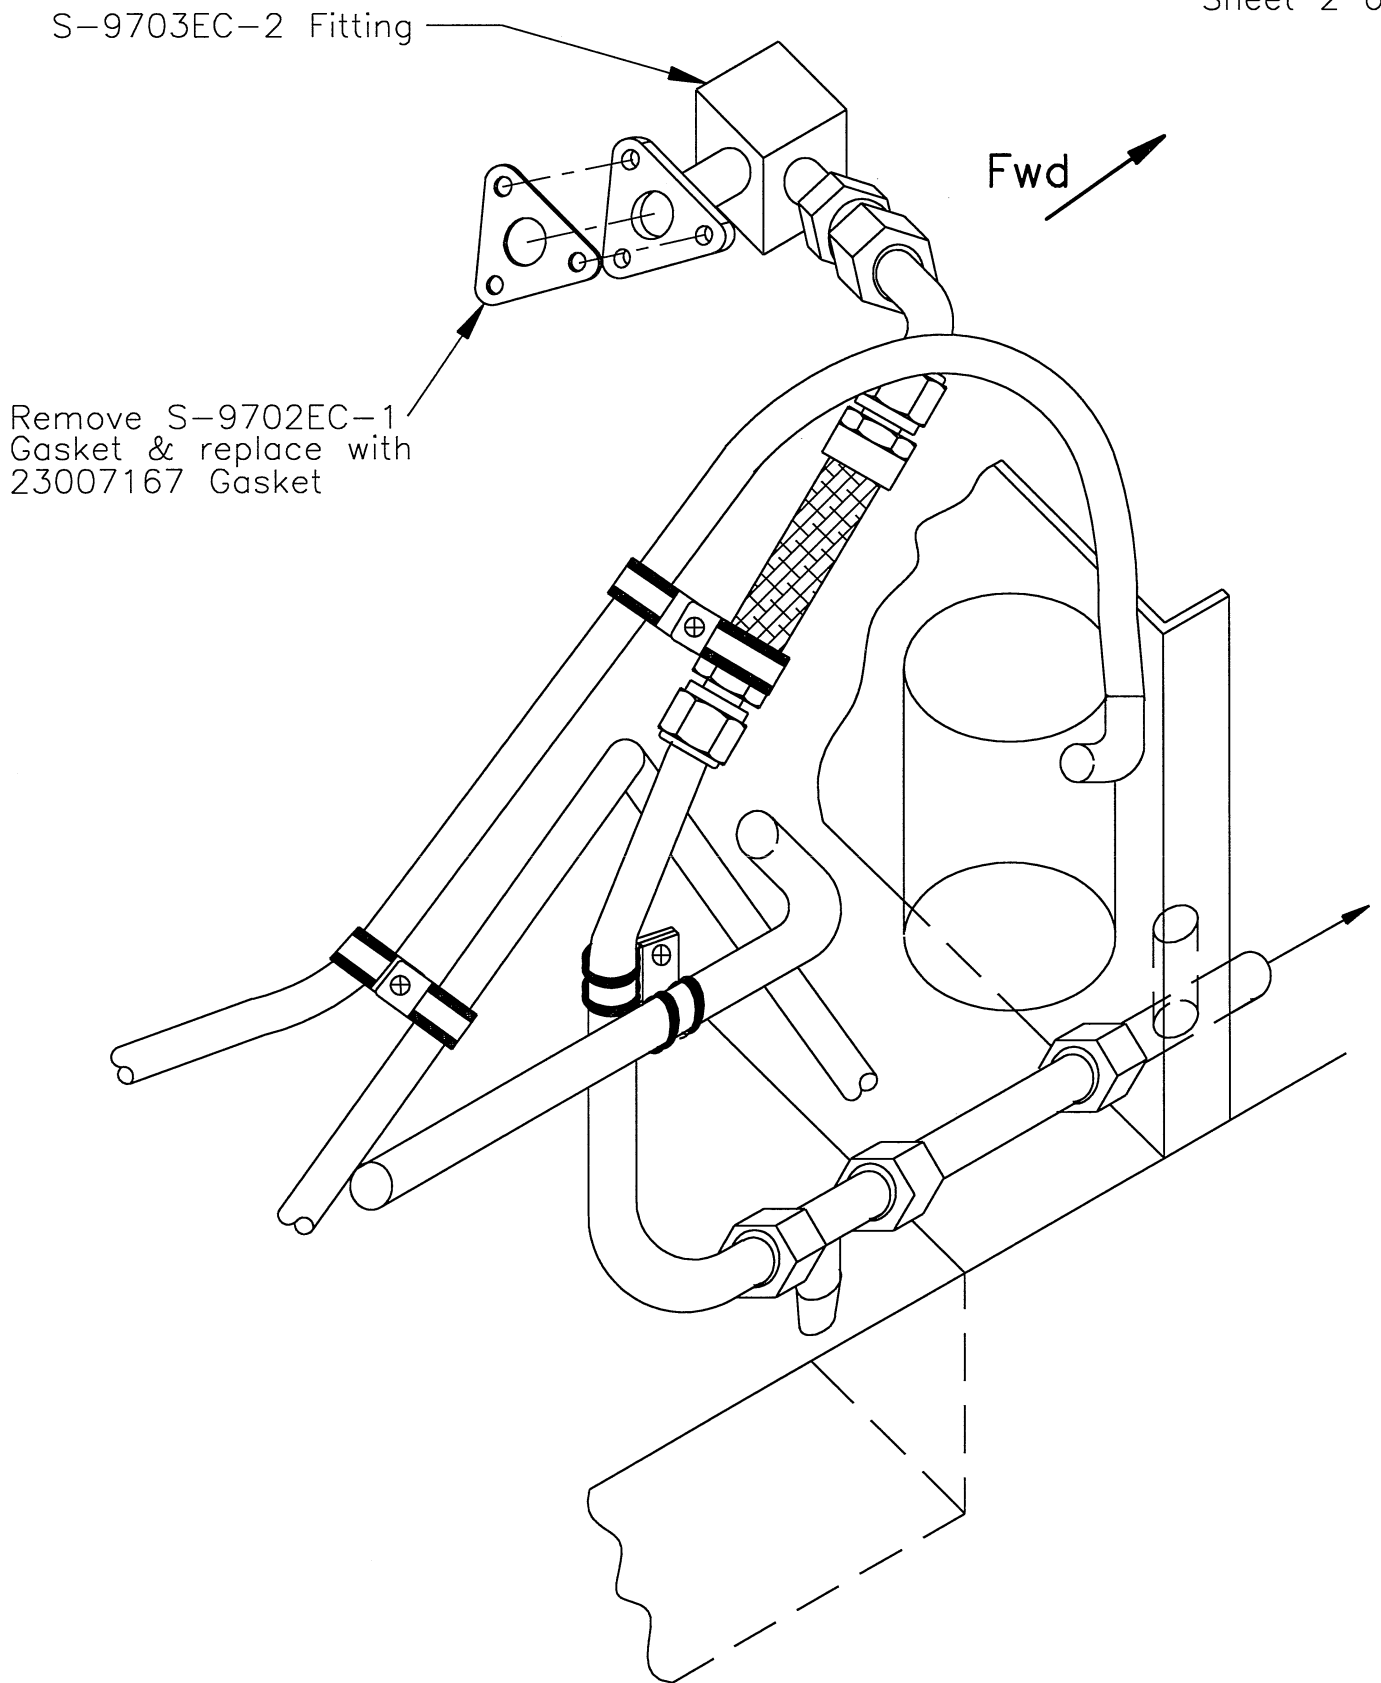
Figure 1: Engine Compartment
Bleed Air System

It has come to our attention that the S-9702EC-1 gasket, shipped with a small number of subject systems (8 units), may not provide a positive seal under all conditions. This document provides authorization and instructions for the removal and replacement of this gasket. Replacement gaskets are available from Air Comm Customer Service Department, telephone 303-440-4075.

Refer to figure 1. Remove retaining bolts from S-9702EC-2 fitting, and remove fitting and gasket. Replace with 23007167 gasket, install fitting and bolts and torque to specifications.
