### Service Letter

**Title:** Bell M429 Environmental Control Unit installation inspection and possible replacement

**Applicability:** Owner/Operators of Bell M429 Helicopters with STC SR00693DE Air Conditioning System

**Reference:** FAA / STC # SR00693DE, Bell M429 Air Conditioning System 429EC-700 Condenser Installation Drawing

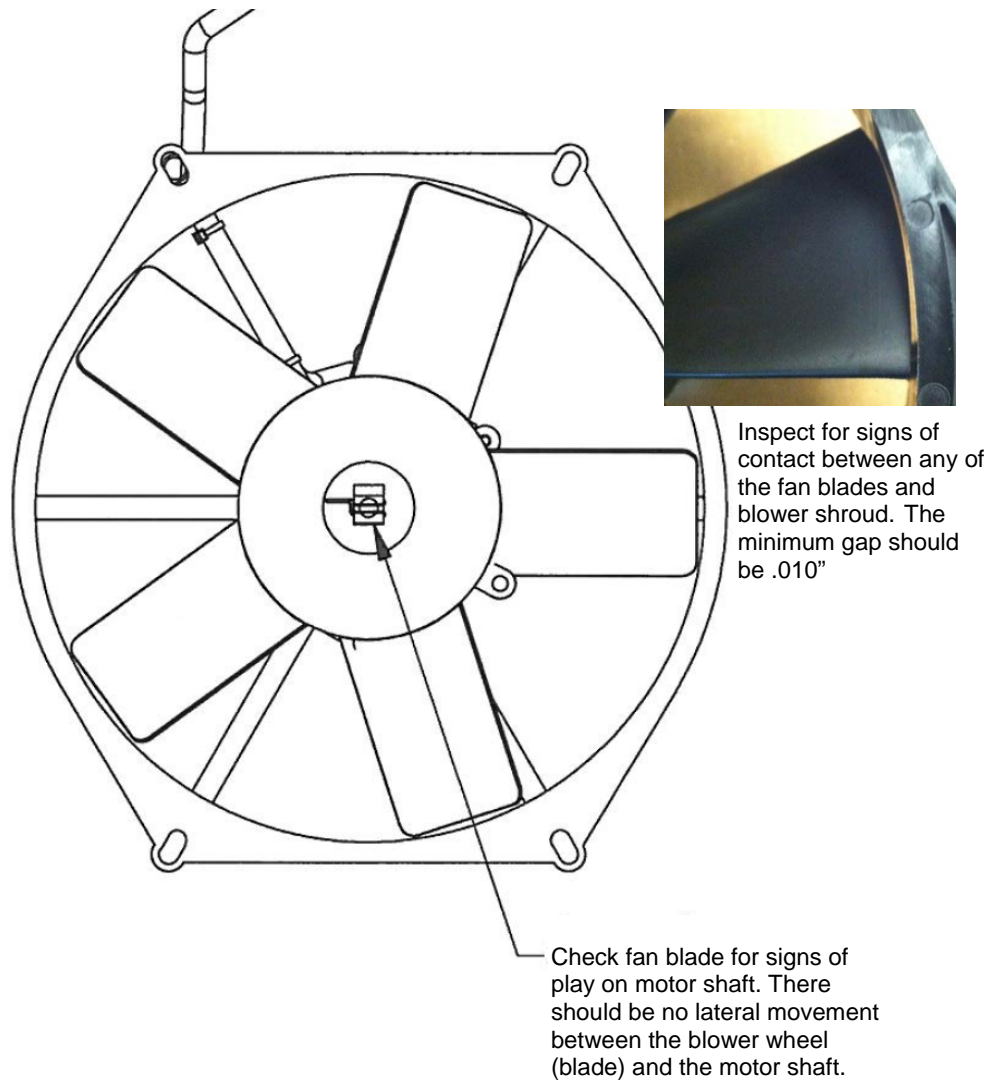
**Figure 1.2**  
**S-6063EC-1 Condenser Blower Assembly**

Air Comm has recently been advised of condenser blower fans developing free play relative to the motor shaft. This could eventually result in reduced fan performance, even to the point that the fan no longer turns, rendering the air conditioning ineffective when the aircraft is not moving forward.

1. Prepare helicopter for maintenance.
2. Remove upper cowlings as necessary to gain access to the condenser assembly (Figure 1.1).
3. Check fan blade for signs of play on the motor shaft. (Figure 1.2) There should be no lateral movement between the blower wheel (blade) and the motor shaft. Inspect for signs of contact between any of the fan blades and blower shroud. There should be no indications of contact or rubbing between the fan blades and the shroud. The minimum gap should be .010". If any anomalies are found, contact Air Comm Corporation for guidance on disposition.
4. Secure aircraft.
5. Contact Air Comm Corporation if additional guidance is required.

In case a non-conforming condition is identified as a result of this verification, the operator shall contact Air Comm Corporation for further instructions.
