**Service Bulletin**

**Title:** SB AS350-8420; Airbus Helicopter AS350 Air Conditioner Relay Panel Wiring

**Applicability:** Airbus Helicopter AS350 Aircraft equipped with Air Comm Air Conditioning Systems with the following serial numbers: AS350-129 through AS350-159. The system serial number is marked on the compressor mount.

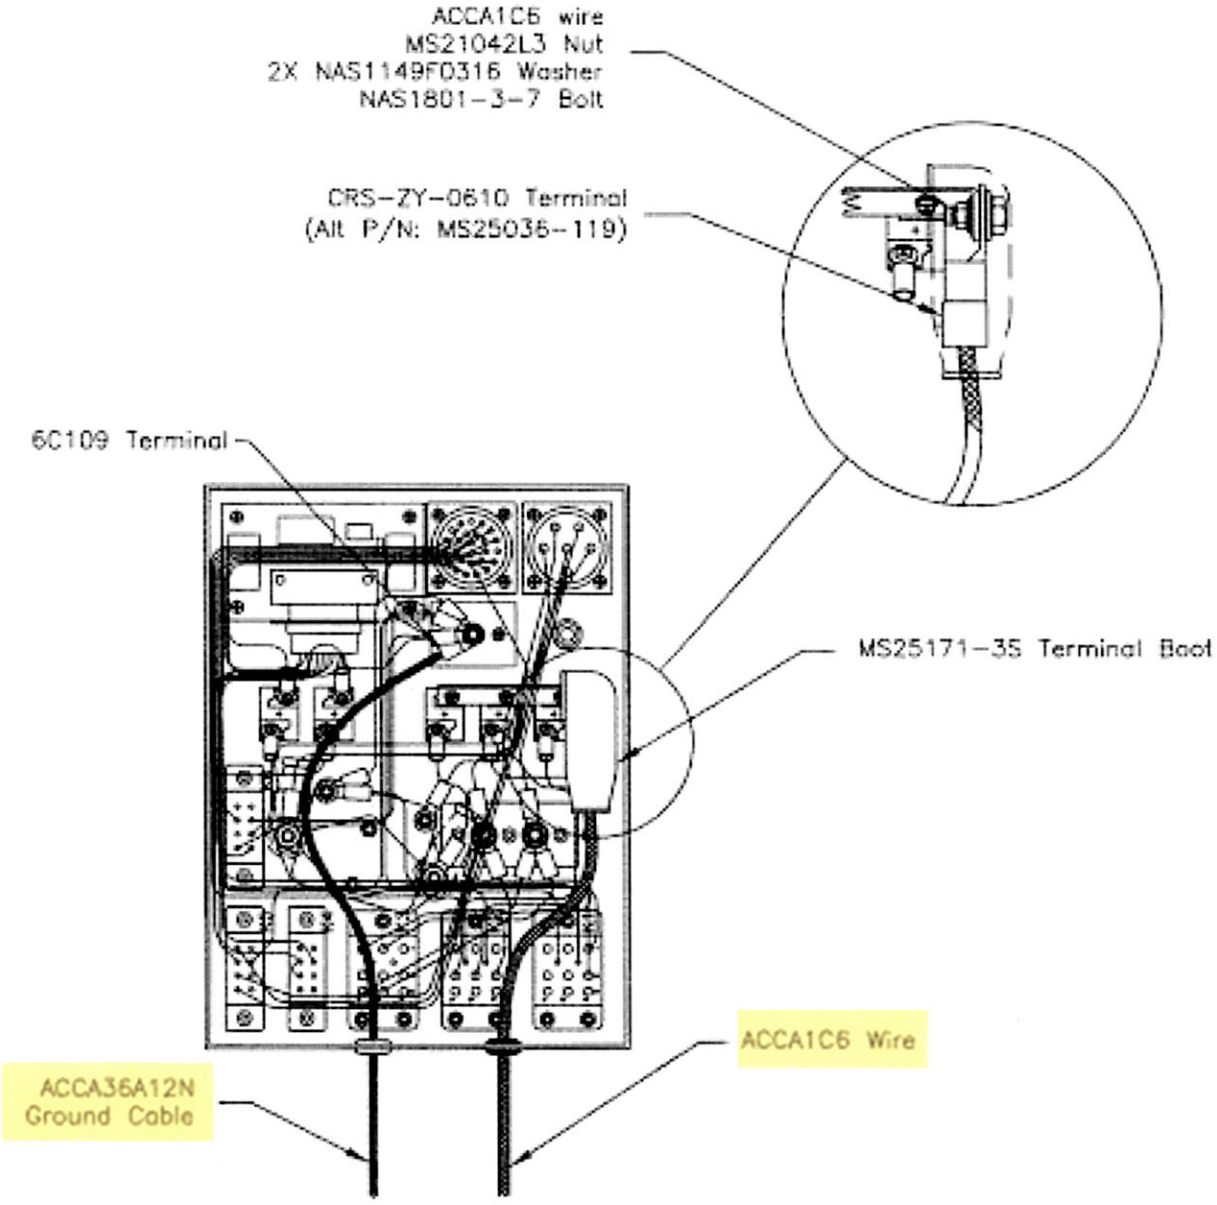
Figure 2: Power and Ground cables route through bottom of enclosure and connect to cover components.

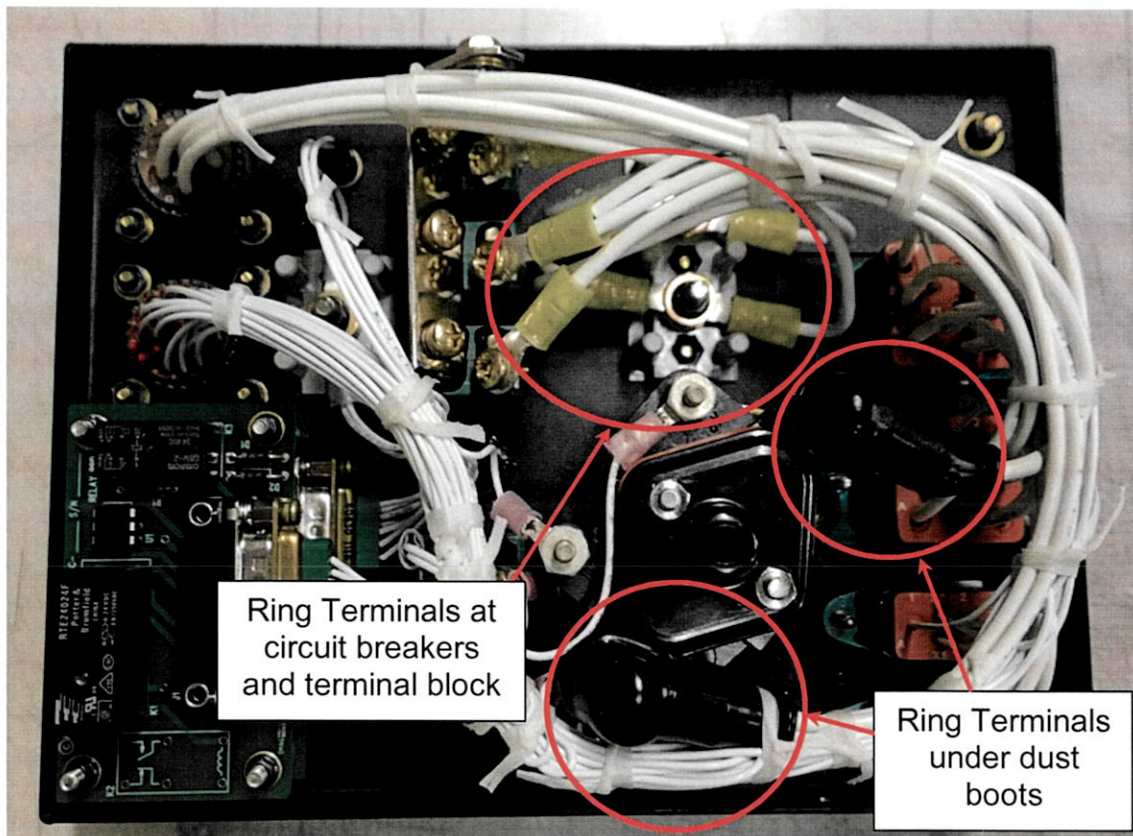
**Figure 3: Components mounted inside the panel cover**

1. Turn the relay panel over to observe the wiring and components.
2. Carefully inspect all heavy-gauge wiring and ring terminal crimps.
3. Inspect for signs of heat-related discoloration (brown/black) on cables, ring terminals, relays and connectors.

4. Pull back the flexible dust boots covering the terminals of the condenser contactor. Inspect these ring terminals for heat-related damage.
5. Check wires for signs of nicks and cuts due to chafing against other components or sheet metal.

6. If any overheated components are found, the air conditioning system must be placed in a non-operational state and remain deactivated until the panel is replaced. Further flight is permitted as long as the air conditioner remains deactivated. Contact Air Comm for instructions on how to obtain a replacement unit.
