Service Letter

Service Letter: No. 326

Subject: Inspection of 412AC-5040-3 Accumulator, when installed with Aeronautical Accessories Hoist Kit (P/N 412-150-400).

Applicability: Bell Helicopter Model 412

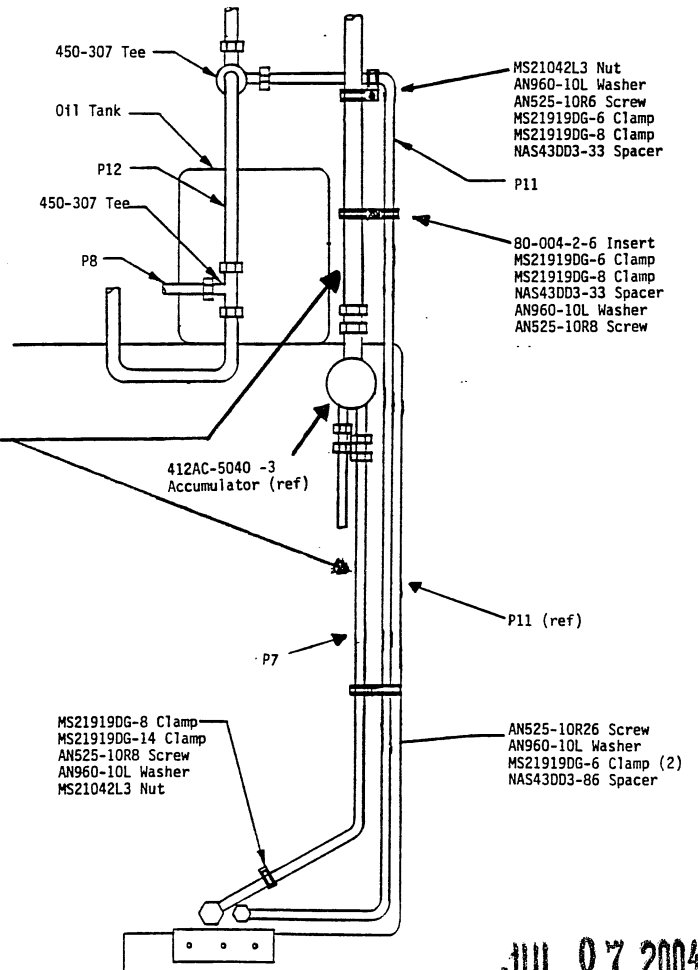
If repositioning of lines becomes necessary, make adjustments in the areas indicated.

Making adjustments to close to the fittings may cause leaks.

4. If no damage is found reapply insulation to the accumulator body.
5. Reposition lines so that no contact or interference occurs between the aircraft structures and the accumulator assy.
 - a. note: that the air conditioner plumbing lines are made of very soft aluminum, and therefore can be reshaped very easily.
