Service Bulletin

Title: SB 412AC-2502; Bell 412 Air Conditioner Relay Panel Wiring

Applicability: Bell Helicopter 412 Aircraft equipped with the Air Comm Air Conditioning System, all serial numbers. The system serial number is marked on the compressor mount.

Reference: FAA STC # SR00066DE

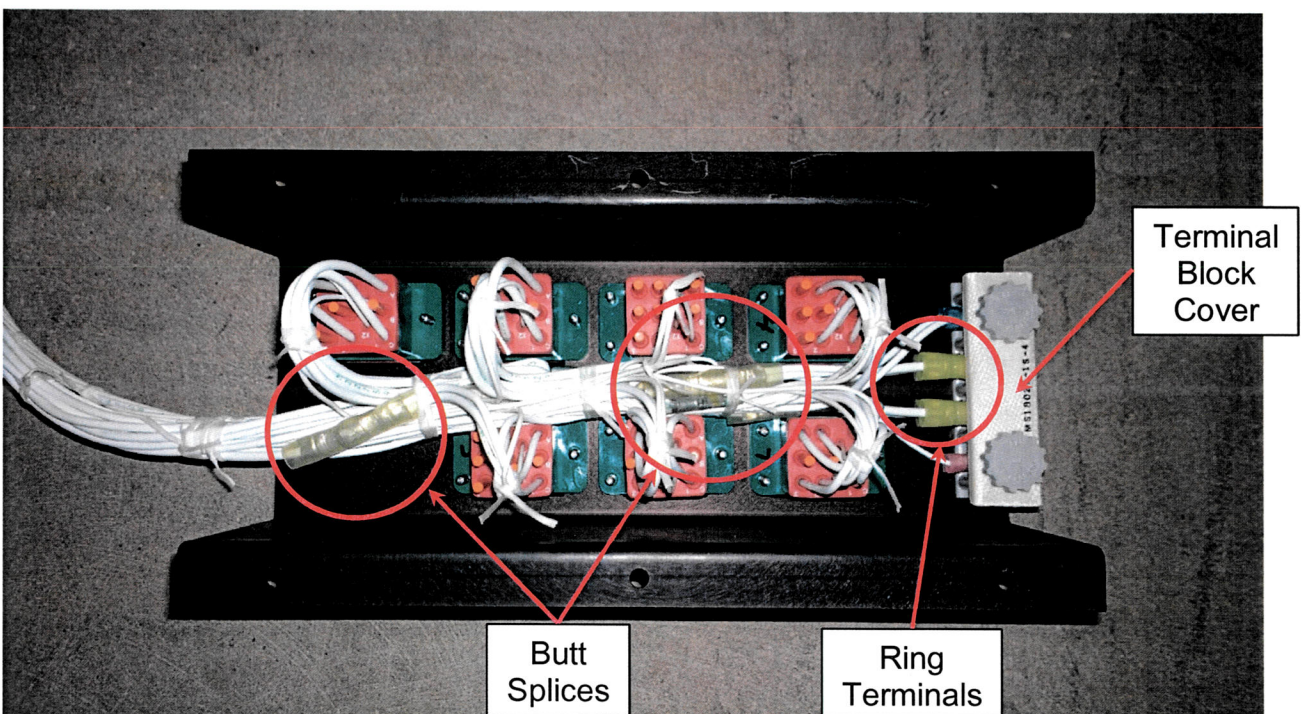
Figure 3: Underside of relay panel showing components and wiring

During a routine periodic inspection, an operator discovered evidence of overheated components inside a 412AC-2502-1 Relay Panel Assembly. Subsequent inspection of other 412 aircraft in the operator's fleet revealed a total of four overheated panels.

3. It will be necessary to remove the cover of the terminal block in order to enable the ring terminals to be fully visible.
4. Carefully inspect each butt splice and ring terminal attached to the terminal block for signs of heat-related discoloration, melted plastic or charred material.

5. Carefully inspect the wiring to ensure all insulation is intact and no brown or black heat-related discoloration is present. Check wires for signs of nicks and cuts due to chafing against other components or sheet metal.

6. If any overheated components are found, the air conditioning system must be placed in a non-operational state and remain deactivated until the panel is replaced. Flight is permitted as long as the air conditioner remains deactivated. Contact Air Comm for instructions on how to obtain a replacement unit.
