Service Bulletin

SB 427-110414; Bell 427 Air Conditioner Blower Motor Connector

Bell Helicopter Model 427 equipped with the Air Comm Corporation

427EC-200-1 thru -4 air conditioning systems

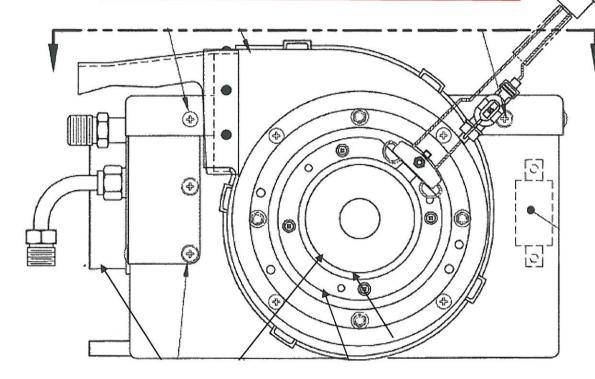
Figure 1 Aft Evaporator Blower Assembly (blower configuration may differ slightly. Connector is used on all 427 aft evaporators)

Field reports have indicated that in some rare occurrences the aft evaporator blower motor connectors may have overheated due to an improper contact crimp or loose fitting terminations. This Bulletin requires a visual inspection and basic pull test of the connectors on the evaporator and condenser blowers to determine if there is evidence of overheating or a loose wire-to-contact interface. If any signs of overheating or loose contacts are found, the A/C system must be made inoperable until the connector is replaced with new replacement connectors.

Locate each connector as shown in Figures 1 and 2. De-mate each connector and inspect both mates for signs of overheating, discoloration or plastic deformation. Gently pull (estimated 5-7 lb force) on each wire to verify the integrity of the contact's crimp. The contacts should be fully seated and locked in the housing so pulling gently on the wires will not dislodge the contacts from the housings.

Inspect this connector and its mate

If any signs of overheating of the housing are present or if the pull test fails, the system must be rendered inoperative and the connector housings and contacts replaced with new replacement connectors using Deutsch HDT-48-00 Crimping tool or equivalent MIL-DTL22520 Type 1 crimping tool before further operation. See Section B for information on how to contact Air Comm Corporation..
