Service Letter

Subject: Bell 427 Air Conditioner Blower Motor Connector Upgrade.

Applicability: Bell Helicopter Model 427 equipped with the Air Comm Corporation 427EC-200-1 thru -4 air conditioning systems

Reference: ACC Service Bulletin SB 427-110414

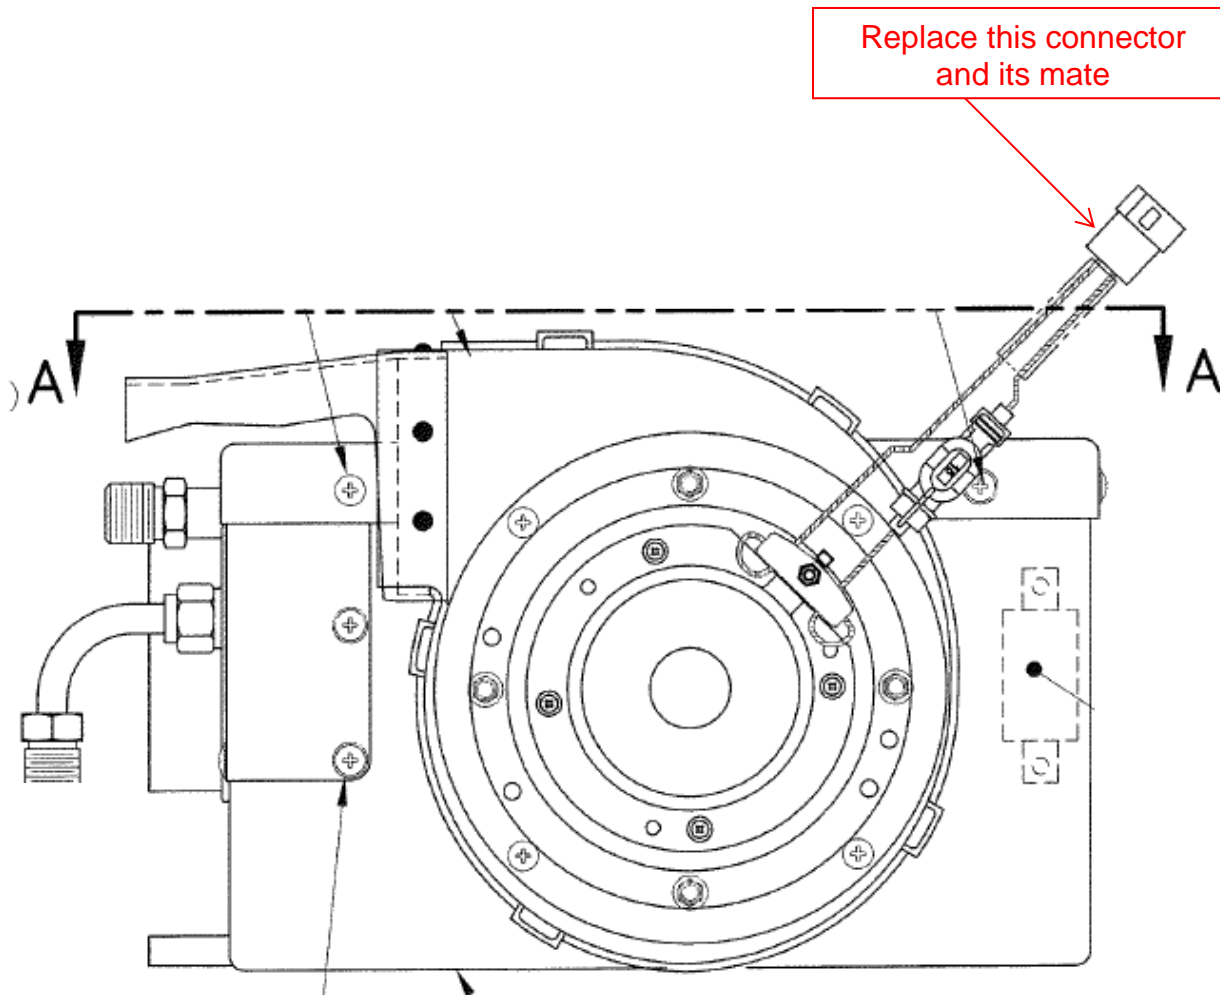
Figure 1 Aft Evaporator Blower Assembly (blower configuration may differ slightly. Connector is used on all 427 aft evaporators)

1. Access the aft evaporator assembly, located on the left side above the aft baggage compartment.
2. Locate the 2 pin connector (see Figure 1) and mark the white wires "Red" and "Black" as appropriate. It may be necessary to remove a portion of the heat shrink covering on the harness.
3. Cut the wires on the back side of the connector shown in Figure 1 and its mate. Remove minimal wire length. Remove and discard the connectors w/pins & sockets.

Install pins, sockets, plugs, and receptacles onto free ends of wires.

Crimp Molex pins using Molex Corporation Tool #0638111000 (Available thru Molex USA 1-800-786-6539) or equivalent wire terminal crimping tool for Molex 1189, 1190 series terminals (2.36mm / .093" dia).

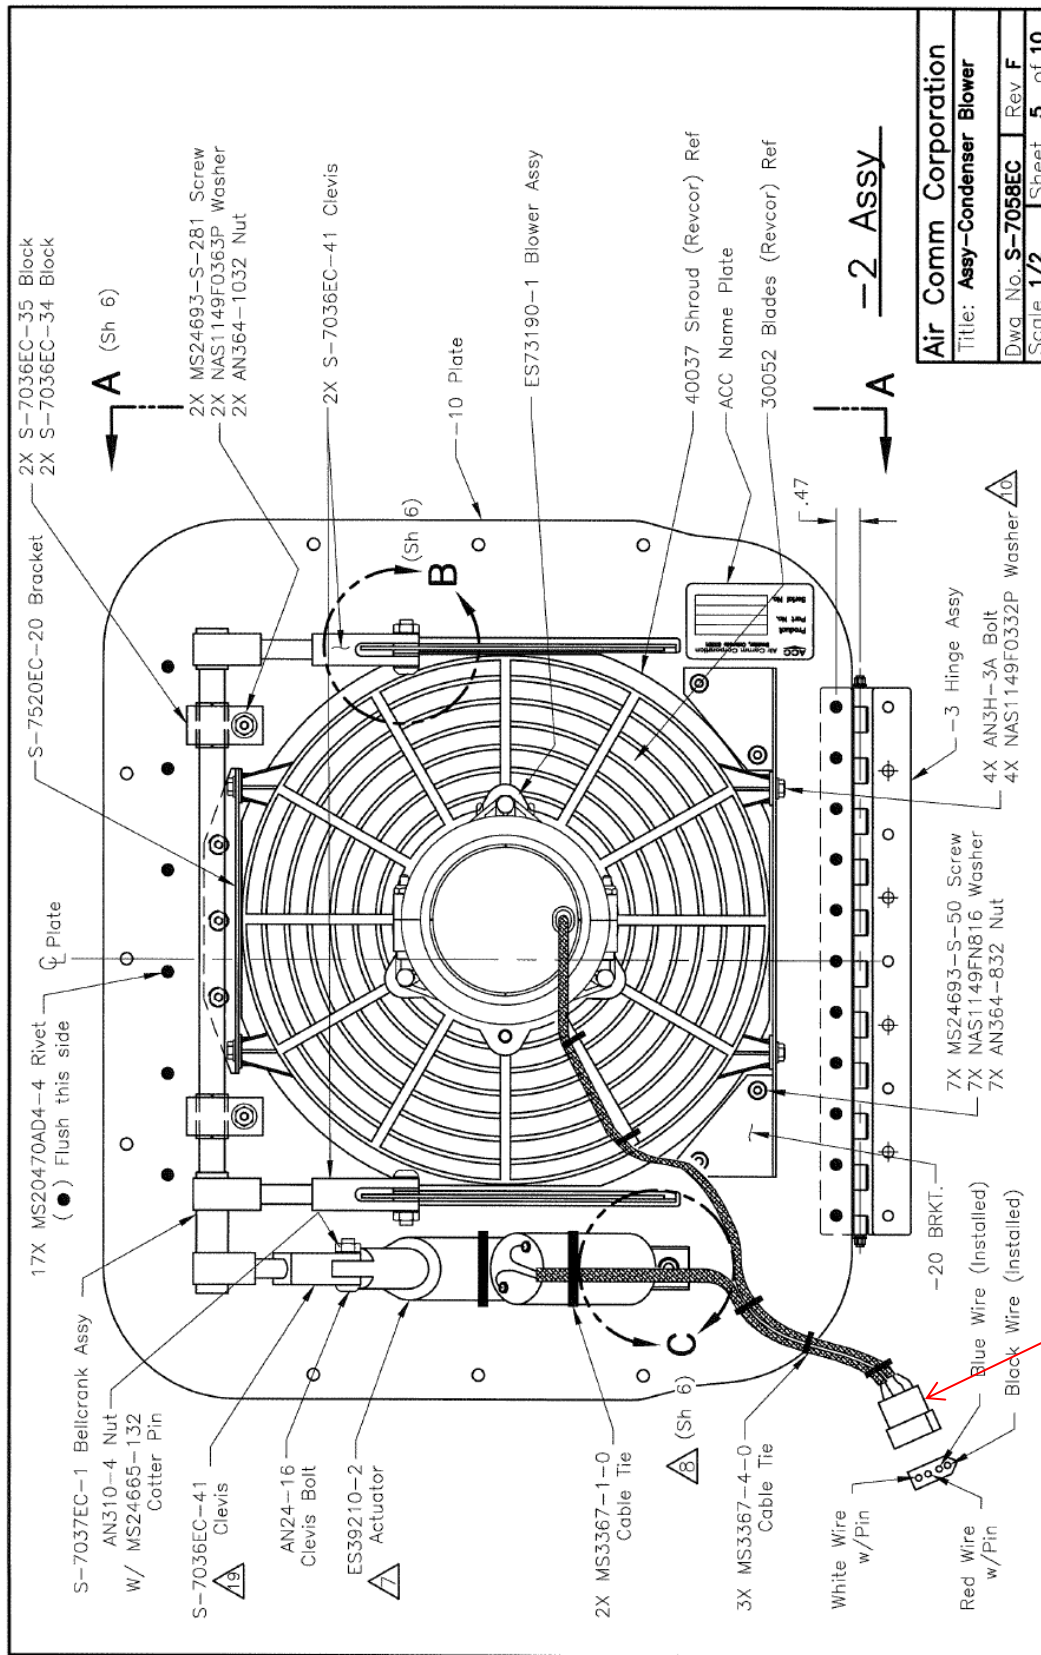
Figure 2. Condenser Blower 427 AC systems

1. Access the condenser assembly, located below the aft cargo compartment. See Figure 2.
2. Locate the 4 pin connector on the blower harness.
3. Identify the wires and remove both the plug and receptacle.

Replace this connector and its mate

Install the supplied pins, sockets, plugs, and receptacles onto free ends of wires.
Crimp Molex pins per instructions on sheet 3.
