Service Letter

Service Letter: No. 314 Rev D

Subject: Air conditioning system, Temperature Control electrical circuit change.

Applicability: Bell Helicopter Model 407

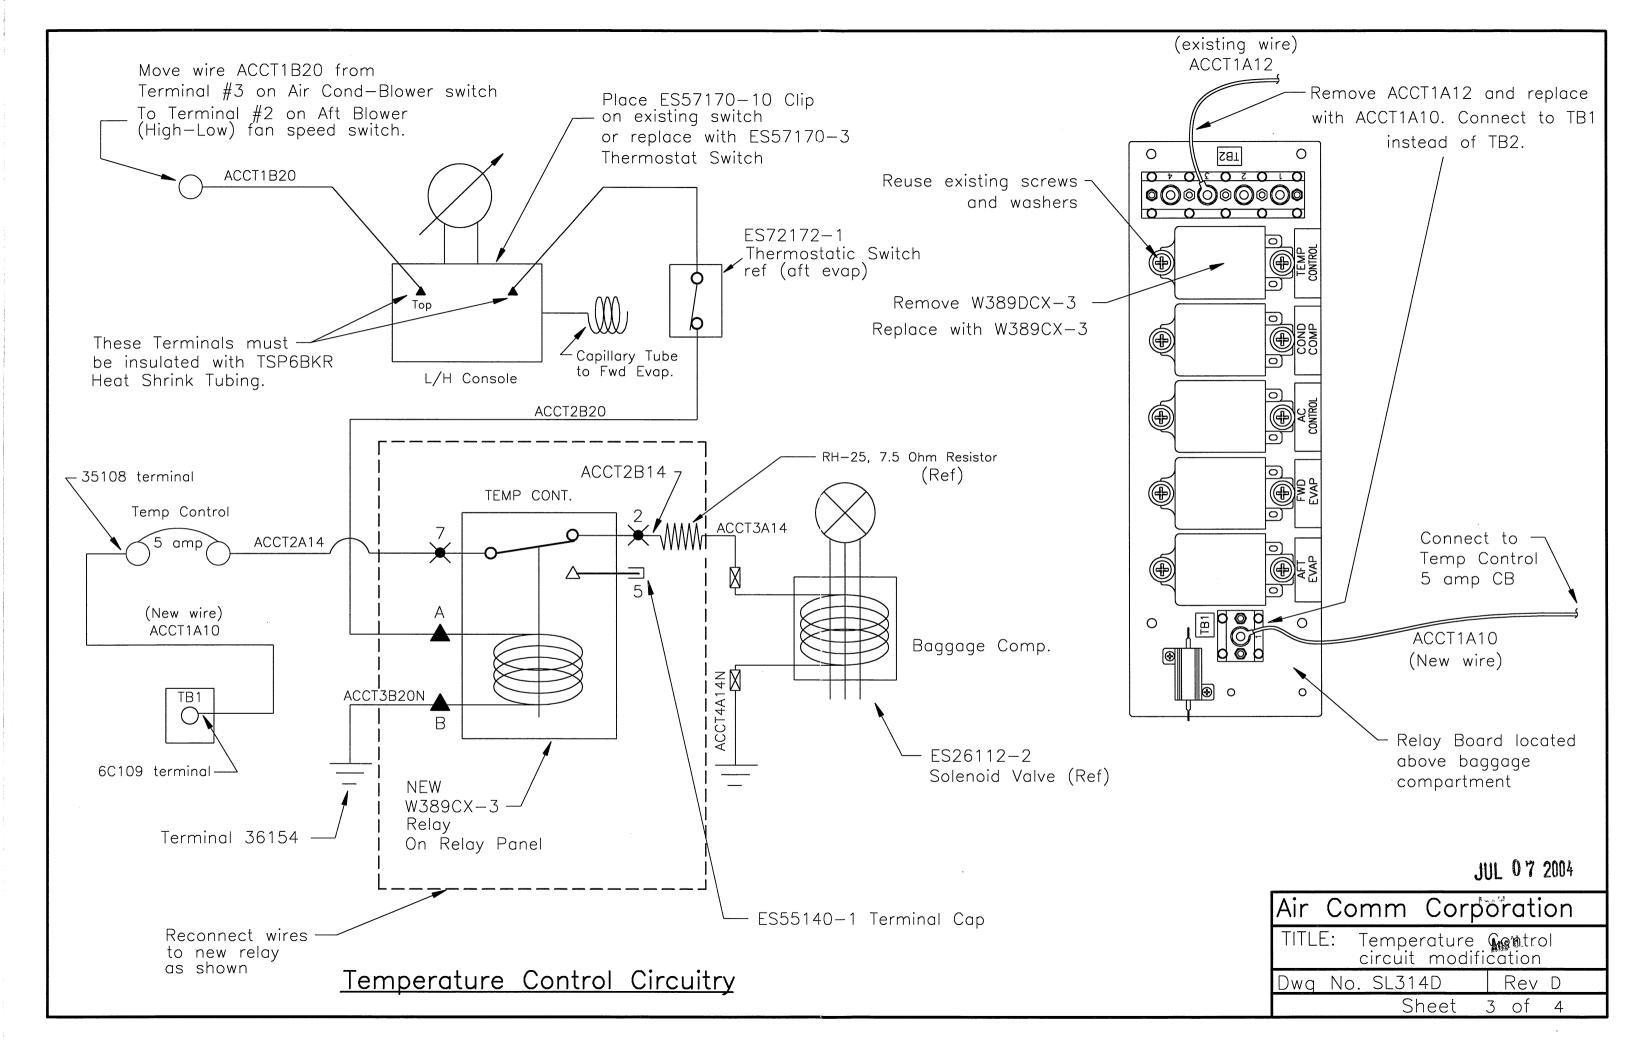
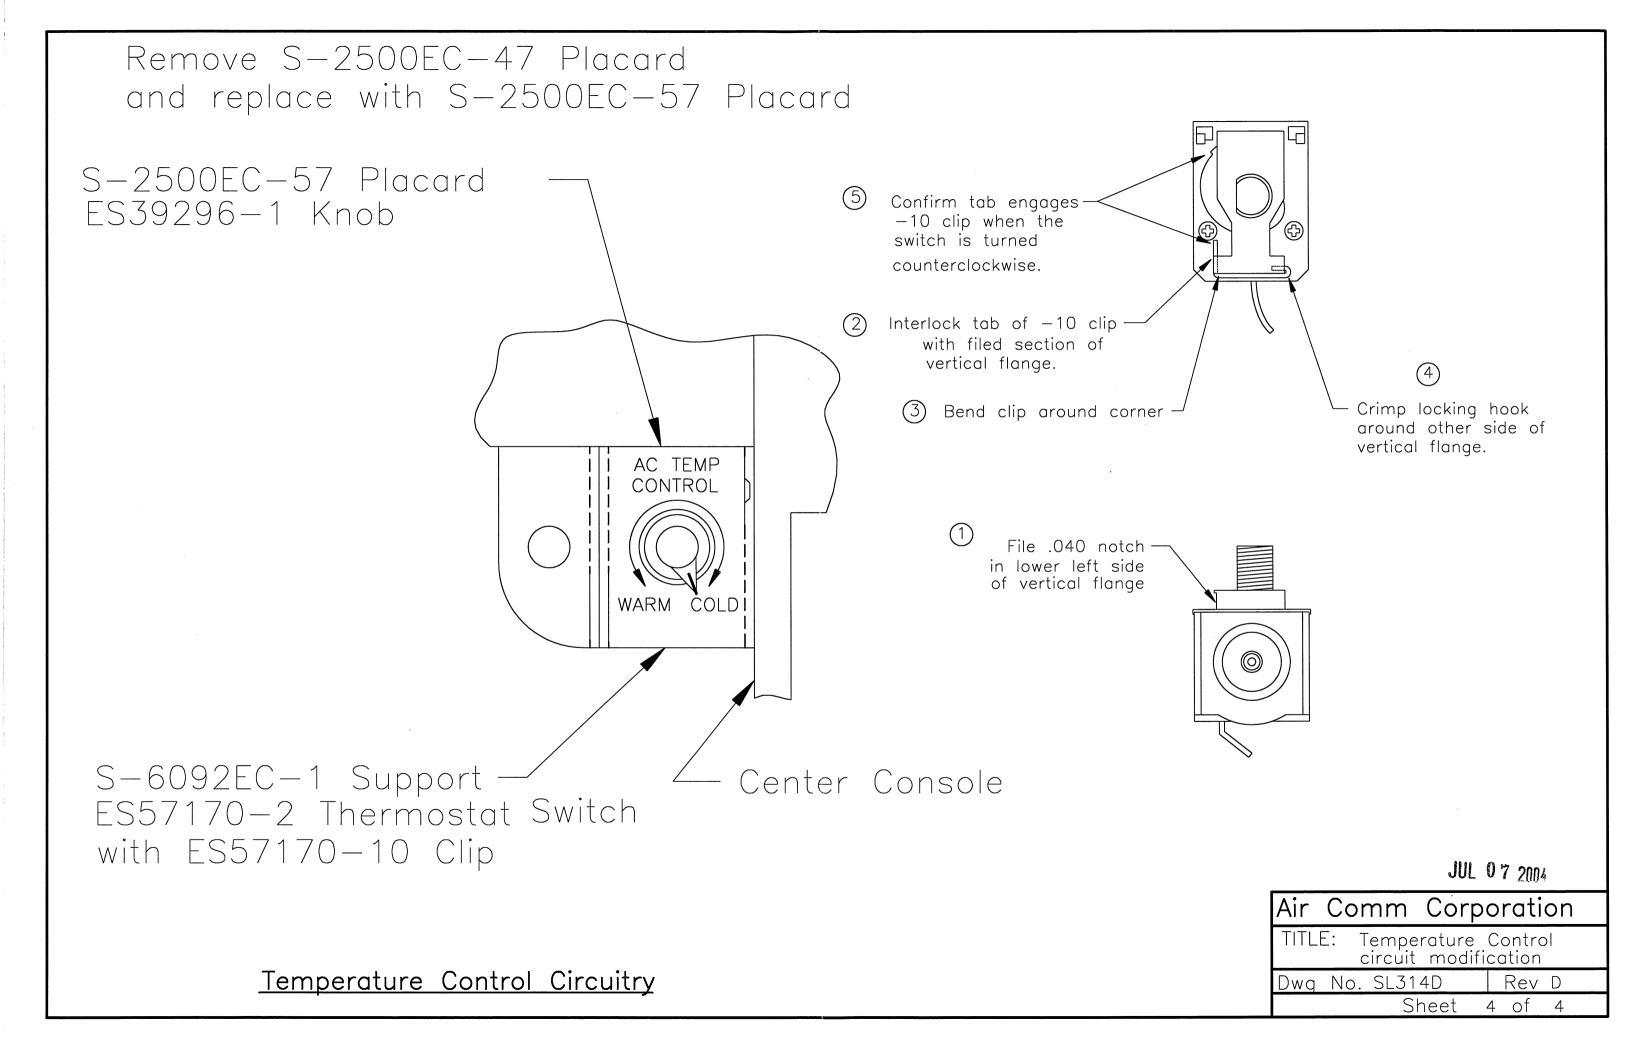
Purpose: To correct a Temperature Control System problem in the Bell 407 Series helicopters.

- 3. Install new relay (W389CX-3) in same position as one that was removed using existing screws and washers.
- 4. Reconnect wires as shown on wiring diagram enclosed. Confirm that the ES55140-1 Terminal Cap is positioned on terminal #5 of W389CX-3 relay. Remove wire ACCT1A12, from TB2 to 5 amp CB for the temperature control. Replace with 10 gauge wire and connect to temperature control circuit breaker and TB1 instead of TB2. Rename wire ACCT1A10.

- 6. The ES57170-10 clip should be placed on the existing temperature control switch as shown. If unable to place -10 clip on the existing switch, remove it and replace with the ES57170-3 temperature control switch. Place the capillary tube from the new switch in the same position as the one that was removed.

- 7. Move wire ACCT1B20 from the Air Cond/Blo switch terminal #3 to the Aft Blower, Hi-Low, fan speed control switch terminal #2.
- 8. Confirm system operation by resetting circuit breakers and testing air conditioning system.
