**Service Letter**

Service Letter: No. 323

Subject: Replacement of Hi-Output Blower Motor Support Bracket.

Applicability: Bell Helicopter Models 206 L 4 & 407 series.

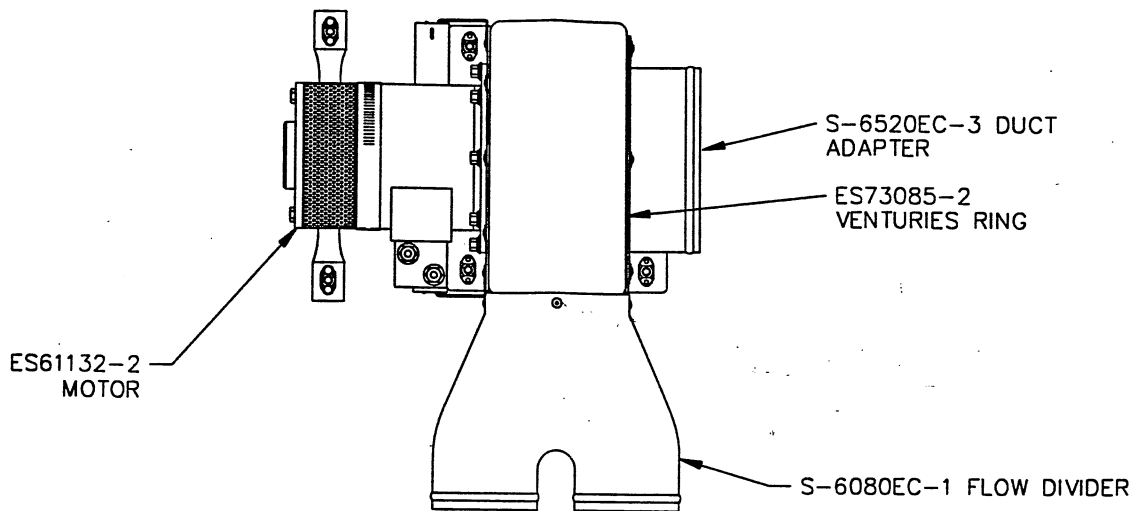
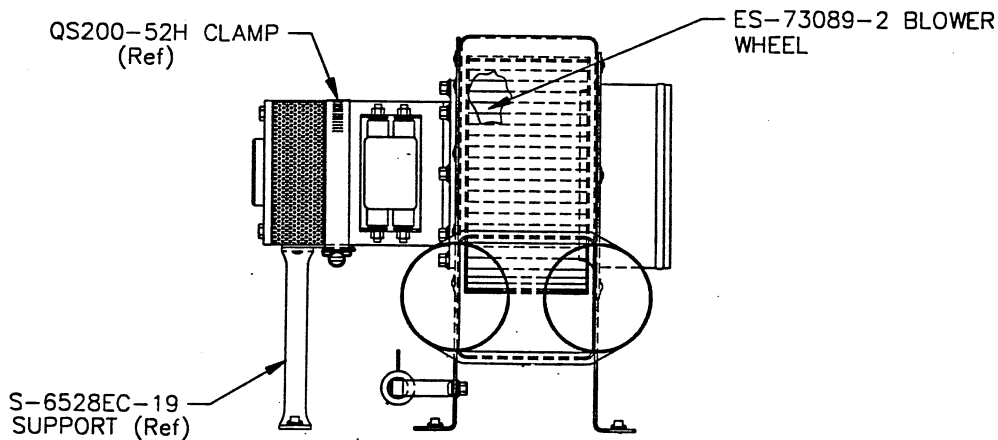
Background: It has come to Air Comm Corporation's attention that the Support Bracket currently in use on its high output Blower Motor assembly (S-6528EC-18), may after time develop cracks along some of the bends in the tubing material. This document provides the necessary instructions for the replacement and up-grade of the Hi-output Blower Motor Support mount, for the AFT Evaporator.

1. Remove Screws (2 pls) holding the feet of the support bracket to the electrical compartment shelf.
2. Loosen band Clamp (QS200-52H) that secures the top half of support bracket to the Hi-Output motor body.
3. Remove support bracket assembly S-6528EC-18 (Aluminum) from aircraft.
4. Install new Up-Graded support bracket S-6528EC-19 (Stainless Steel) in position below motor body.
5. Reinstall screws through the electrical shelf in to the bottom of the support feet nut plates, and tighten in place.
6. Reinstall band clamp (QS200-52H) around plate on the top of the support bracket, and tighten clamp.
