Service Letter: No. 349

Subject: Inspection of the Bell 407 Air Conditioner Driveshaft Mounted Pulley and Drive Ring Assembly.

Applicability: Bell Helicopter Model 407 Equipped with the Air Comm Air Conditioning system, Serial Numbers AC407-80 and subsequent.

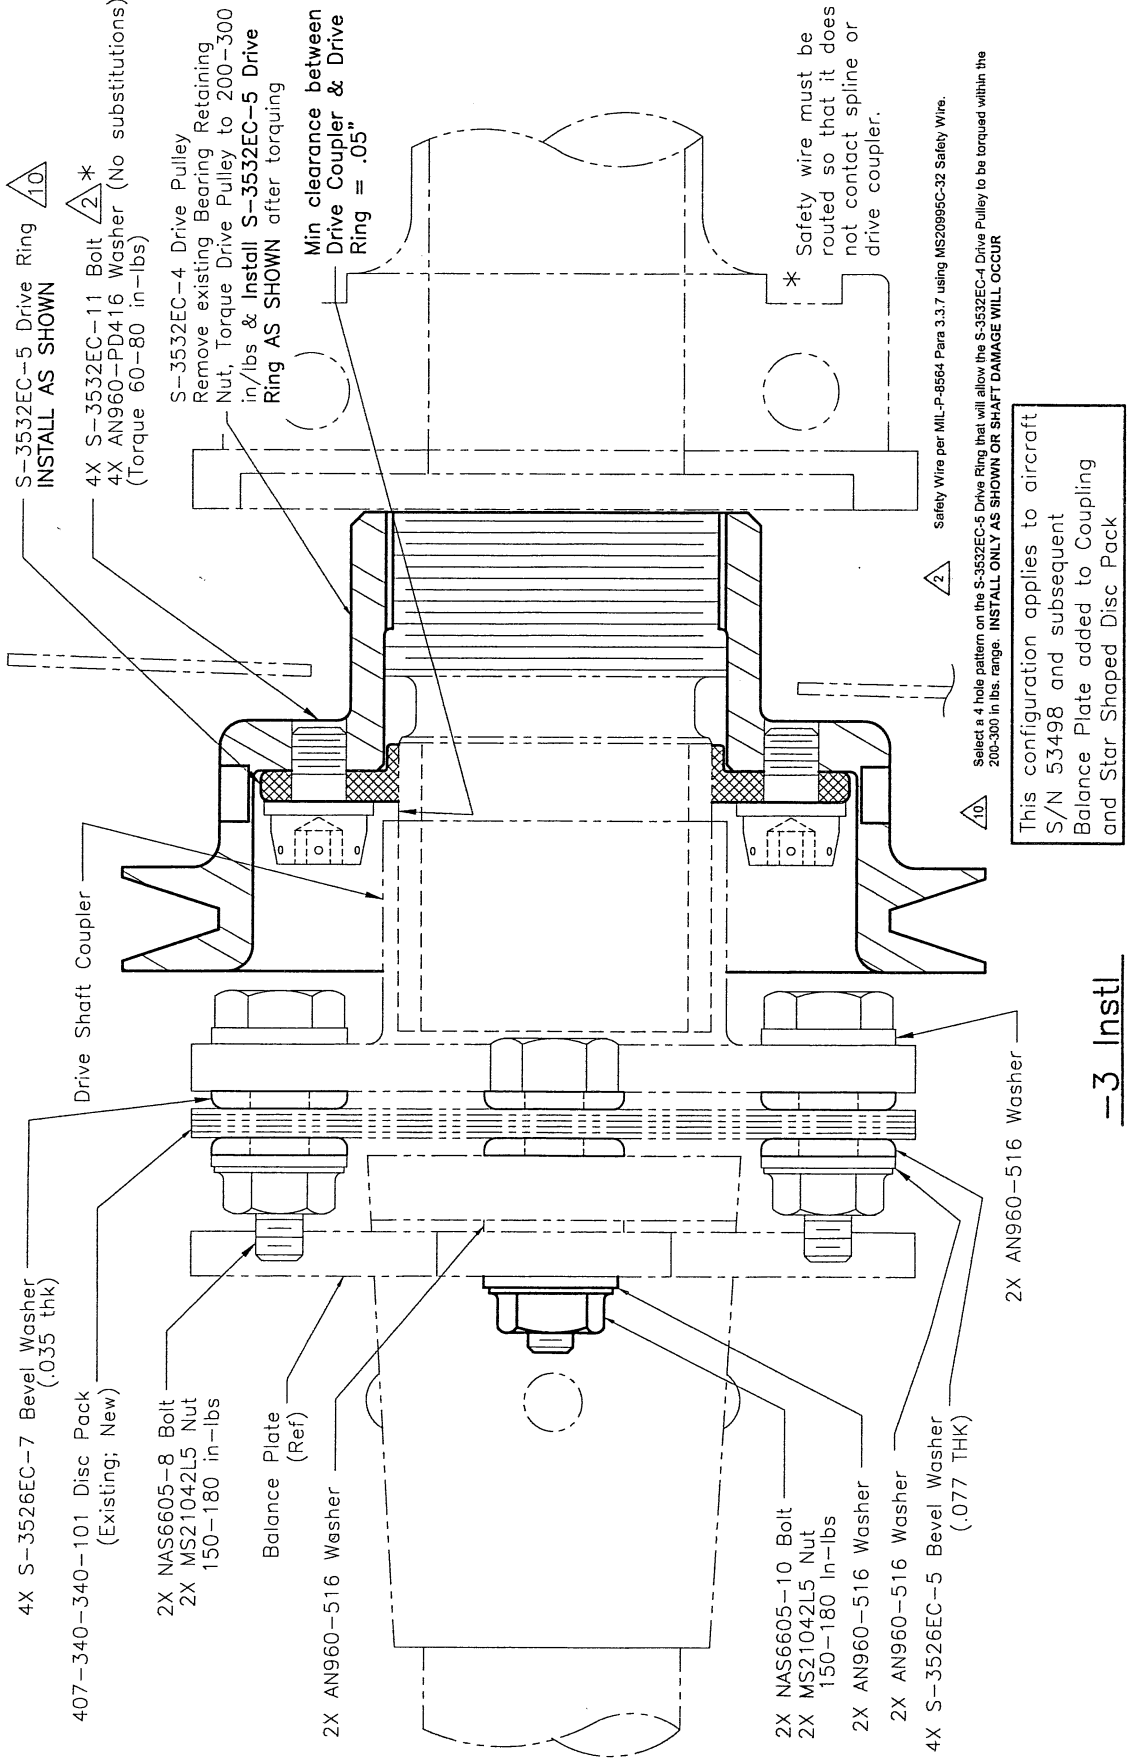
-3 Instl

S-3532EC-4 Pulley & S-3532EC-5 Drive Ring Installation (-3 Installation)

We highly recommend that all operators inspect the installation of the S-3532EC-4 Pulley & S-3532EC-5 Drive Ring assembly on helicopters equipped with the Air Comm Corporation air conditioning system, to insure that the S-3532EC-5 Drive Ring is installed as shown on Pages 2 thru 5 of this Service Letter. **The splined leg of the Drive Ring must be oriented aft to insure the .05 inch clearance with the drive shaft coupler.**

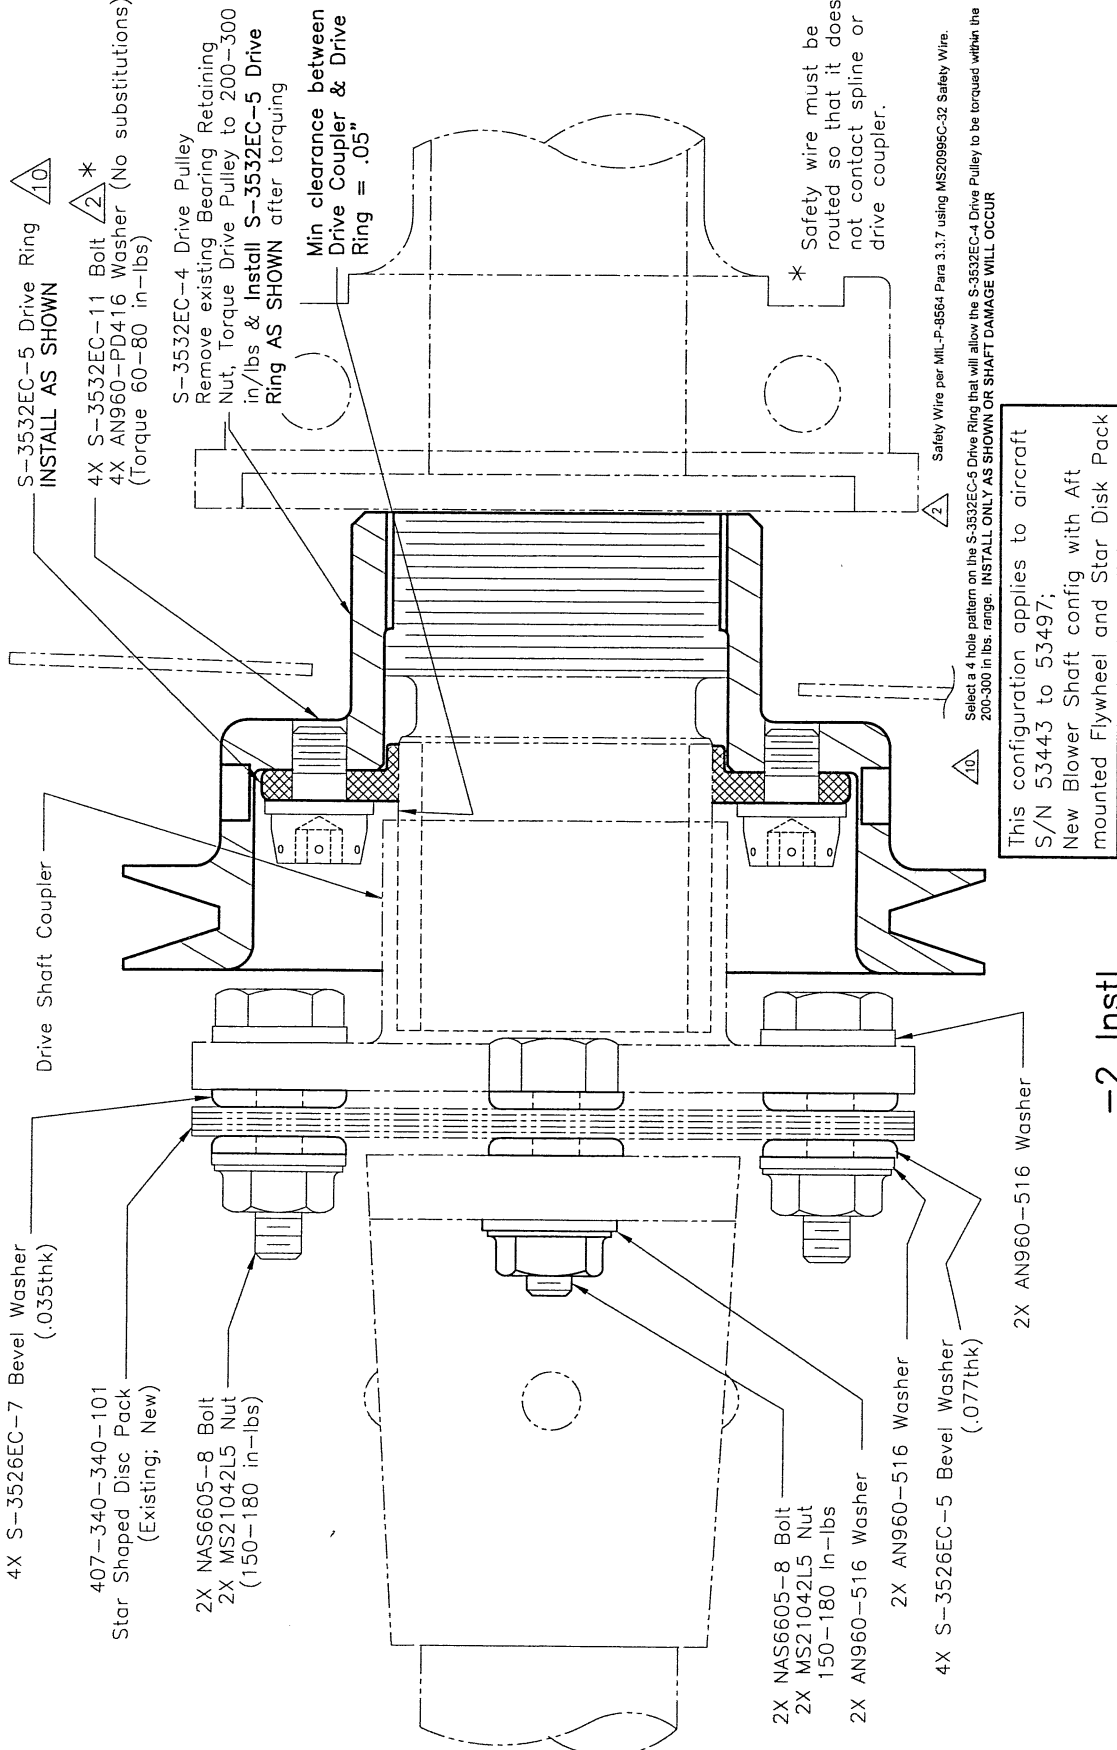
-2 Instl

S-3532EC-4 Pulley & S-3532EC-5 Drive Ring Installation (-2 Installation)

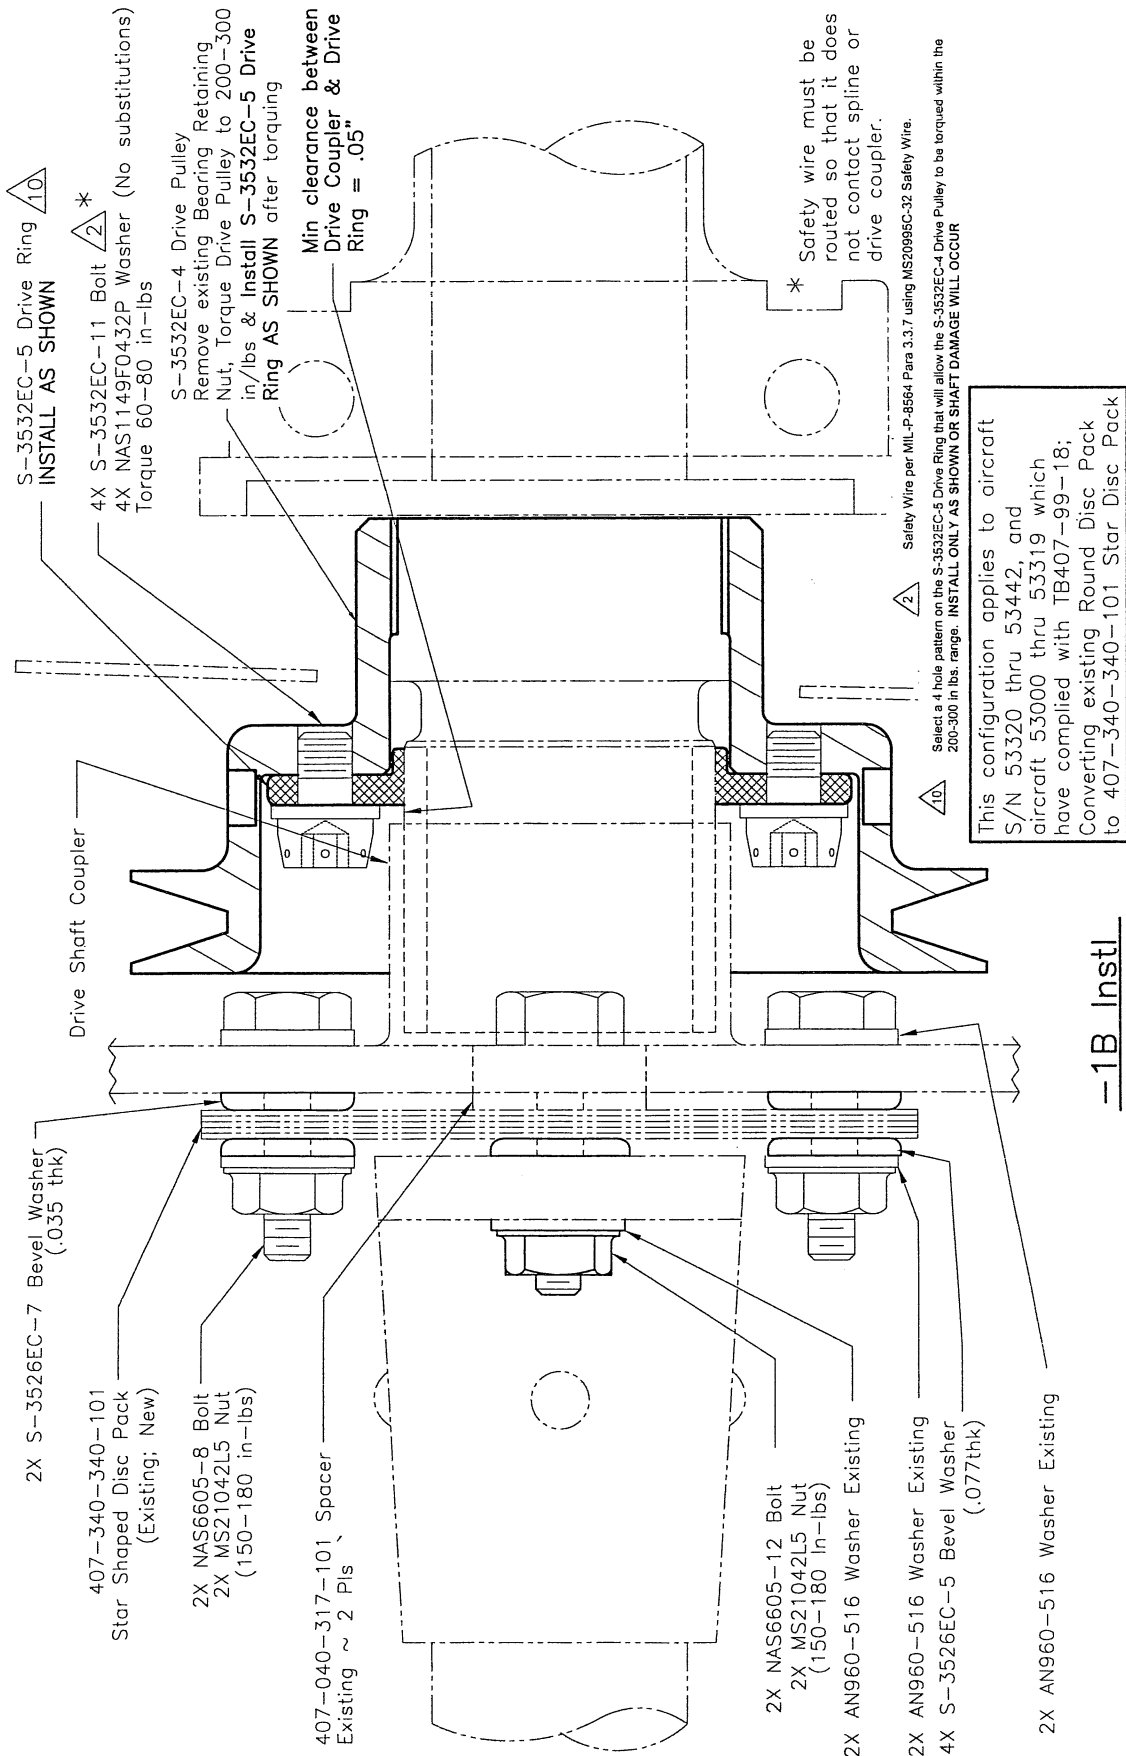
S-3532EC-4 Pulley & S-3532EC-5 Drive Ring Installation (-1B Installation)

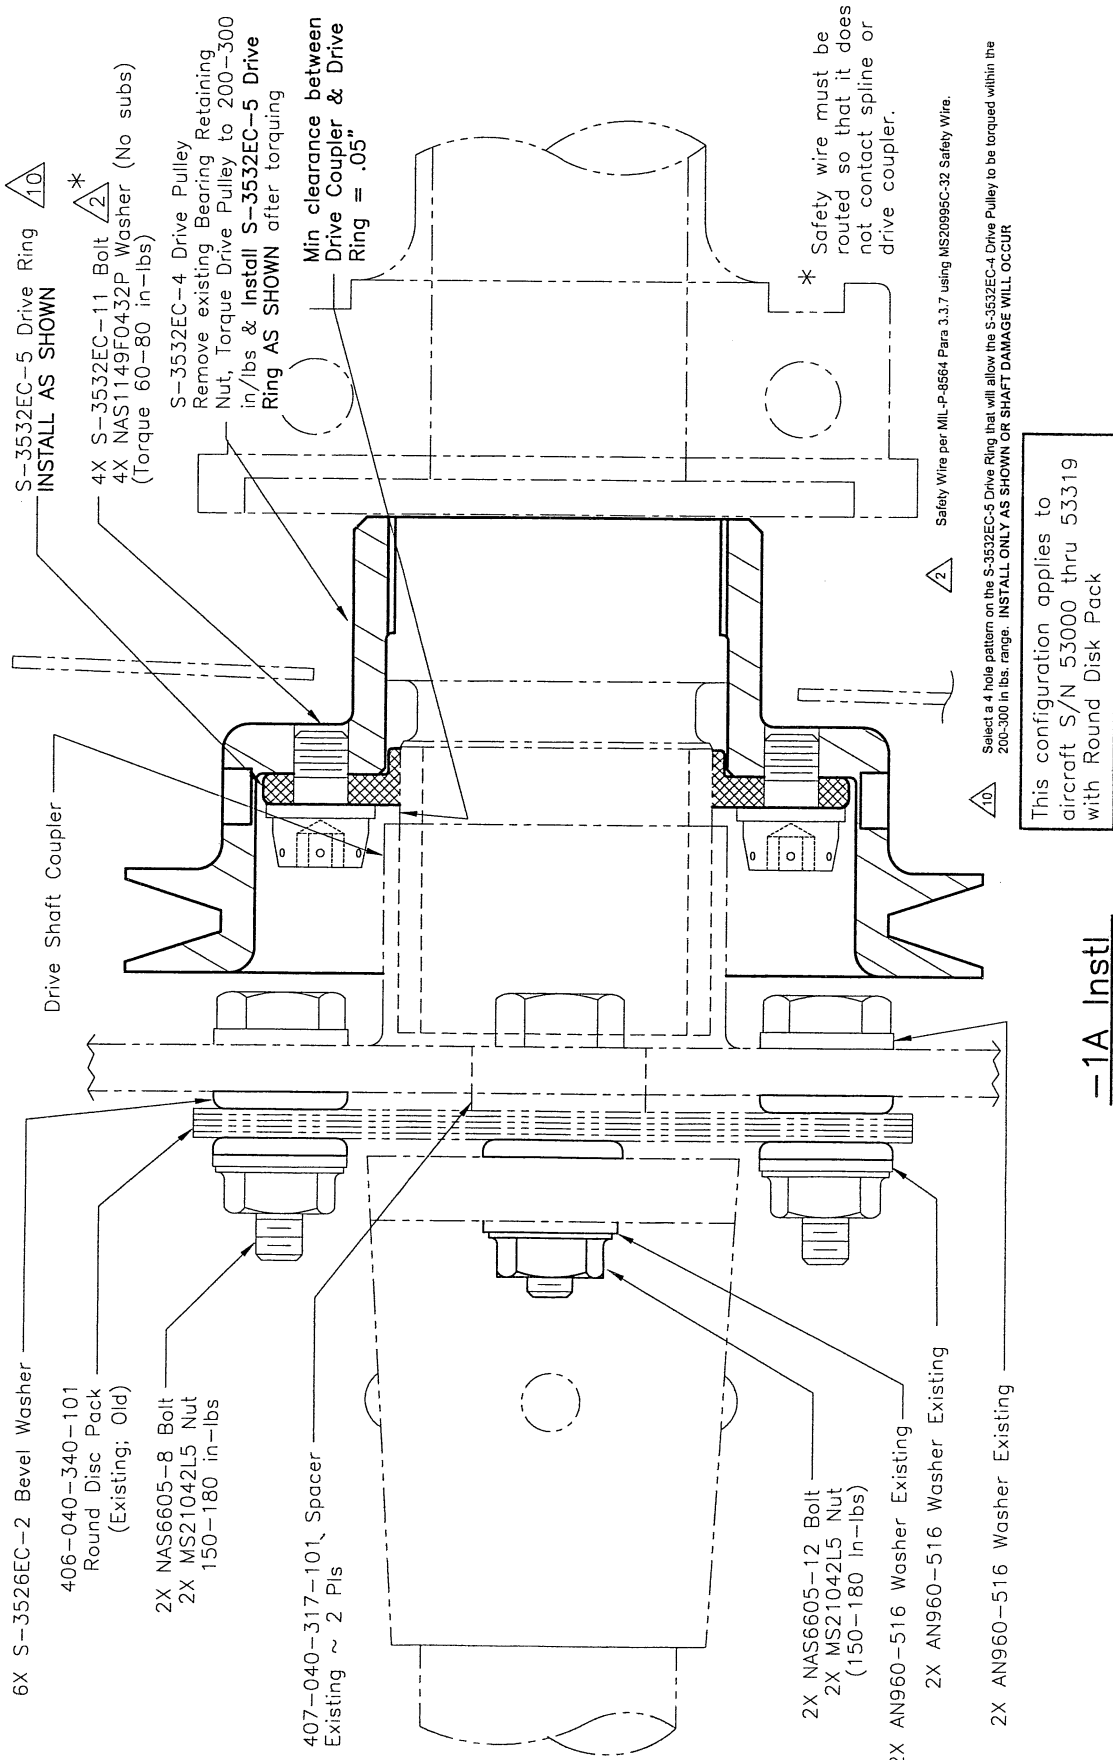
-1A Instl

S-3532EC-4 Pulley & S-3532EC-5 Drive Ring Installation (-1A Installation)
