**Service Bulletin:** SB407-101; Bell 407 Air Conditioner Compressor Drive Pulley.

**Subject:** Inspection & Torquing Procedure for the Air Conditioner Compressor Drive Pulley Installation.

**Applicability:** Bell 407, Equipped with the Air Comm Corporation 407EC-201 Air Conditioner System.

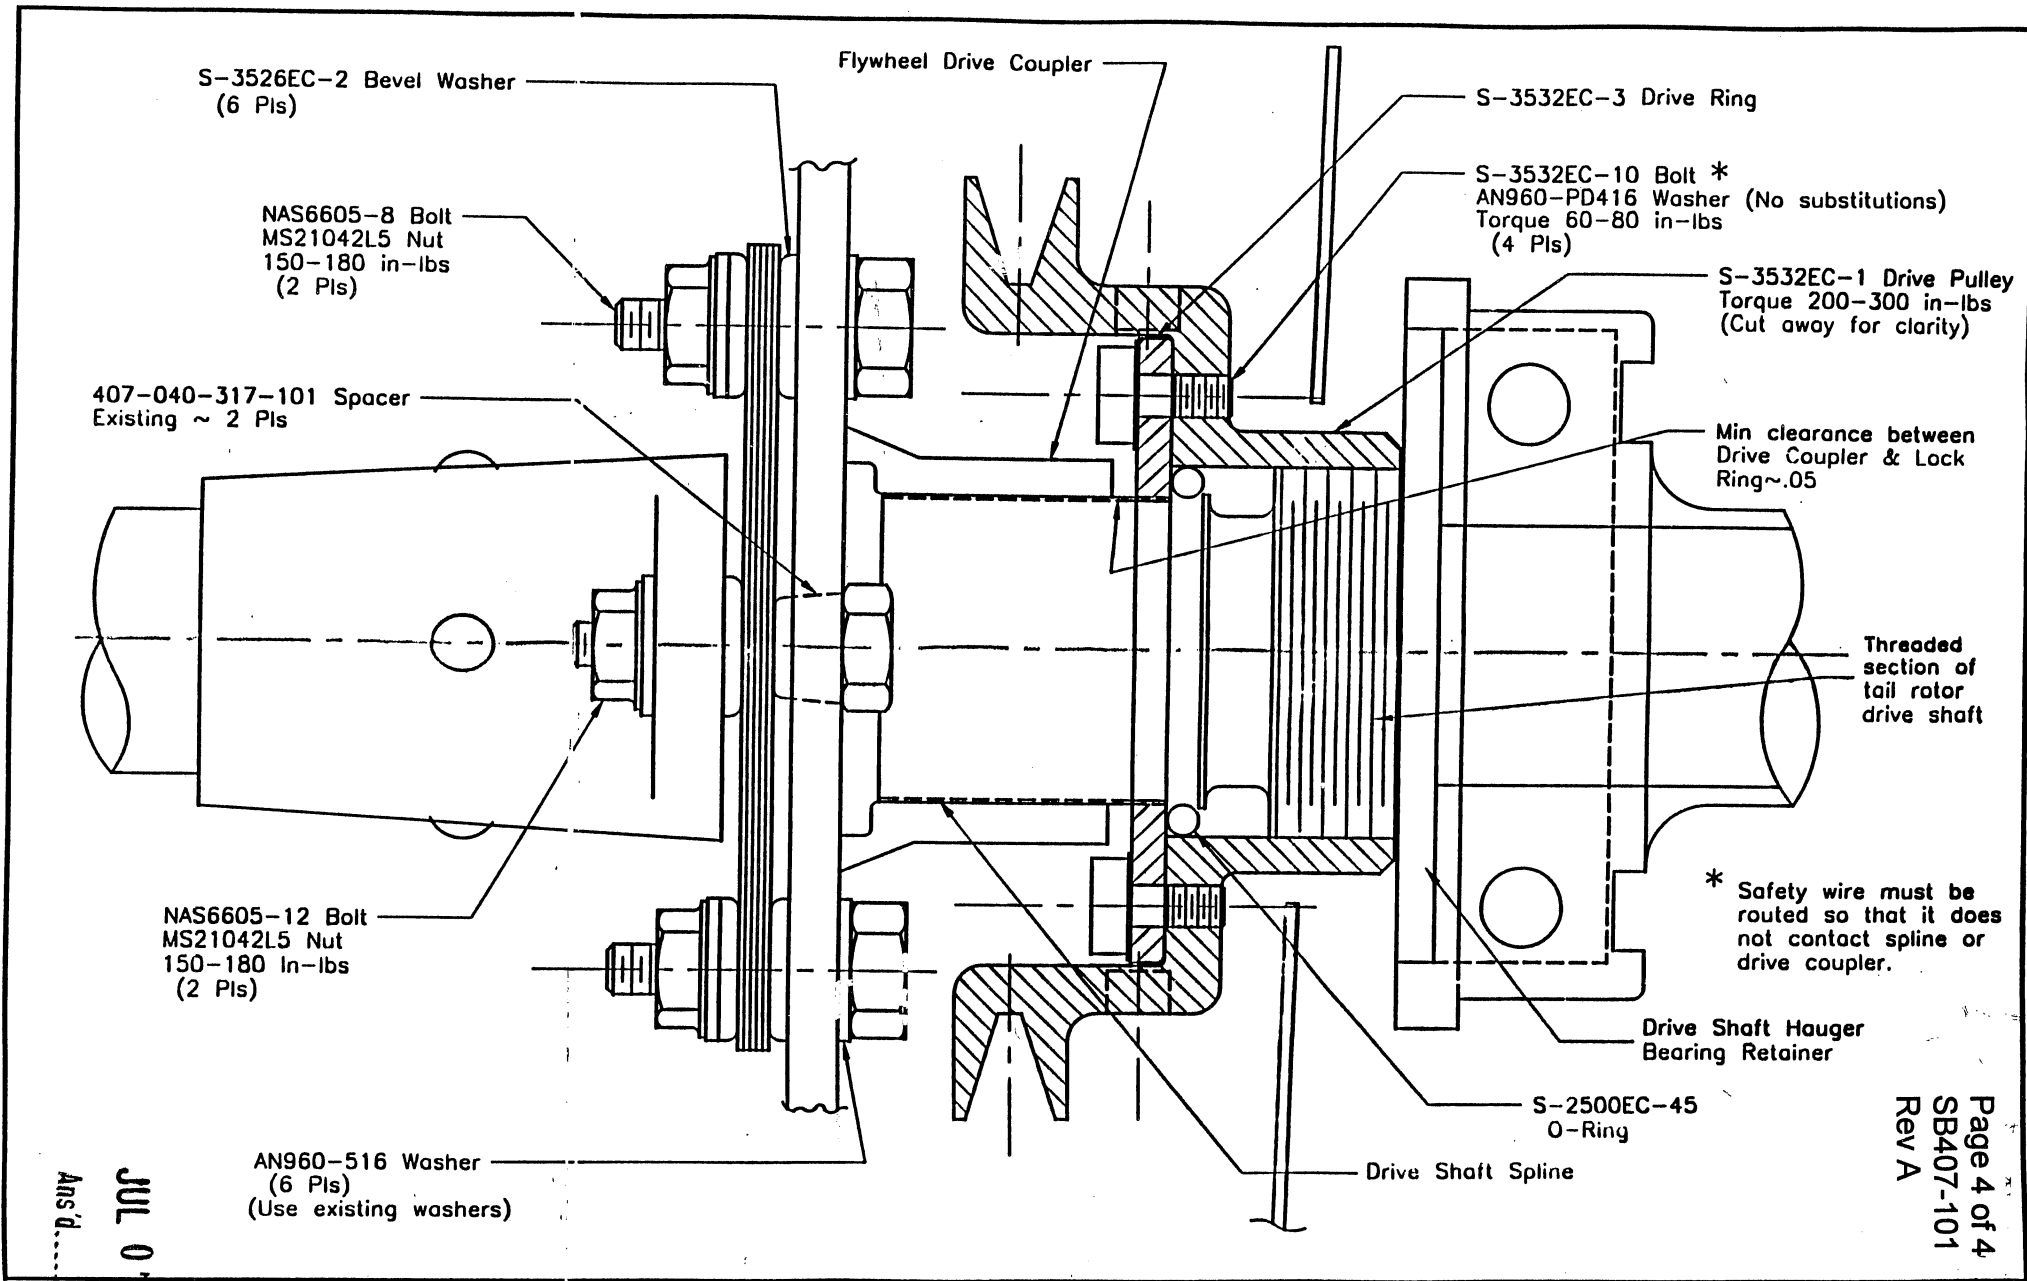
Figure 1 Compressor Drive Pulley Installation Details

It has come to our attention that excessive driveshaft spline wear may occur if the Compressor Drive Pulley is not properly installed.

This wear may occur at the Drive Ring Spline interface. To prevent wear in this area during operation the Drive Pulley must not rotate relative to the thread on the shaft.

Wear of the Compressor Drive Ring Spline and Compressor Drive Pulley Threads is caused by insufficient torque, or improper torquing procedures when installing the Compressor Drive Pulley (P/N S-3532EC-1).

2. Install Compressor Drive Pulley and Drive Ring as follows.
  - a. Install the Compressor Drive Pulley (P/N S-3532EC-1) on the forward end of the Tail Rotor Driveshaft, thread the pulley tightly against the face of the Driveshaft Hanger Bearing Retainer.
  - b. Torque Compressor Drive Pulley to 200 – 300 in lbs., using a .257 Dia X .13 Deep Spanner wrench, utilizing one of the four available holes on the pulley body. (See note page 3 of 4).
  - c. Install the Drive Ring (P/N S-3532EC-3) on the Driveshaft Spline, and slide into place. Align four of the twelve holes provided in the drive ring with the four threaded holes in the Compressor Drive Pulley.

Alignment of the four holes in the Drive Ring to match those in the Compressor Drive Pulley is accomplished by a "trial and error" method of placing the Drive Ring on the Driveshaft spline to check for hole alignment. Several rotations of the Drive Ring may be necessary to achieve the desired hole alignment. If rotation of the Pulley is required to achieve the Drive Ring hole alignment, the pulley torque must be increased. Do not exceed 350 in lbs of torque.

- d. Once the correct hole alignment is achieved between the Drive Ring and the Compressor Drive Pulley, Install the four retaining Bolts (P/N S-3532EC-10) and Washers (P/N AN960-PD416) torque to 60 – 80 in lbs., and safety the bolts in pairs using .032 safety wire.

- e. Install Flywheel Drive Coupler, Flywheel and existing Drive Shaft mounting hardware as shown on Page 4 of 4, torque nuts to 150 –180 in lbs.

Minimum clearance between the Flywheel Drive Coupler, and the Drive Ring is .050 inch.
